## MULTIPLE HISTORIC CHINATOWN BUILDINGS Graffiti Cleaning and Prevention

Honolulu, Hawaii

### **Final Report**

September 16, 2015

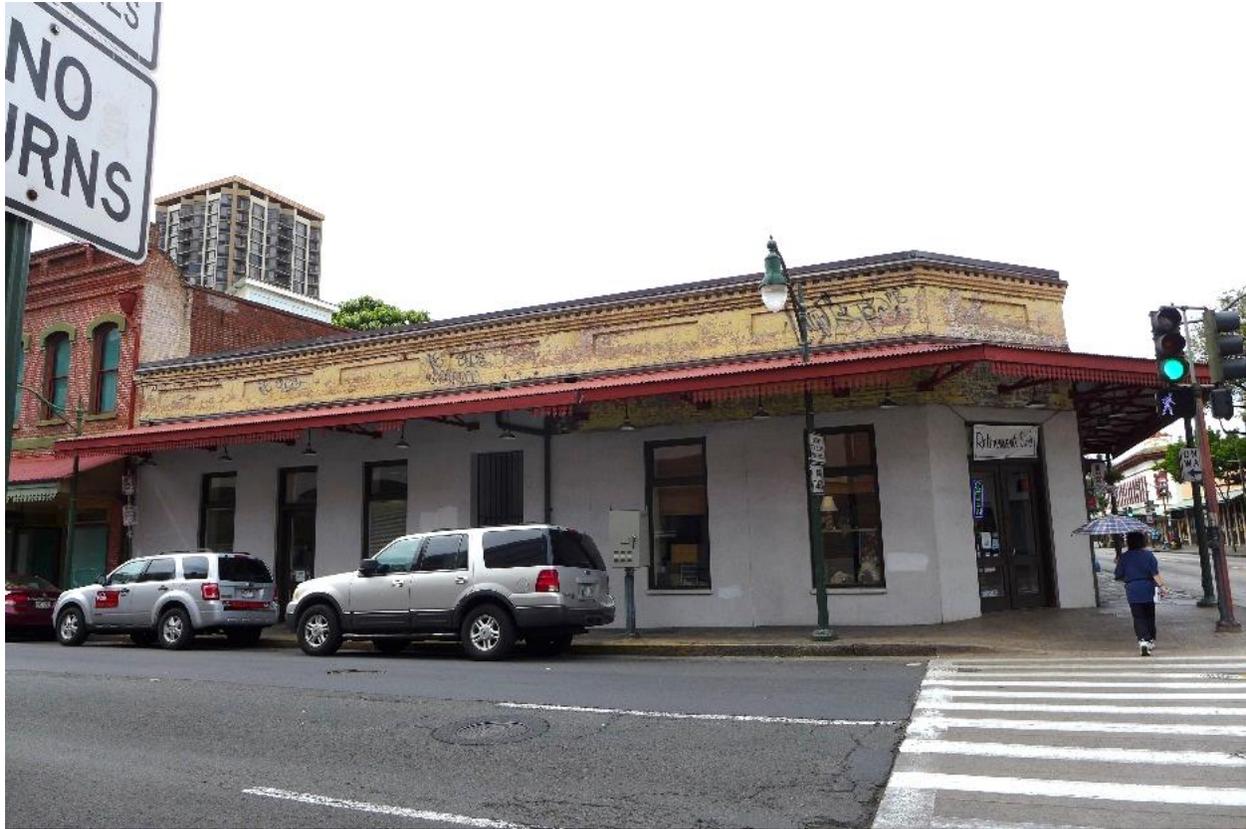
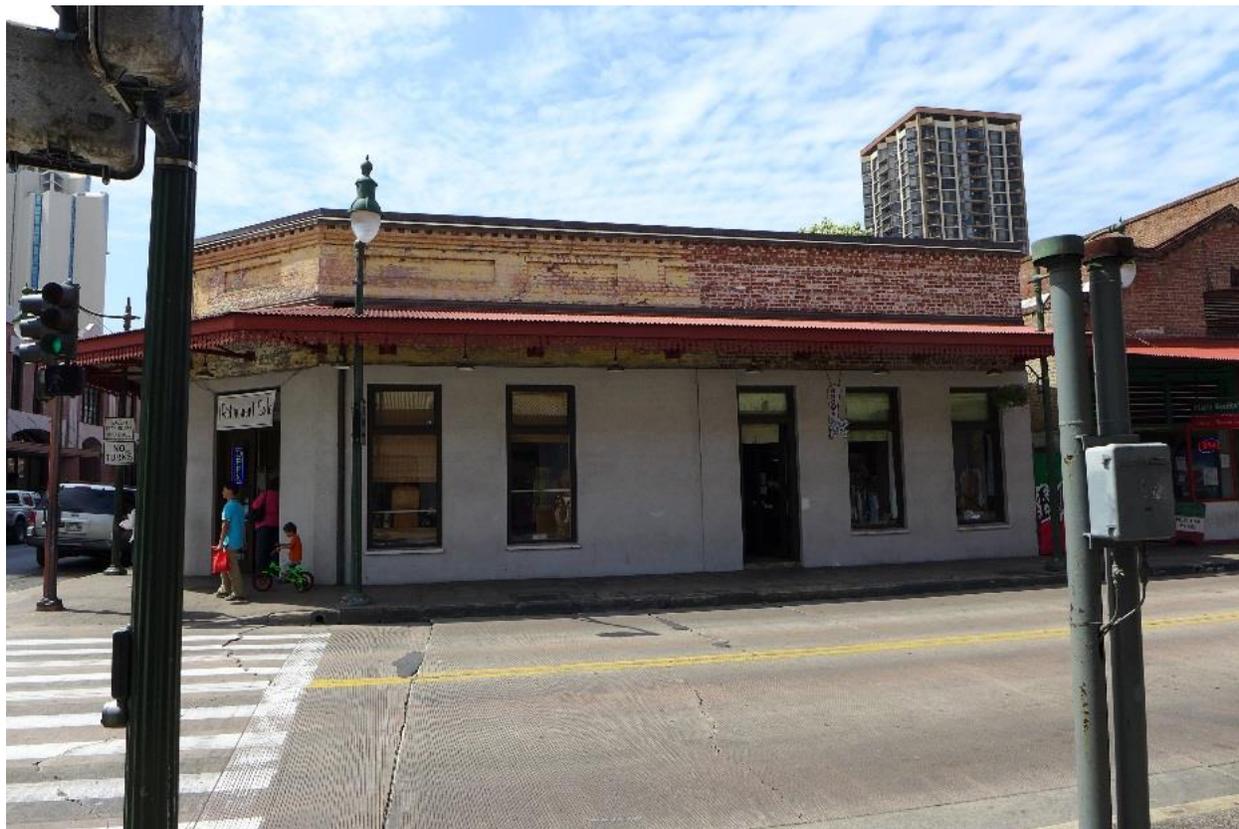
**1 North Hotel Street** is a single story brick and stucco building that is three and one half bays in width and four and one half bays in depth and is located on the northwest corner of Nuuanu Avenue and Hotel

Street (Figures 1 and 2). A metal canopy is anchored at the base of the parapet and extends over the adjacent sidewalk. The parapet above the canopy is corbelled brick with loose peeling remnants of a previously applied paint coating. The wall surface below the canopy is painted stucco (applied over the brick) with some isolated areas of exposed brick aligning with the canopy connection. The large punched openings include wood-framed fixed windows.

The graffiti present includes spray paint markings on the brick parapet. Locations where previously applied graffiti has been painted over are visible on the exterior plaster.

*Figure 1. General view of 1 North Hotel Street looking northwest.*

*Figure 2. General view of 1 North Hotel Street looking west.*

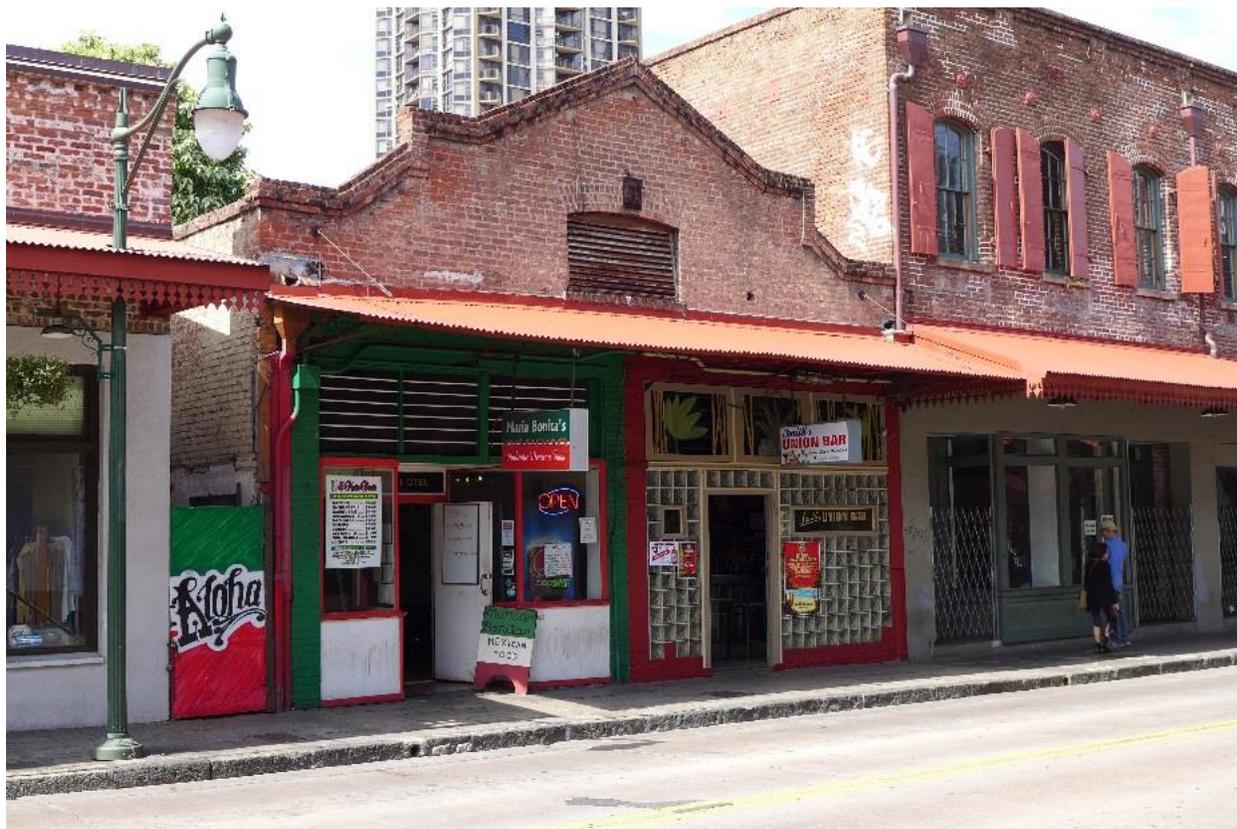
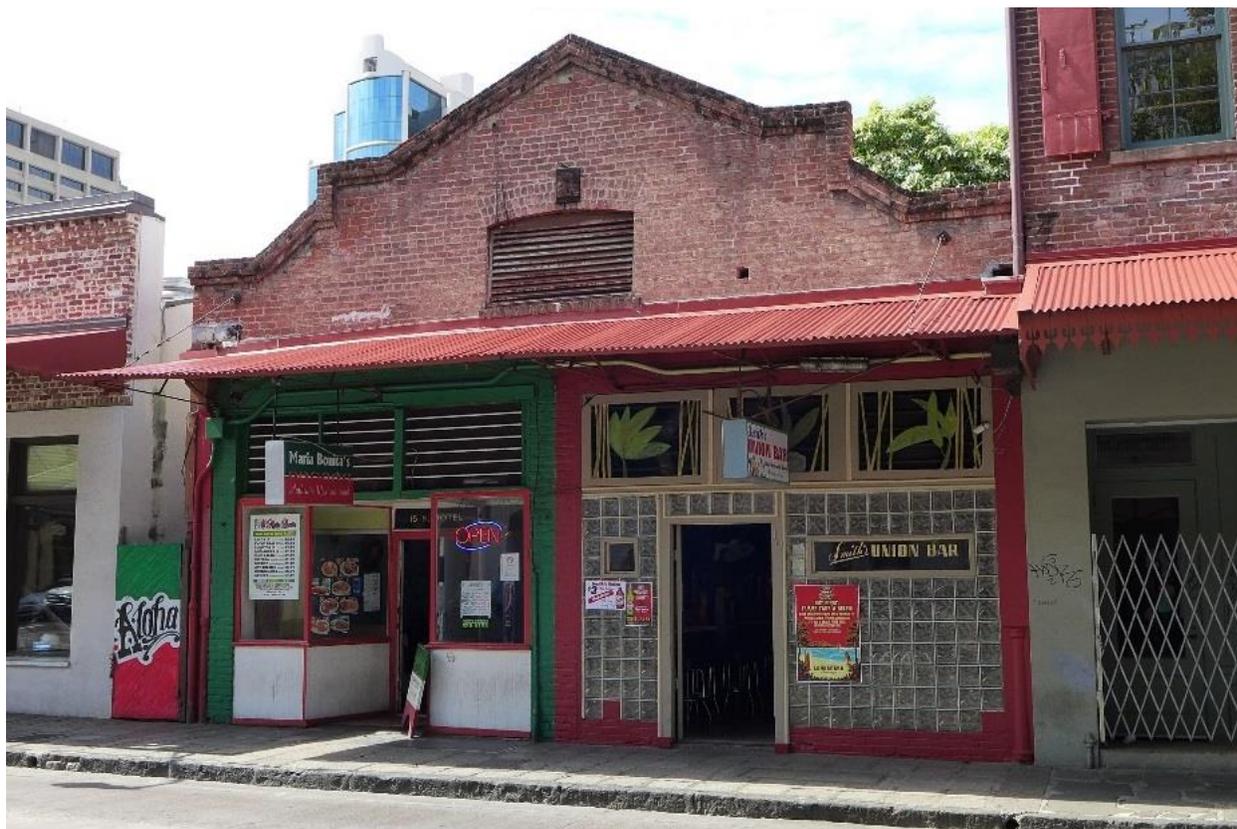
**15–19 North Hotel Street** is a single story brick building located on the west side of Hotel Street (Figures 3 and 4). The building is two bays in width and flanked by other buildings on the northwest and southeast. Although the building is divided into two storefronts, a single metal canopy originates at the base of the parapet and extends across both sections. The stepped, gabled parapet above the canopy is unpainted brick and includes a central vented opening. The storefronts beneath the canopy include painted brick, wood panels, and one painted cast iron element. Fenestration at 15 North Hotel Street includes a wood-framed storefront with fixed glazing and a large louver above the entrance. Fenestration at 19 North Hotel Street includes glass block, a corbelled cornice and parapet, and a corbelled arch over the large louvered vent above the entrance.

No graffiti was observed at the time of our site visit; however, previous graffiti on the painted brick has likely been overpainted.

*Figure 3. General view of 15-19 North Hotel Street looking northwest.*

*Figure 4. General view of 15-19 North Hotel Street looking west.*

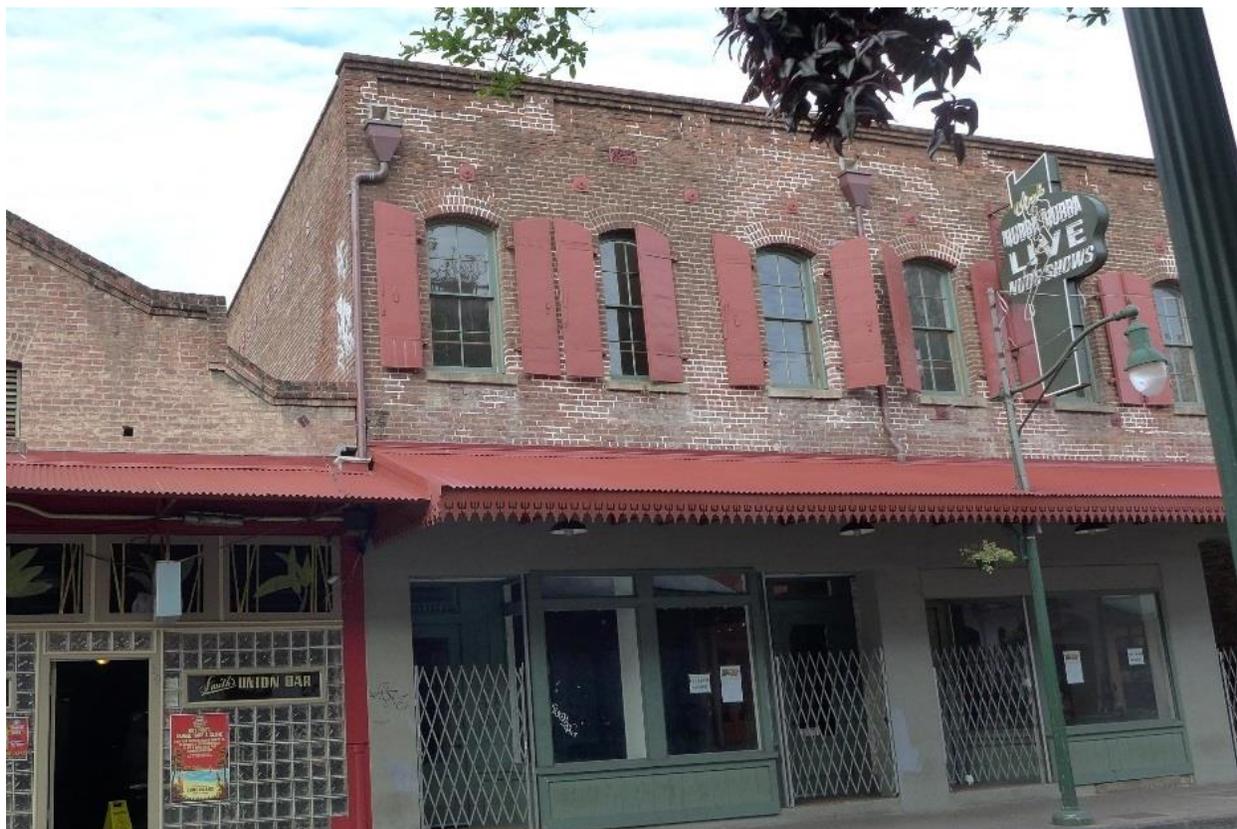
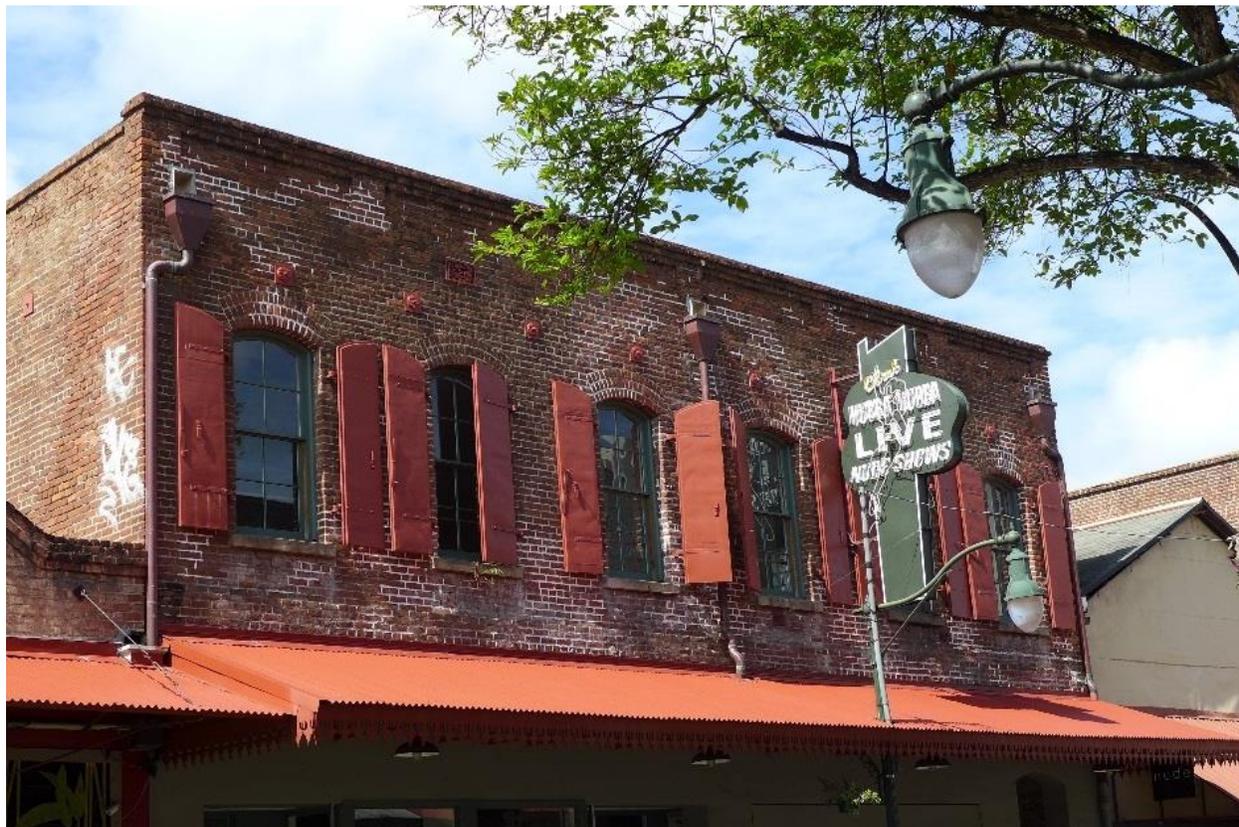
**25 North Hotel Street** is a two-story brick building located on the west side of North Hotel Street (Figures 5 and 6). The building is six bays in width and flanked by other buildings on the northwest and southeast. A metal canopy originates at the top of the first floor and extends over the adjacent sidewalk. The second story is brick and capped with a simple corbelled parapet. The brick exhibits many previous attempts at mortar joint repointing. Six arched window openings including wood four-over-four light double hung light wood sash extend across the second floor. Each window has two operable shutters.

The first floor wall surface (below the canopy) is painted stucco (applied over the brick). The first floor openings include recessed entrances and large wood-framed storefronts with fixed windows.

The graffiti present includes markings from a black indelible marker. Markings are concentrated at the recessed entrances. Locations of previously applied graffiti have been overpainted with paint that is slightly lighter in color than the adjacent coating. At the second story there is an isolated area of white spray painted graffiti on the brick surface.

*Figure 5. General view of 25 North Hotel Street looking west.*

*Figure 6. View of the second story windows at 25 North Hotel Street looking northwest.*

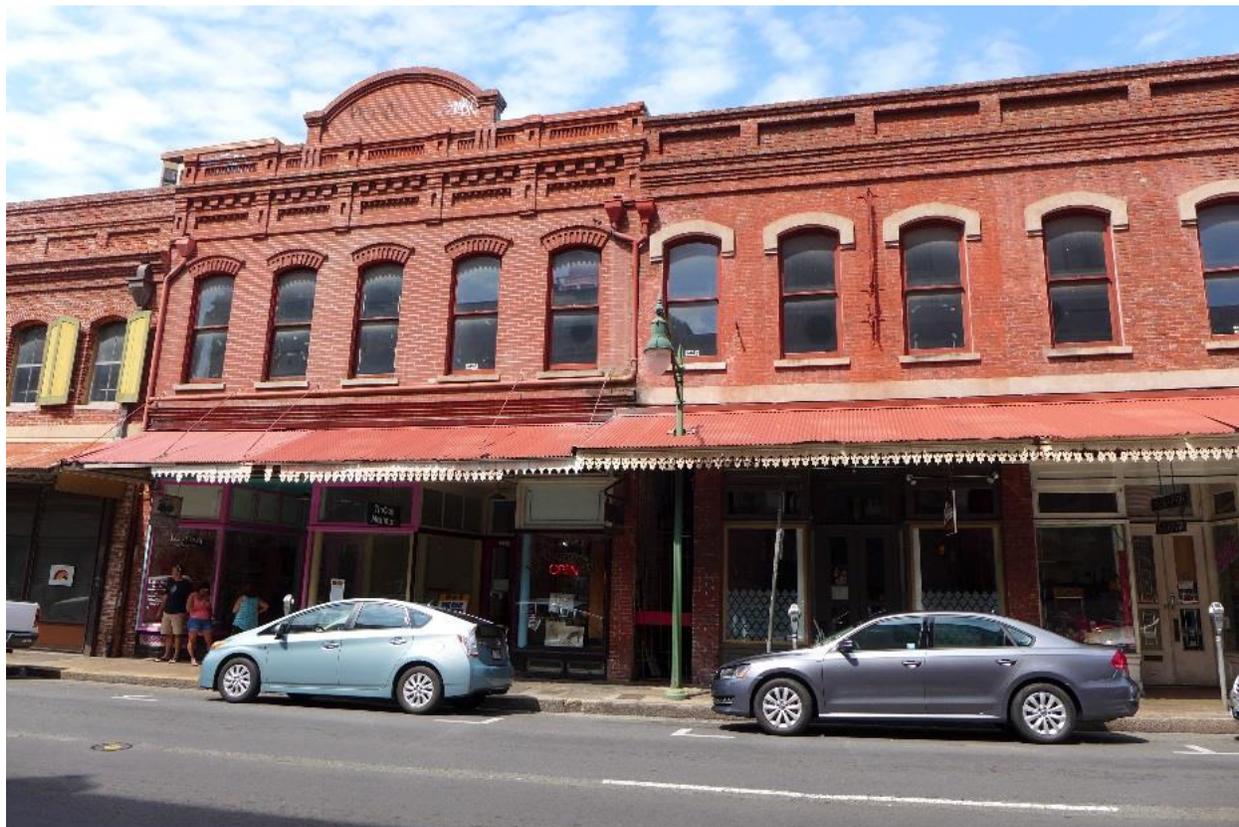
**1024–1034 Nuuanu Avenue** is located on the northwest side of Nuuanu Avenue between North Hotel Street and North King Street (Figures 7 and 8). The facade is ten bays wide and flanked by other building to the northeast and southwest. The address includes two distinct two-story brick facades. Each facade has arched openings on the second floor with wood-framed one-over-one light double-hung windows. The facade to the east includes stone arches and the brick appears to have been previously painted red; this coating has either worn away or been partially removed. The facade to the west includes brick arches above the opening and the brick facade does not appear to have been coated in the past. Metal storefronts are located between brick piers at the first floor of each facade. A metal canopy originates from the top of the first floor, extending over the sidewalk at each facade.

*Figure 7. General view of 1024-1034 Nuuanu Avenue looking northwest.*

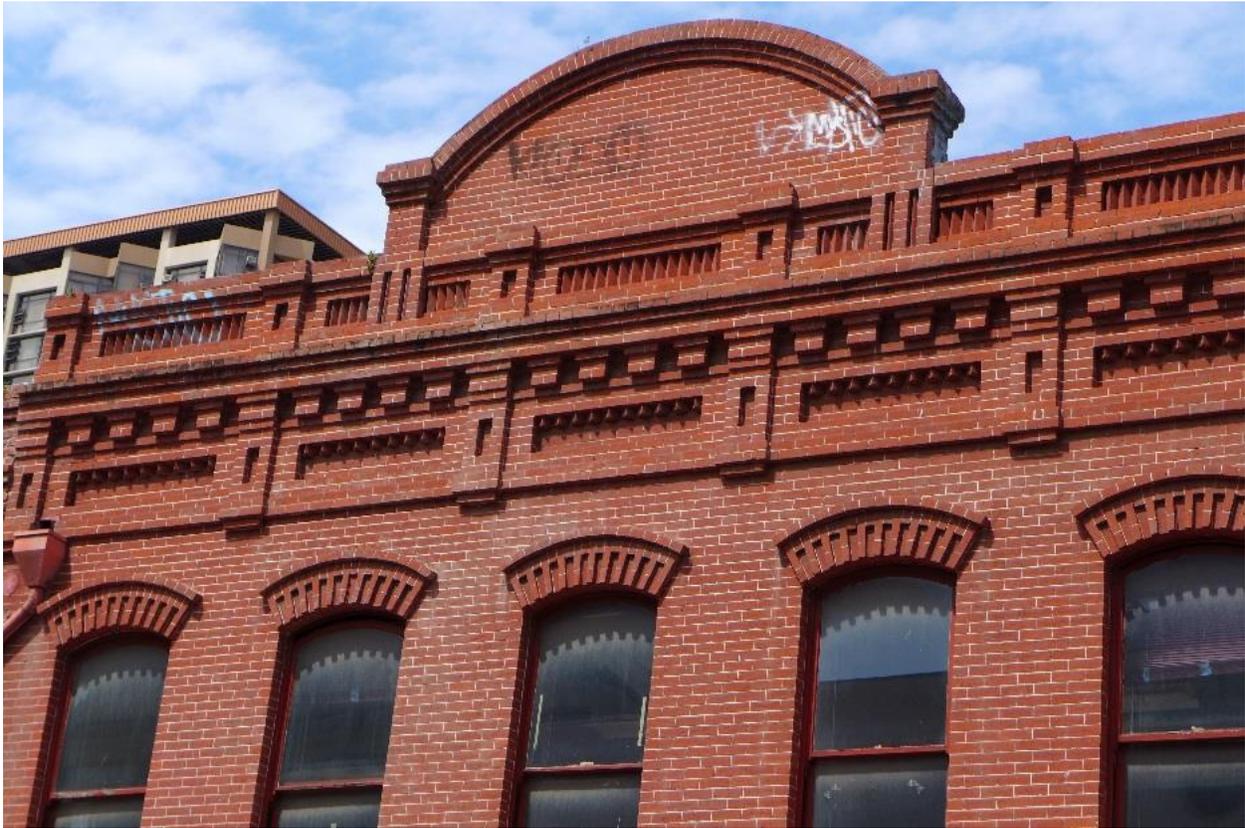
The graffiti observed includes isolated areas of black, blue, and white spray painted markings at the parapet.

*Figure 8. Parapet graffiti at 1024-1034 Nuuanu Avenue.*

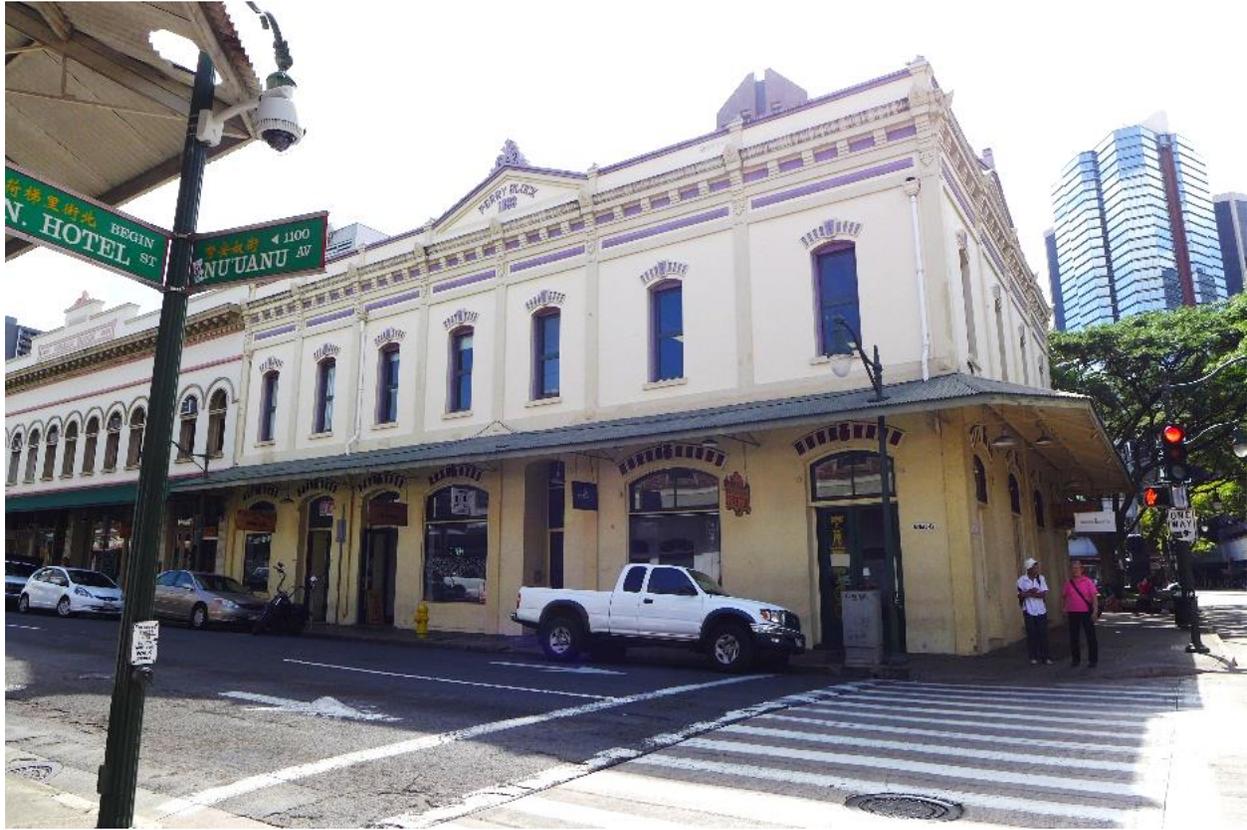
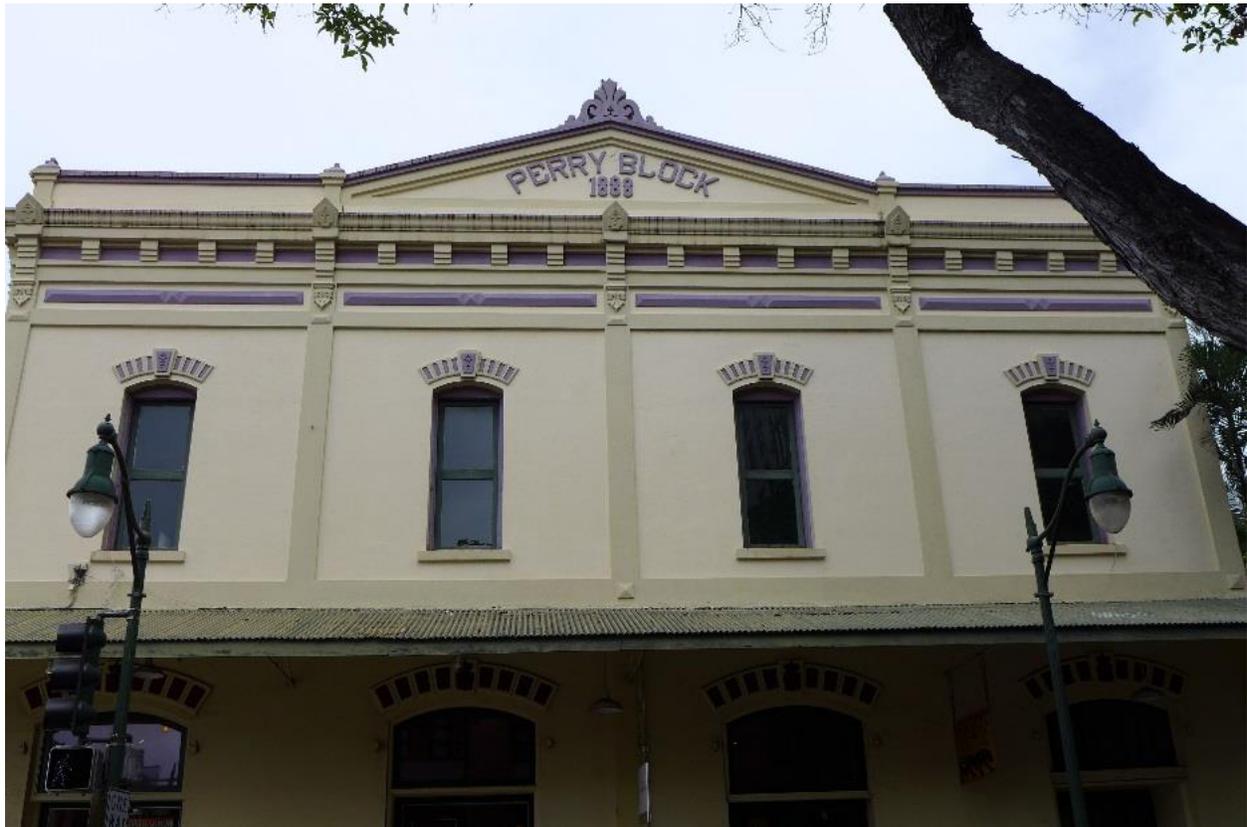
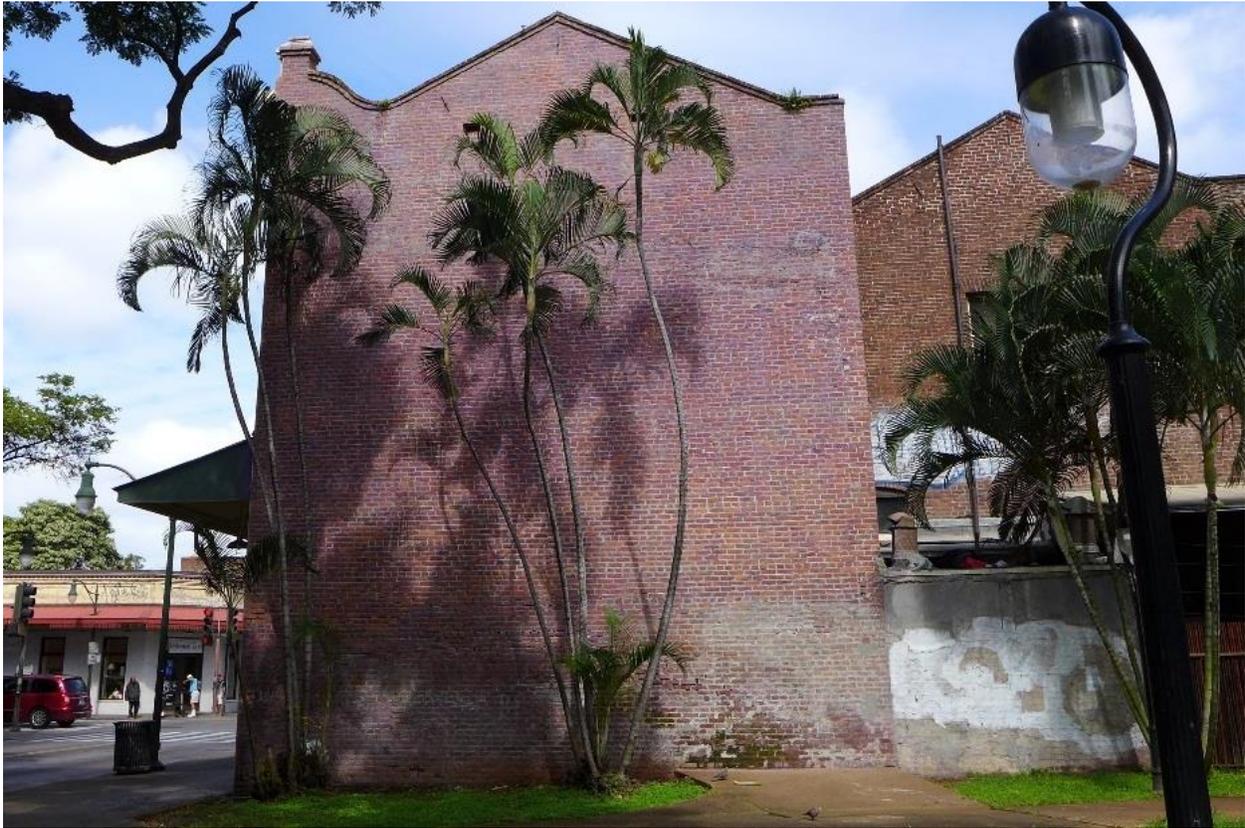
**1111 Nuuanu Avenue**, known as the Perry Block, is a decoratively painted, two-story exterior plaster building located on the southeast corner of North Hotel Street and Nuuanu Avenue (Figures 9 through 11) that is four bays in width and seven bays in depth. Each bay includes an arched opening at each floor. The first floor openings include wood-framed fixed windows and paired wood doors with arched transoms and the second floor windows are one-over-one fixed sash in wood frames. On both the Nuuanu Avenue and North Hotel Street facades, there is a metal canopy at the top of the first floor and a decorative cornice at the parapet. The southeast facade of the Perry Block is brick. This facade was previously covered with extensive painted graffiti that has since been removed by chemical means using an unreported product. Although shadowing of the previous graffiti is still visible, the building owner is reportedly satisfied with the level of graffiti removal.

The graffiti currently present includes isolated locations of black indelible markings.

*Figure 9. General view of 1111 Nuuanu Avenue (Perry Block) building looking southeast.*

*Figure 10. View of the Perry Block building from North Hotel Street.*

*Figure 11. Previously painted brick southeast facade of the Perry Block building looking northwest.*

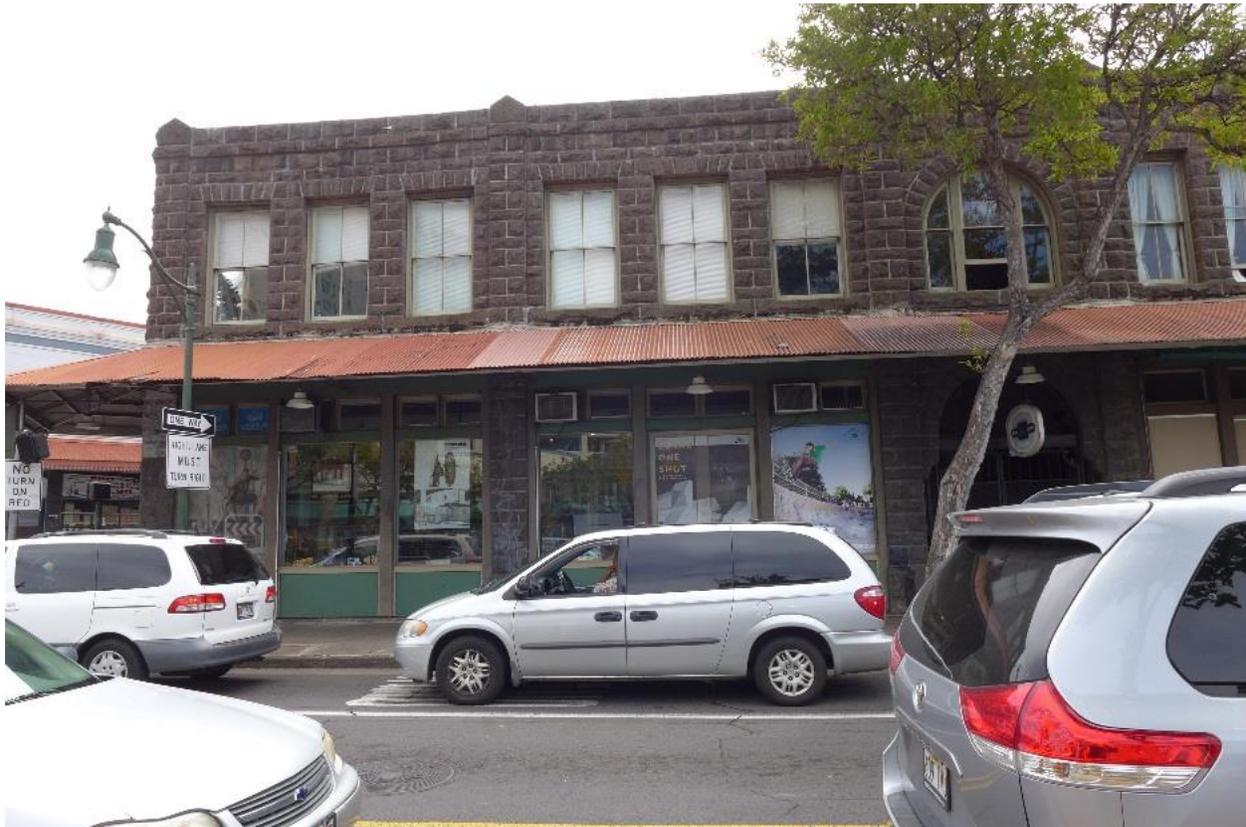
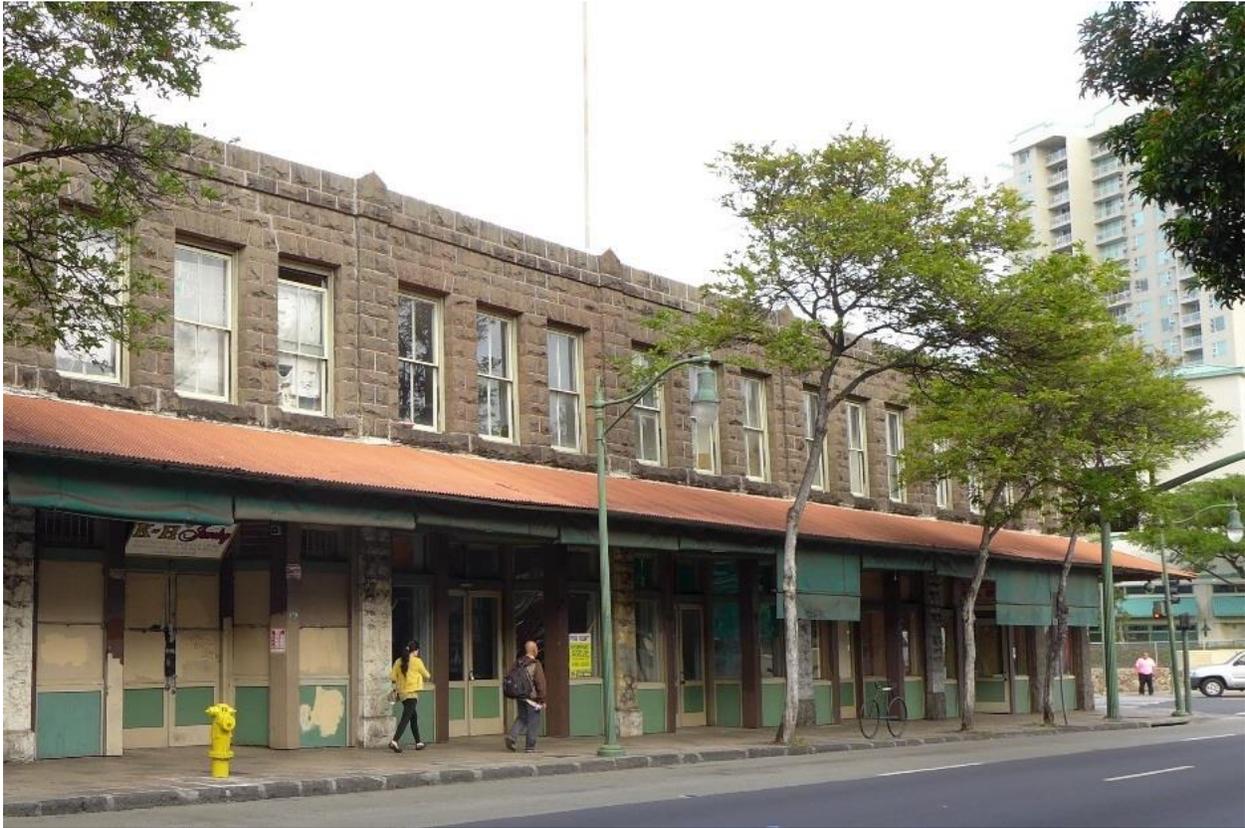
**175 North King Street** is located on the southwest corner of North King Street and River Street (Figures 12 and 13). The building is twenty bays in width and thirteen bays in depth. The River Street and North King Street facades include ashlar rock-faced basalt stone with one-over-one or two-over-two light wood double-hung windows at the second floor, and wood panels and storefront glazing in the openings between stone columns at the first floor. Large areas of the stone façade were previously painted with a silver colored metallic paint. This coating was reportedly applied prior to the tenure of the current owner. The west facade of the building includes a painted stucco surface at the first floor.

The graffiti observed includes isolated areas of white spray-painted markings at grade level on the stone facades and black spray-painted graffiti on the west facade.

*Figure 12. View of 175 North King Street (Armstrong Building) from River Street looking southeast.*

*Figure 13. General view of 175 North King Street looking northwest.*

Removal of the silver coating from 175 North King Street may be considered to restore the stone facades to their originally intended appearance. If this is desirable, we recommend using the Smart Strip Pro product following the procedure below.

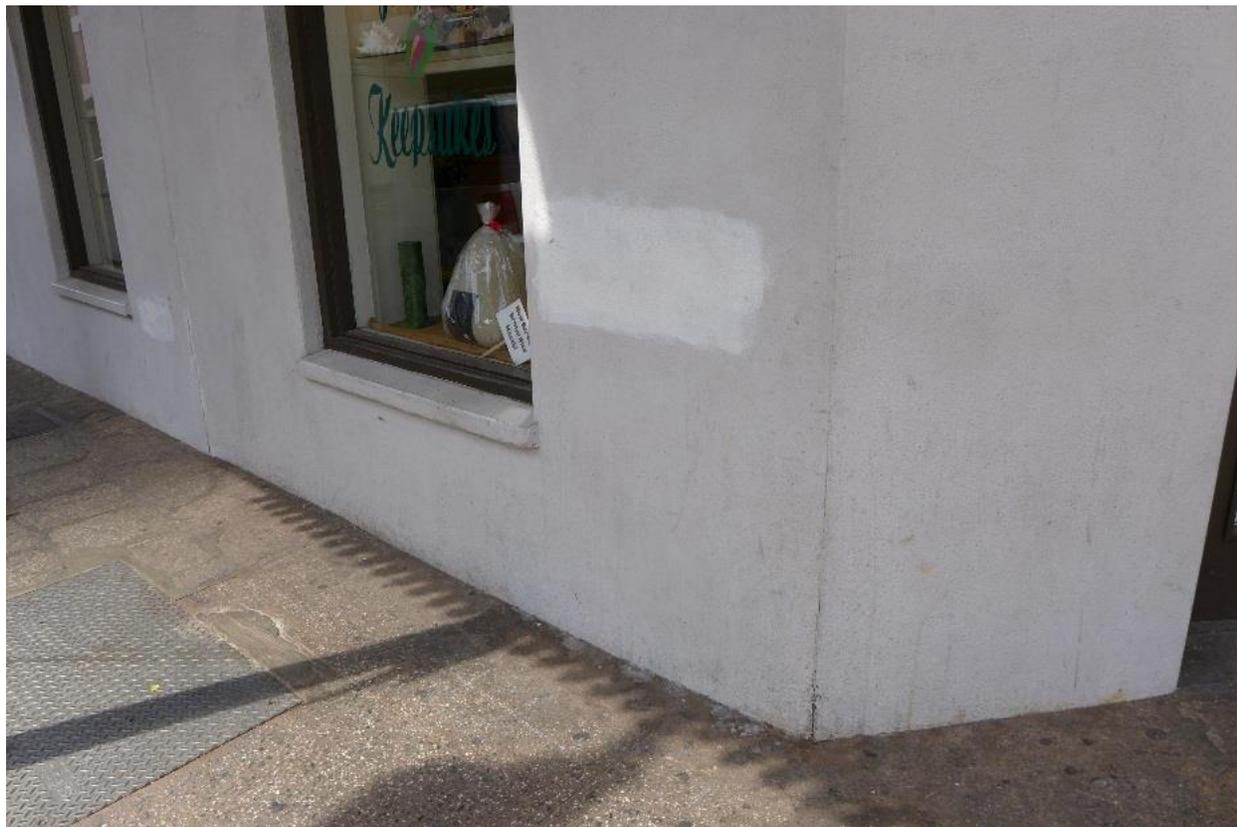
Overpainting is a graffiti removal method that covers the graffiti instead of removing it (Figure 14). Overpainting is appropriate for substrates, such as stucco and painted brick that were painted historically. The overpainting should match the base paint in color and sheen, and should be compatible with the base paint. Multiple applications may be required to cover dark colored graffiti. Where existing paint coatings are deteriorated or soiled, additional surface preparation such as scraping and/or cleaning may be required prior to overpainting. Overpainting is not an appropriate graffiti removal method if the substrate was not

*Figure 14. Example of graffiti that has been overpainted at the 1 North Hotel Street building.*

If this protocol is used to remove graffiti from an existing painted surface, removal of the underlying paint may result. Overpainting is recommended to address graffiti on historically painted surface.

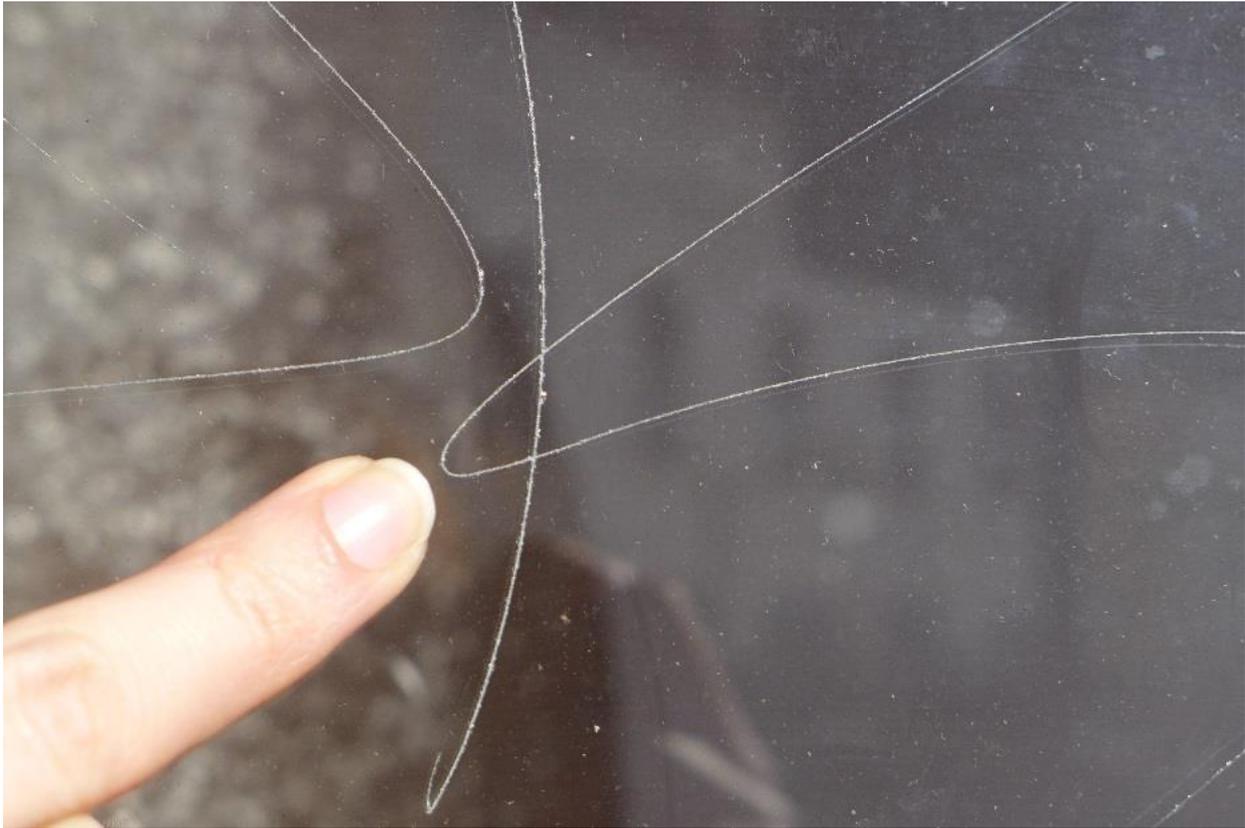
Graffiti in the form of glass scratching is also reported to be common in Chinatown (Figure 15). This type of graffiti typically includes scratching symbols or names into the glass surface with knives, keys, or other sharp objects. Depending on the depth of the markings, scratched surfaces are typically addressed by polishing the surface of the glass with cerium oxide. If the areas are deeply scratched, the area may need to be abraded with a high grit silicon carbide paper prior to polishing. The repair of deep scratches may alter the optical qualities of the glass. If scratching is severe, or covers a large area of the unit, replacement of the glass may be recommended. Replacement may also be recommended if repeated polishing efforts in the same location alter the optical qualities of the glass.

*Figure 15. Example of typical scratched glass graffiti.*

Optically clear protective window films are marketed as sacrificial coverings for use on glazing in graffiti prone areas. The films are applied to the exterior of the window and can be removed and replaced if glass graffiti occurs. These films may add additional protection against glass breakage. Shaded or solar protection options are also available.

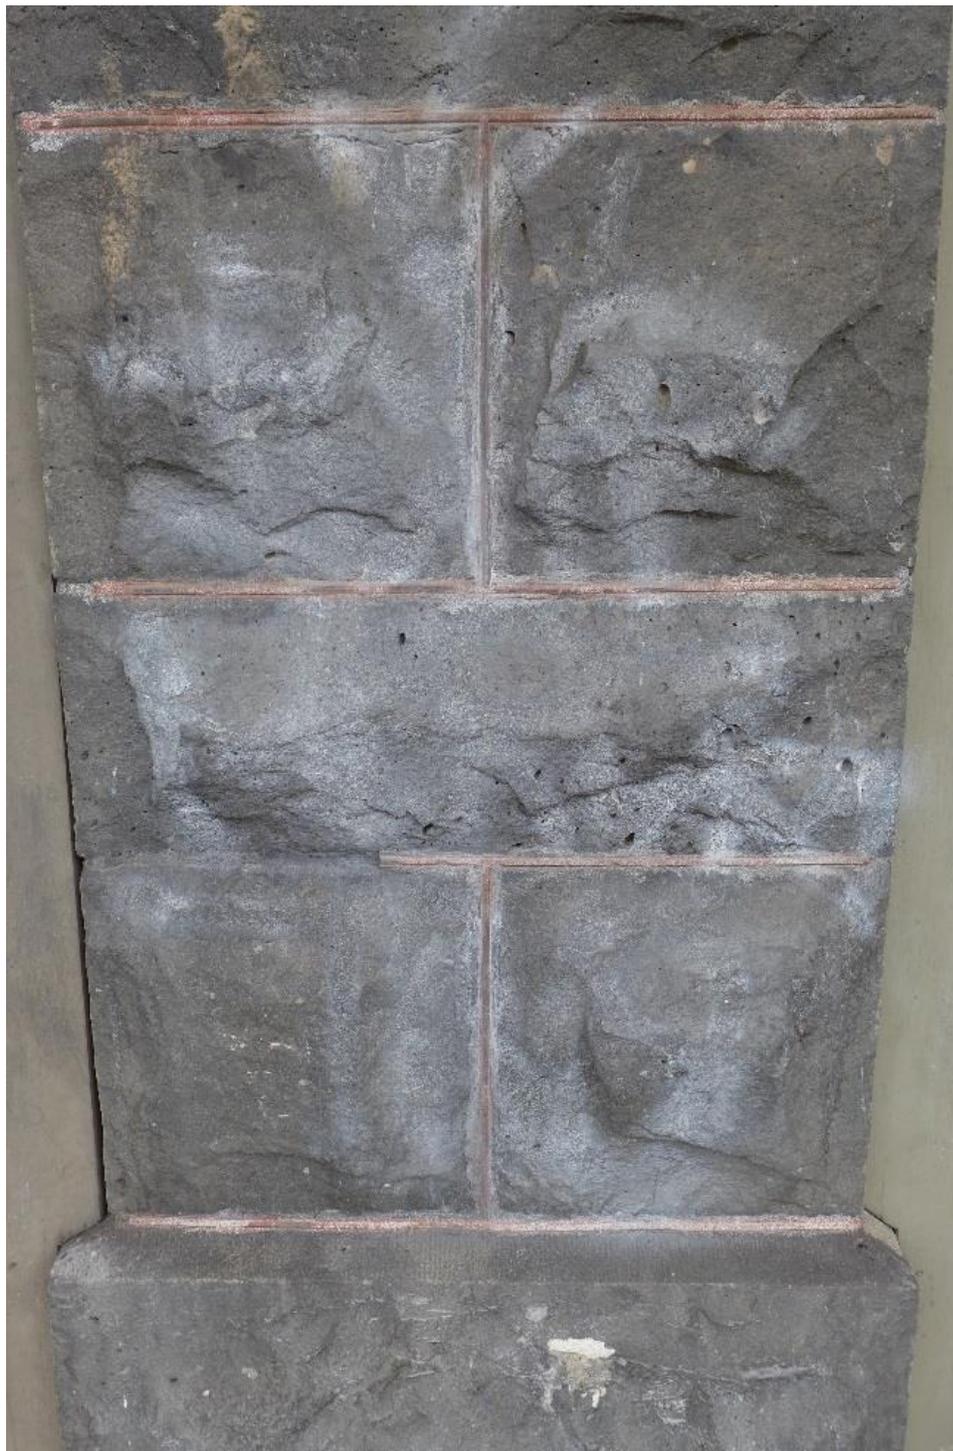
The products were applied to locations with a basalt stone substrate and white spray paint and silver painted coatings. The white spray painted area had reportedly been previously treated with a liquid paint stripper. However, the manufacturer or product name of the liquid paint stripper was not provided.

*Figure 16. Spray painted graffiti trial area at 175 North King Street prior to trials.*

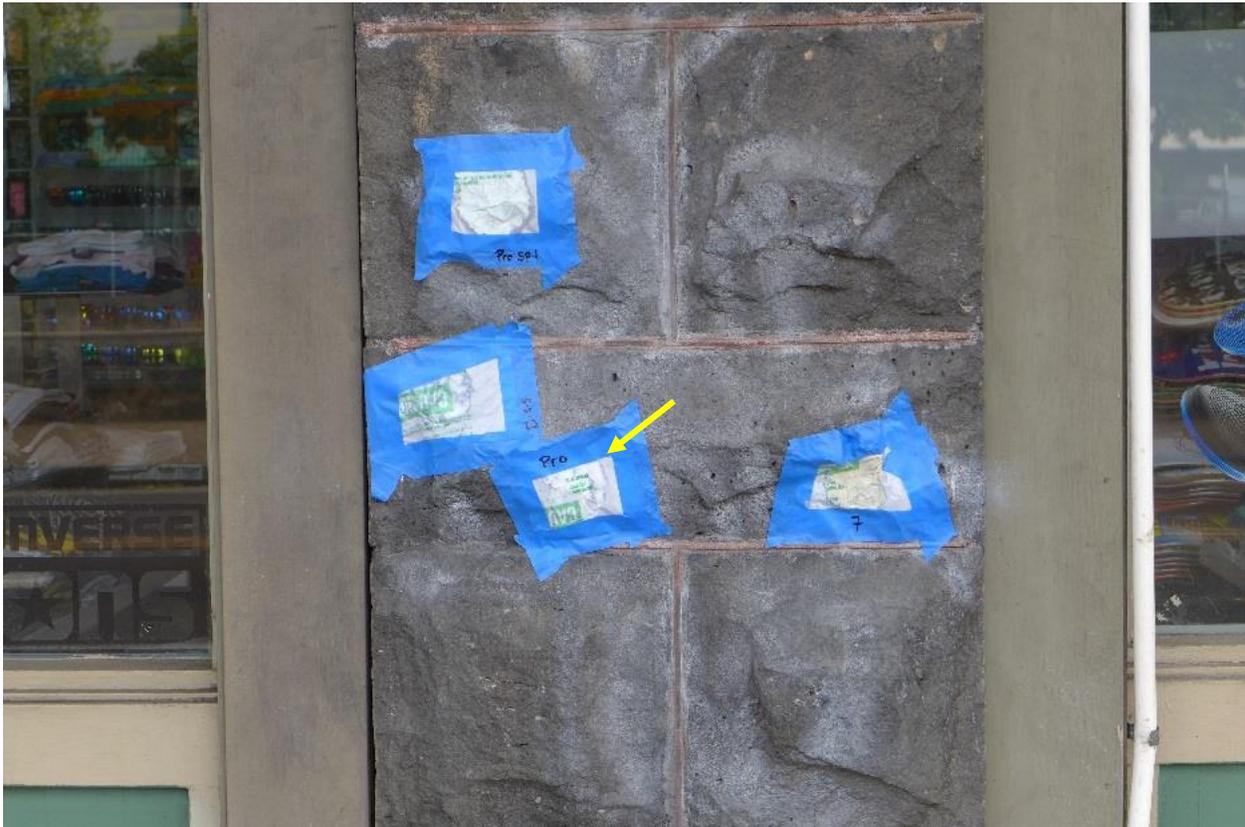
The products were applied according to manufacturer's printed instructions, covered with laminated paper and tape along the edges to increase adhesion (laminated paper is not typically supplied for Safety Peel 1; however it was used in this trial for consistency), and allowed to remain in place for approximately 17 hours or overnight. When the trial areas were reviewed the day after the application, the tape and paper coverings were no longer present; however, the chemical paste remained on the stone surface. (If the paper remains in place throughout the dwell period, improved effectiveness would be expected.)

*Figure 17. Spray paint removal trials in progress. The Smart Strip Pro trial location is indicated with an arrow.*

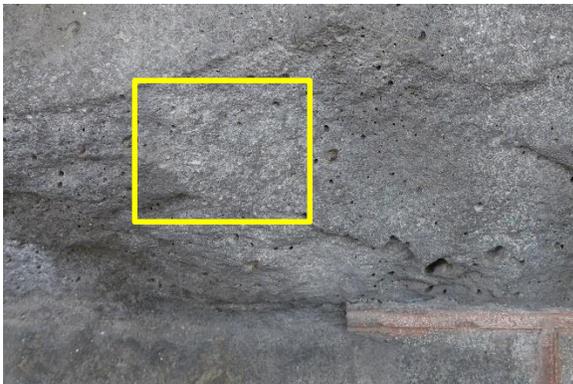
*Figure 18. Trial area of Smart Strip Pro prior to application.*

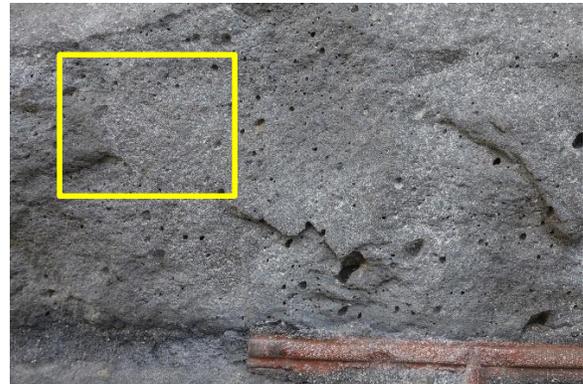
*Figure 19. Trial area of Smart Strip Pro after application. White deposits on the stone surface have been reduced, but deposits in the pores remain.*

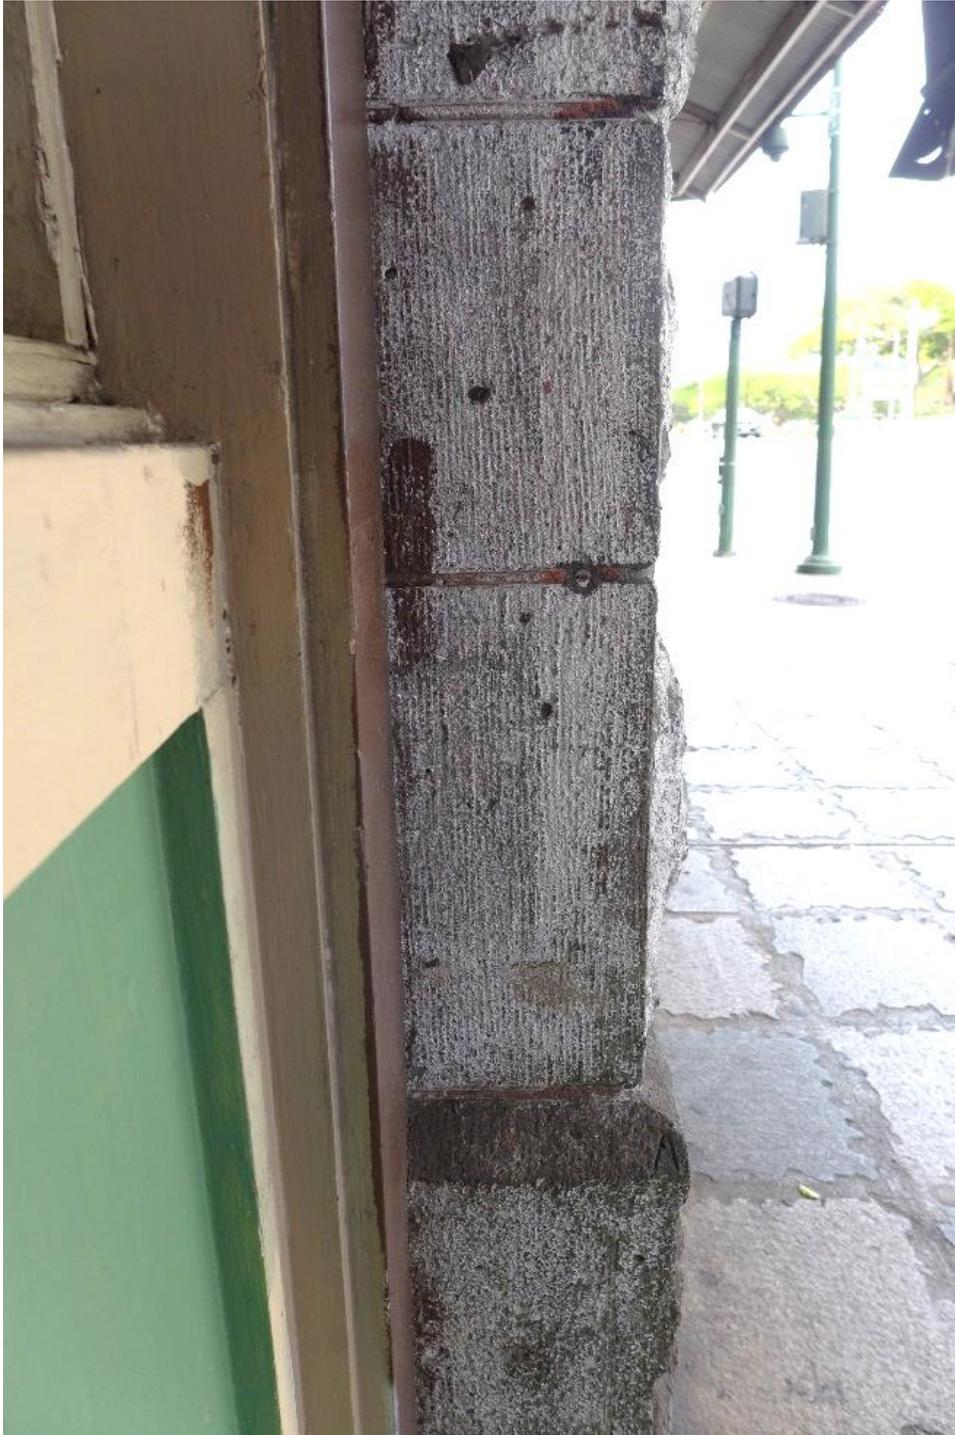
*Figure 20. Silver paint removal trial area.*
