## MULTIPLE HISTORIC CHINATOWN BUILDINGS Graffiti Cleaning and Prevention

Honolulu, Hawaii

### **Final Report**

September 16, 2015

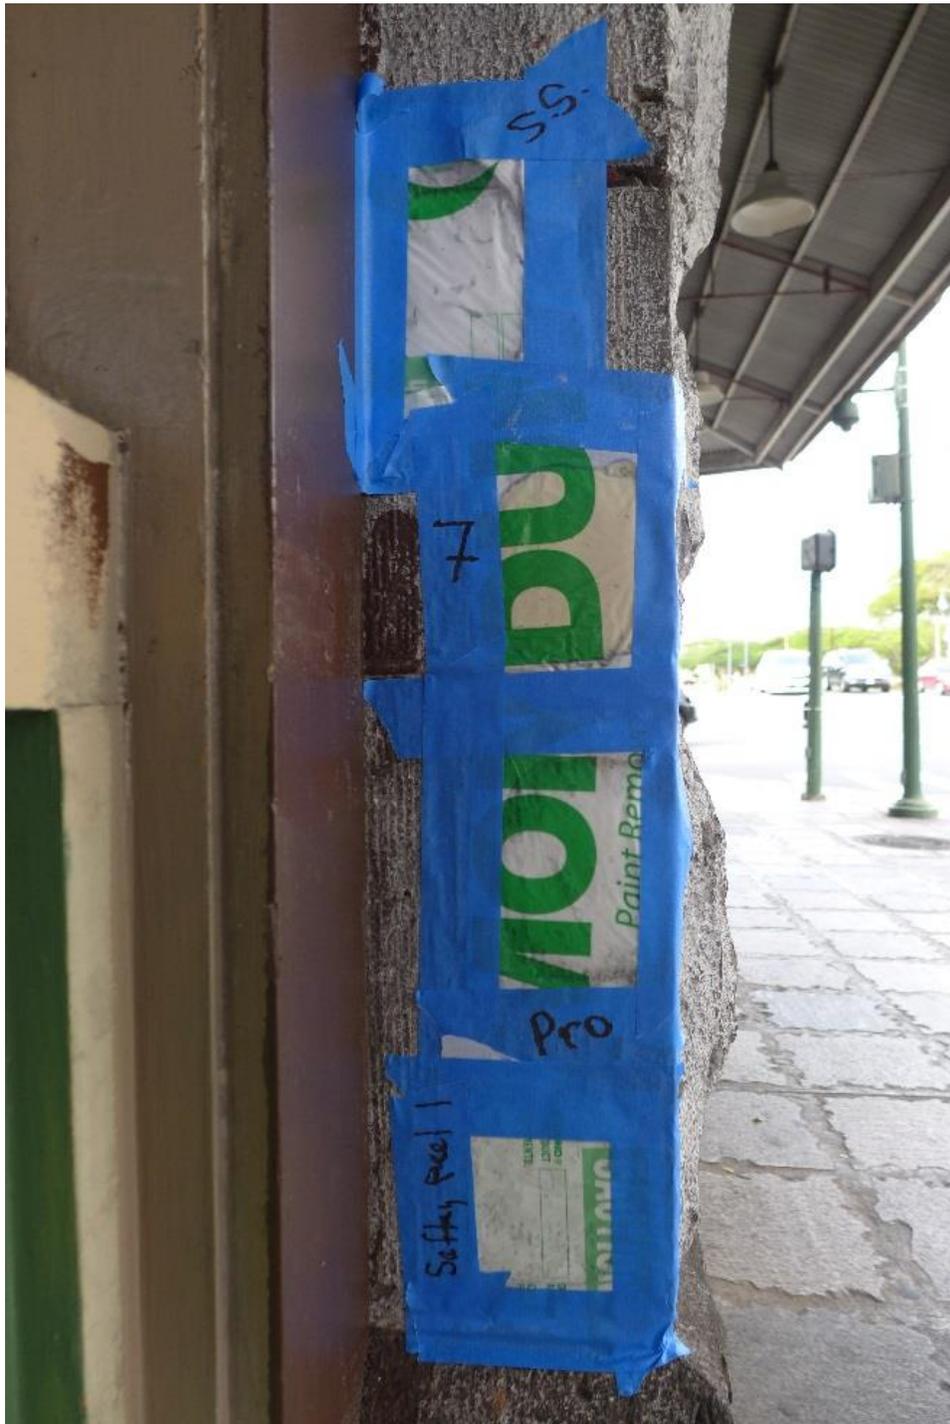
Figure 21. Trial locations after application.

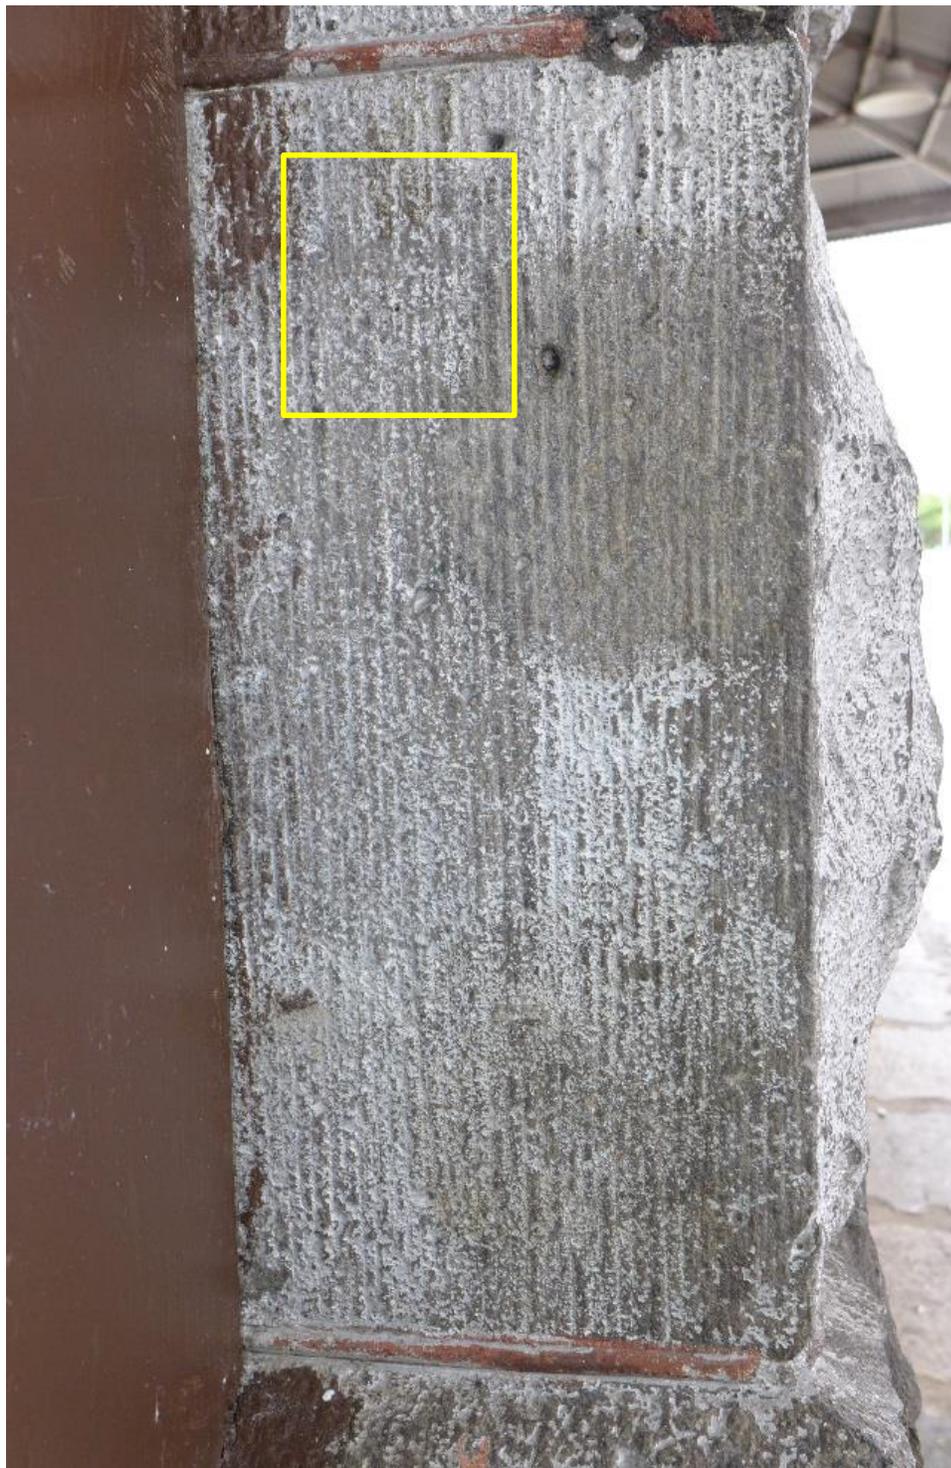
*Figure 22. Smart Strip Pro location after trial.*

Removal of the silver coating from 175 North King Street may be considered to restore the stone facades to their originally intended appearance. If this is desirable, we recommend using the Smart Strip Pro product following the procedure below.

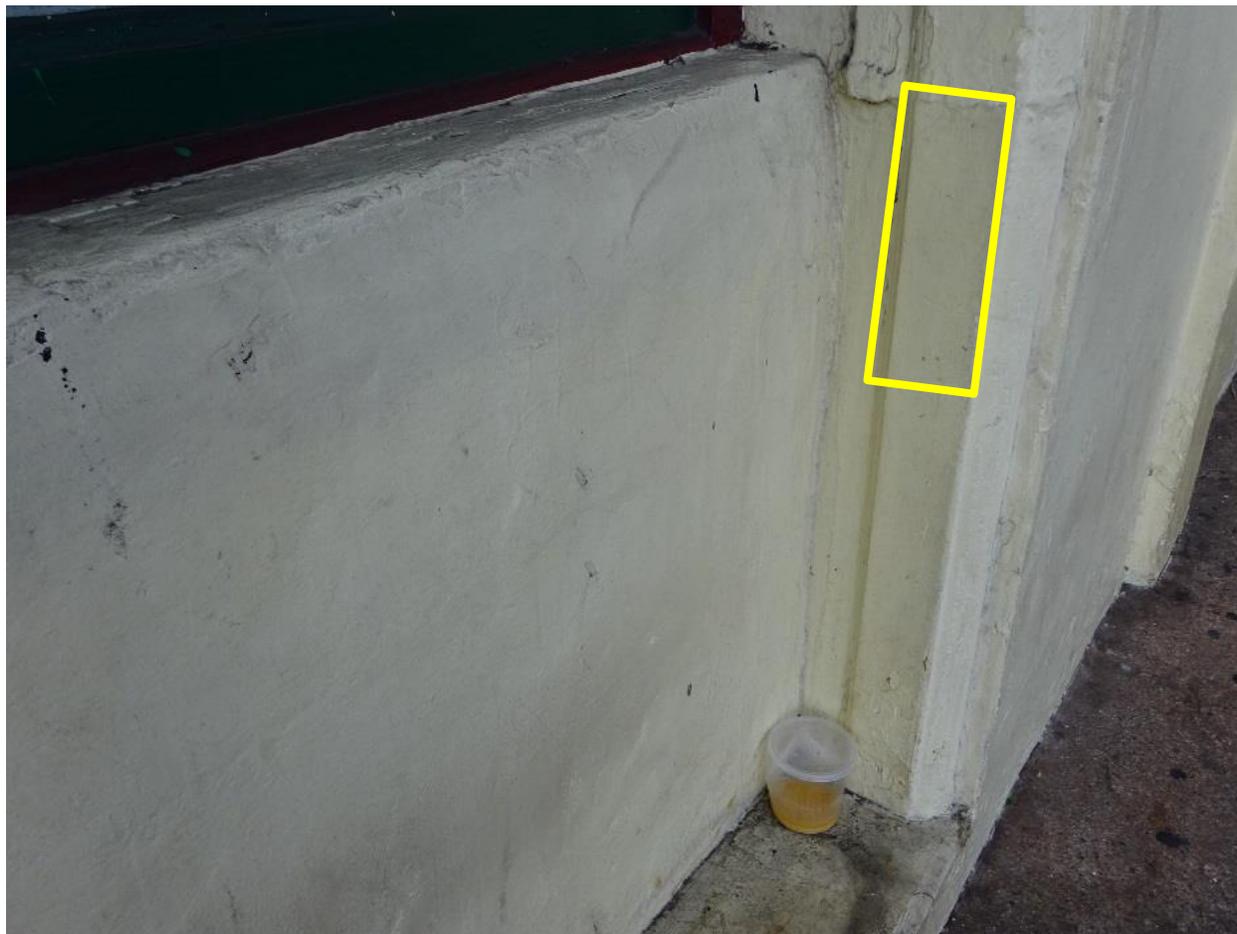
Limited trials of a film-forming water-based clear protective coating were applied to various substrates to review the aesthetic effects of the application. The coating discolored the substrate on the brick and stone surfaces; however, no discernable difference was observed on the painted stucco surface. If further consideration is given to use of clear protective coatings after reviewing the concerns presented above regarding their use, additional products should be identified and tested on the intended substrates prior to widespread application. If aesthetically acceptable, the products should be tested for effectiveness in terms of removal of graffiti applied to the coated surface.

*Figure 23. Rectangle indicates area of clear protective coating trial on painted stucco approximately one week after installation. The area is indistinguishable from the surrounding surface.*

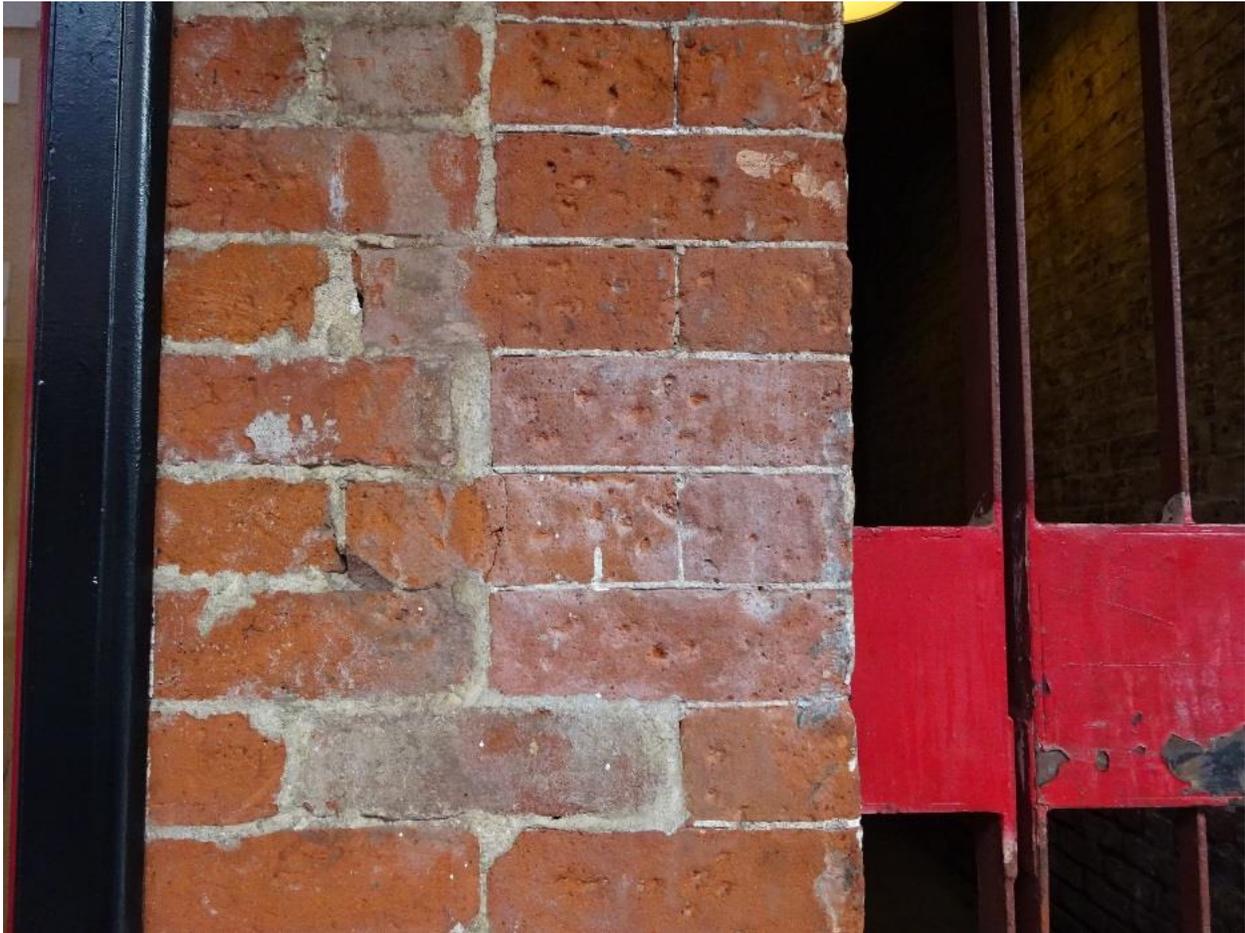
*Figure 24. The area of clear protective coating trial on brick approximately one week after installation. The product appears as a milky white haze on the brick surface.*

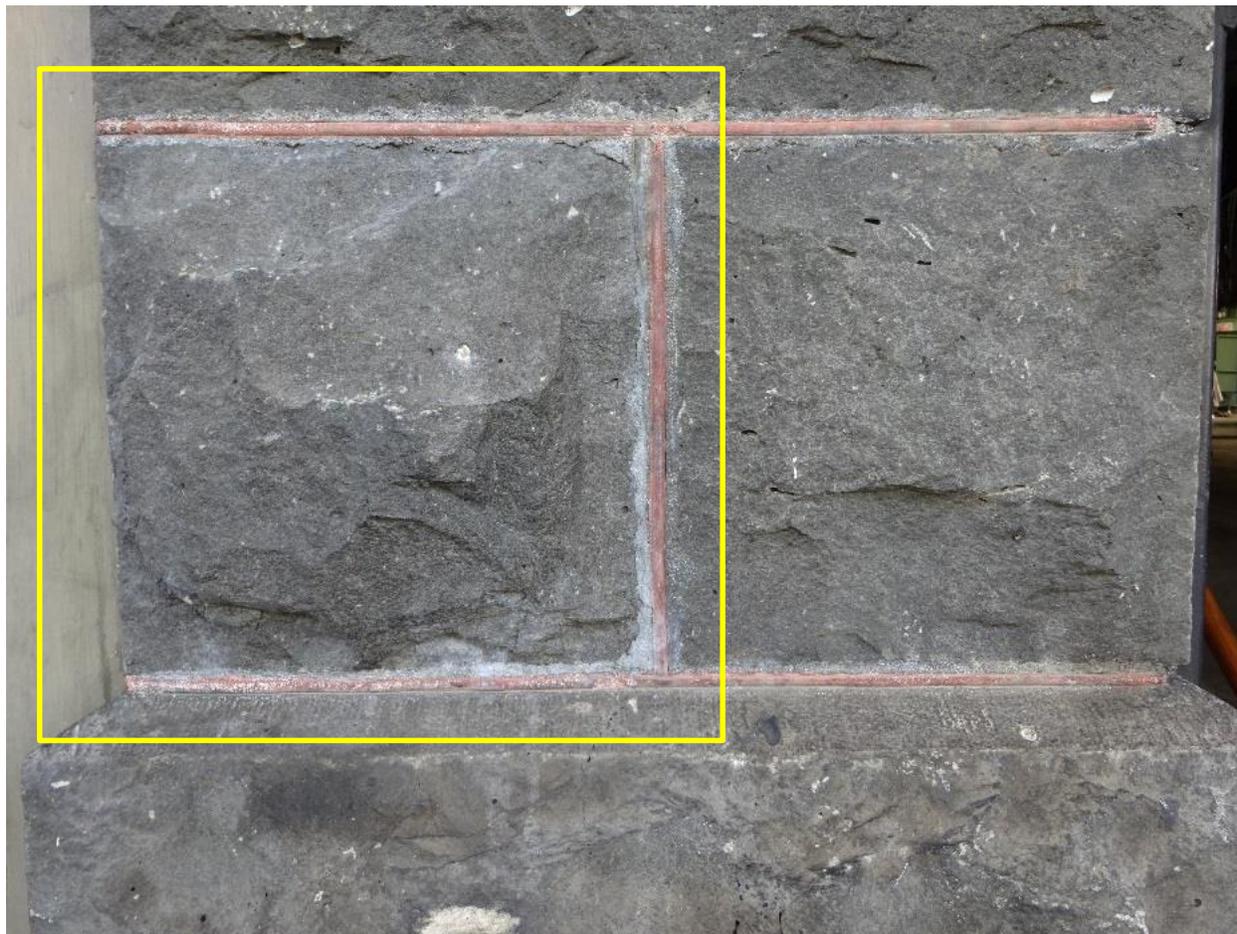
*Figure 25. The area of clear protective coating trial on stone approximately one week after installation. The product appears as a slight milky white haze on the stone surface.*
