# Water Damage & Repair

James Engler, P.A.

Chinatown  
Preservation  
Talks 2015

Glenn Mason, AIA  
Mason Architects

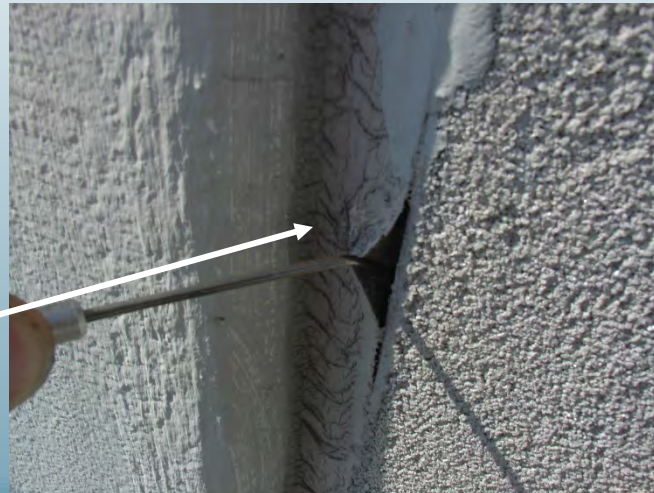
Sealant adhesion failure

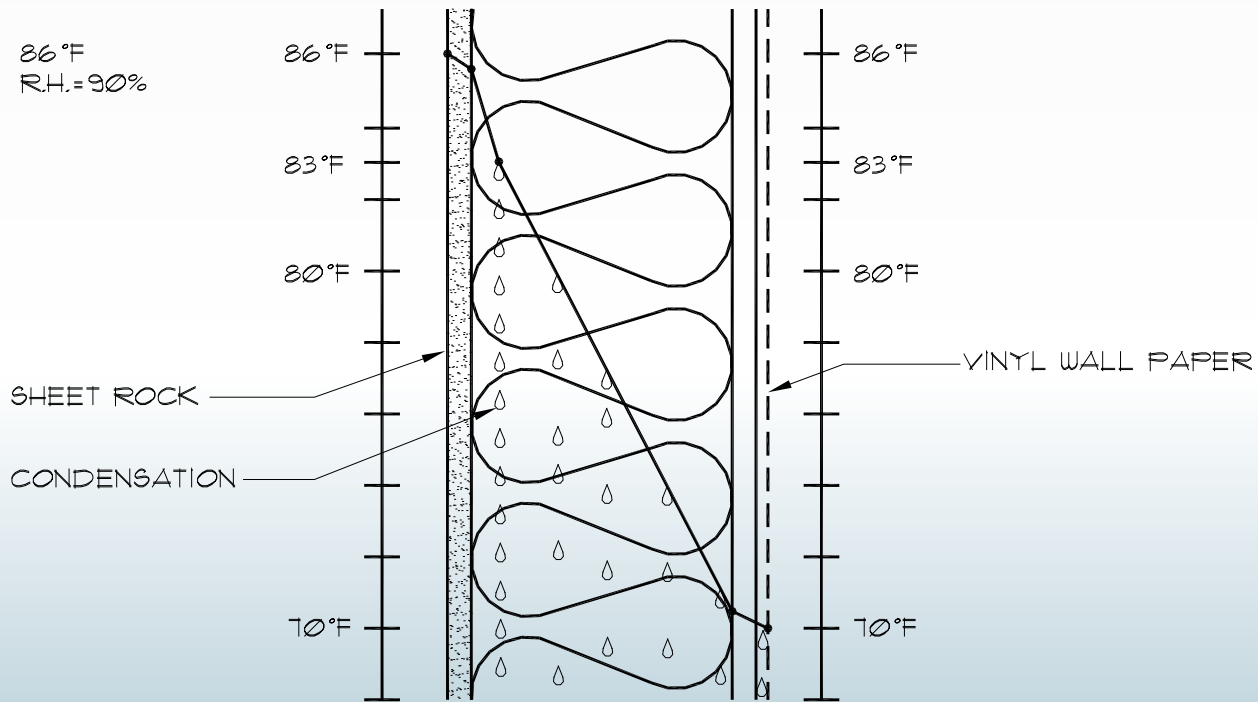
## WHERE CONDENSATION OCCURS

DEW POINT = 83°F

← BREEZEWAY/HALLWAY  
COVERED EXTERIOR  
SPACE →

← AIR CONDITIONED  
SPACE →

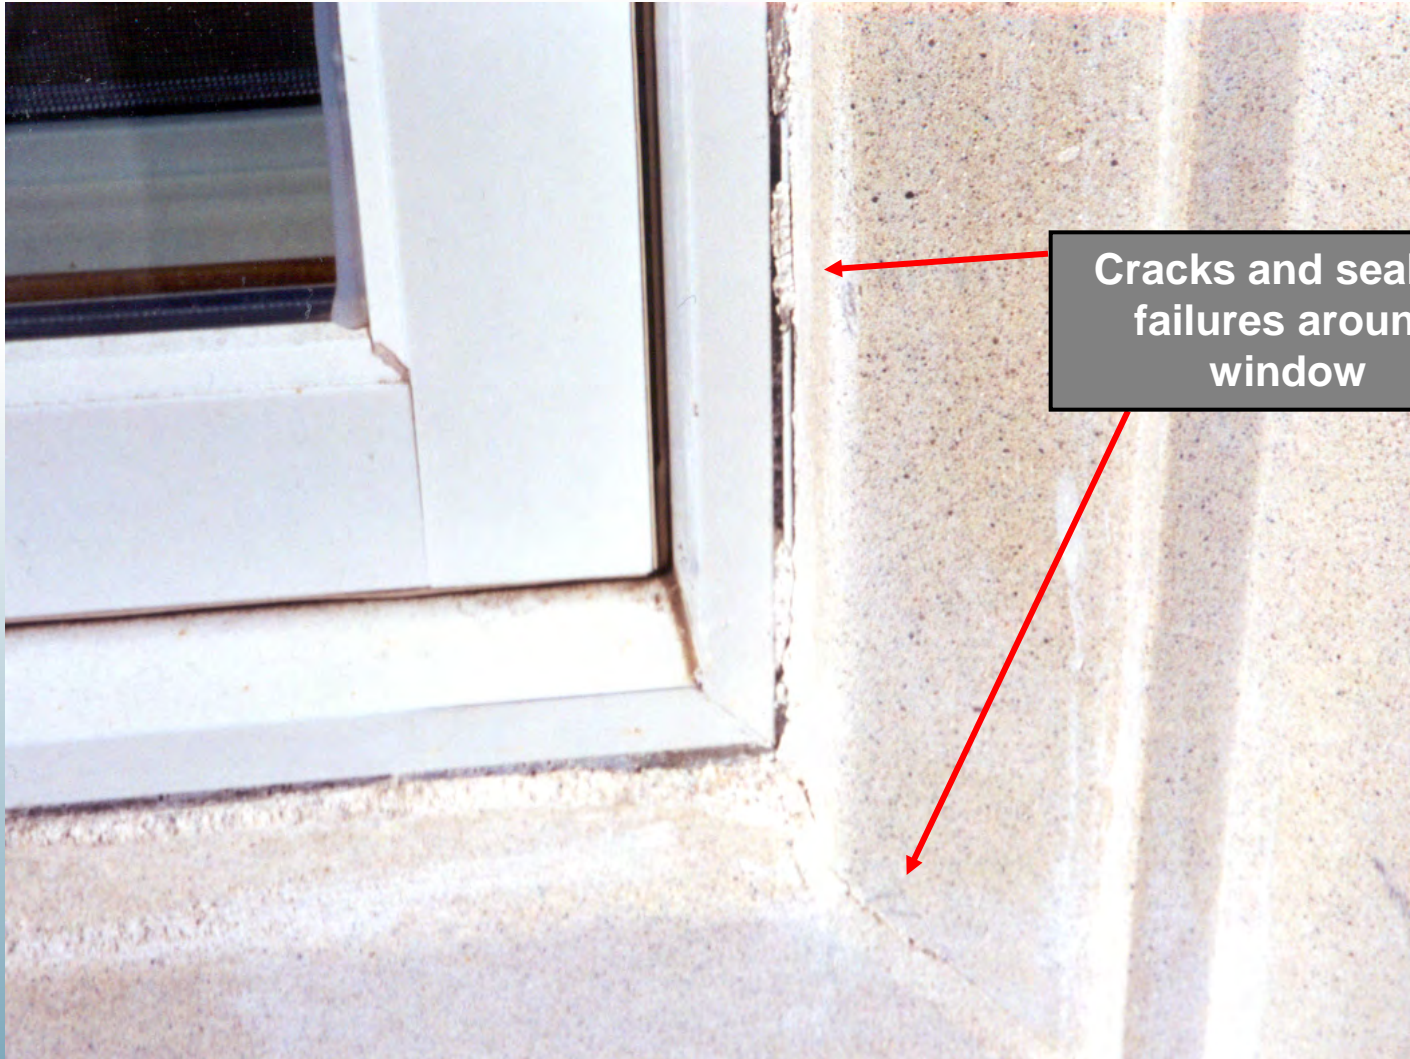
**Cracks and sealant failures around window**

- Multi-Family Residential Building
- Unknown if details were wrong or installer modified details
- Improper Sealant Geometry
- Window Flashings are missing or improperly lapped.
- No sill pans to promote drainage
  - Belt and Suspenders!
- **RESULT = Severe water intrusion into wall cavity.**

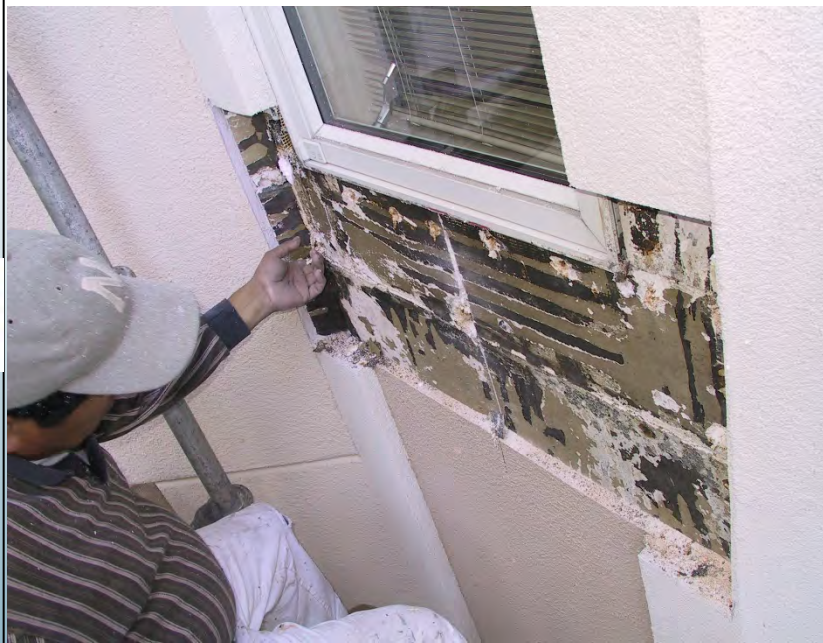
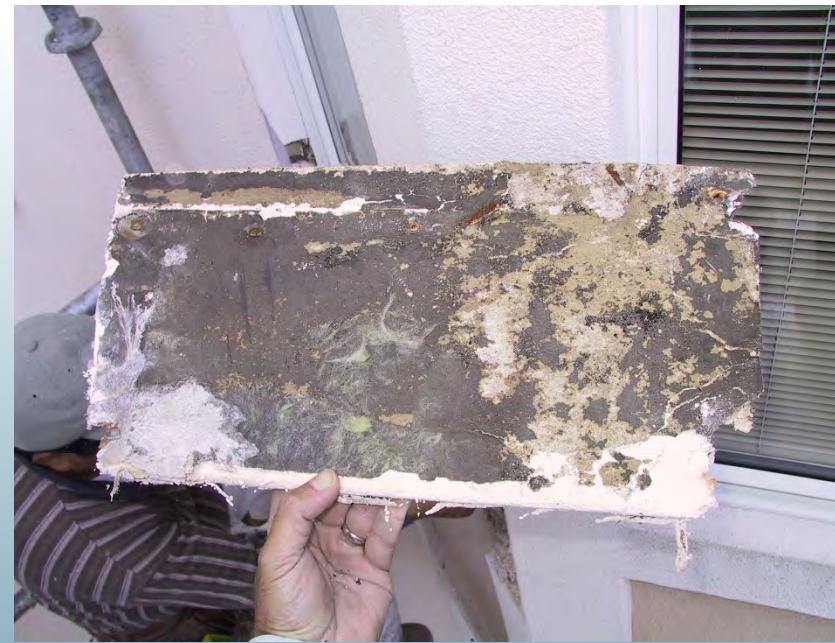
All window-to-exterior cladding needs to be closely inspected, especially EIFS.

Seal perimeter of windows openings with sealant.

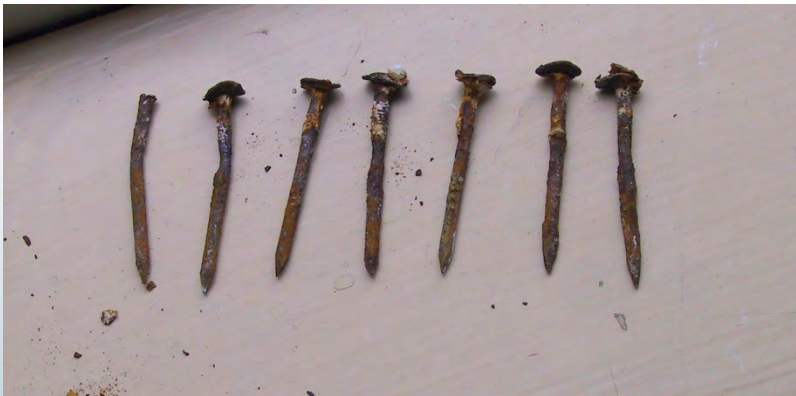
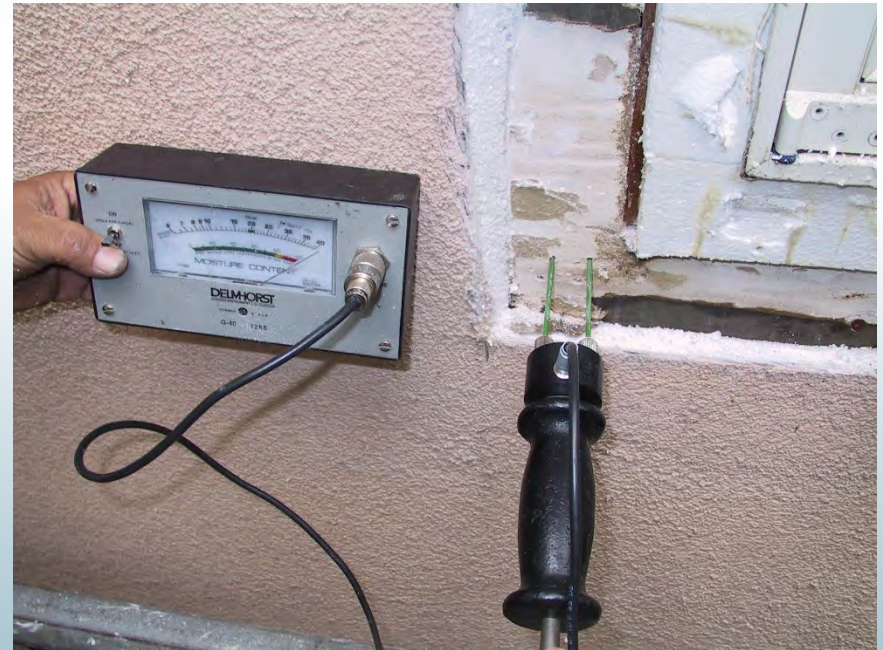
Gypsum wall board holds water, promotes mold growth and corrodes fasteners

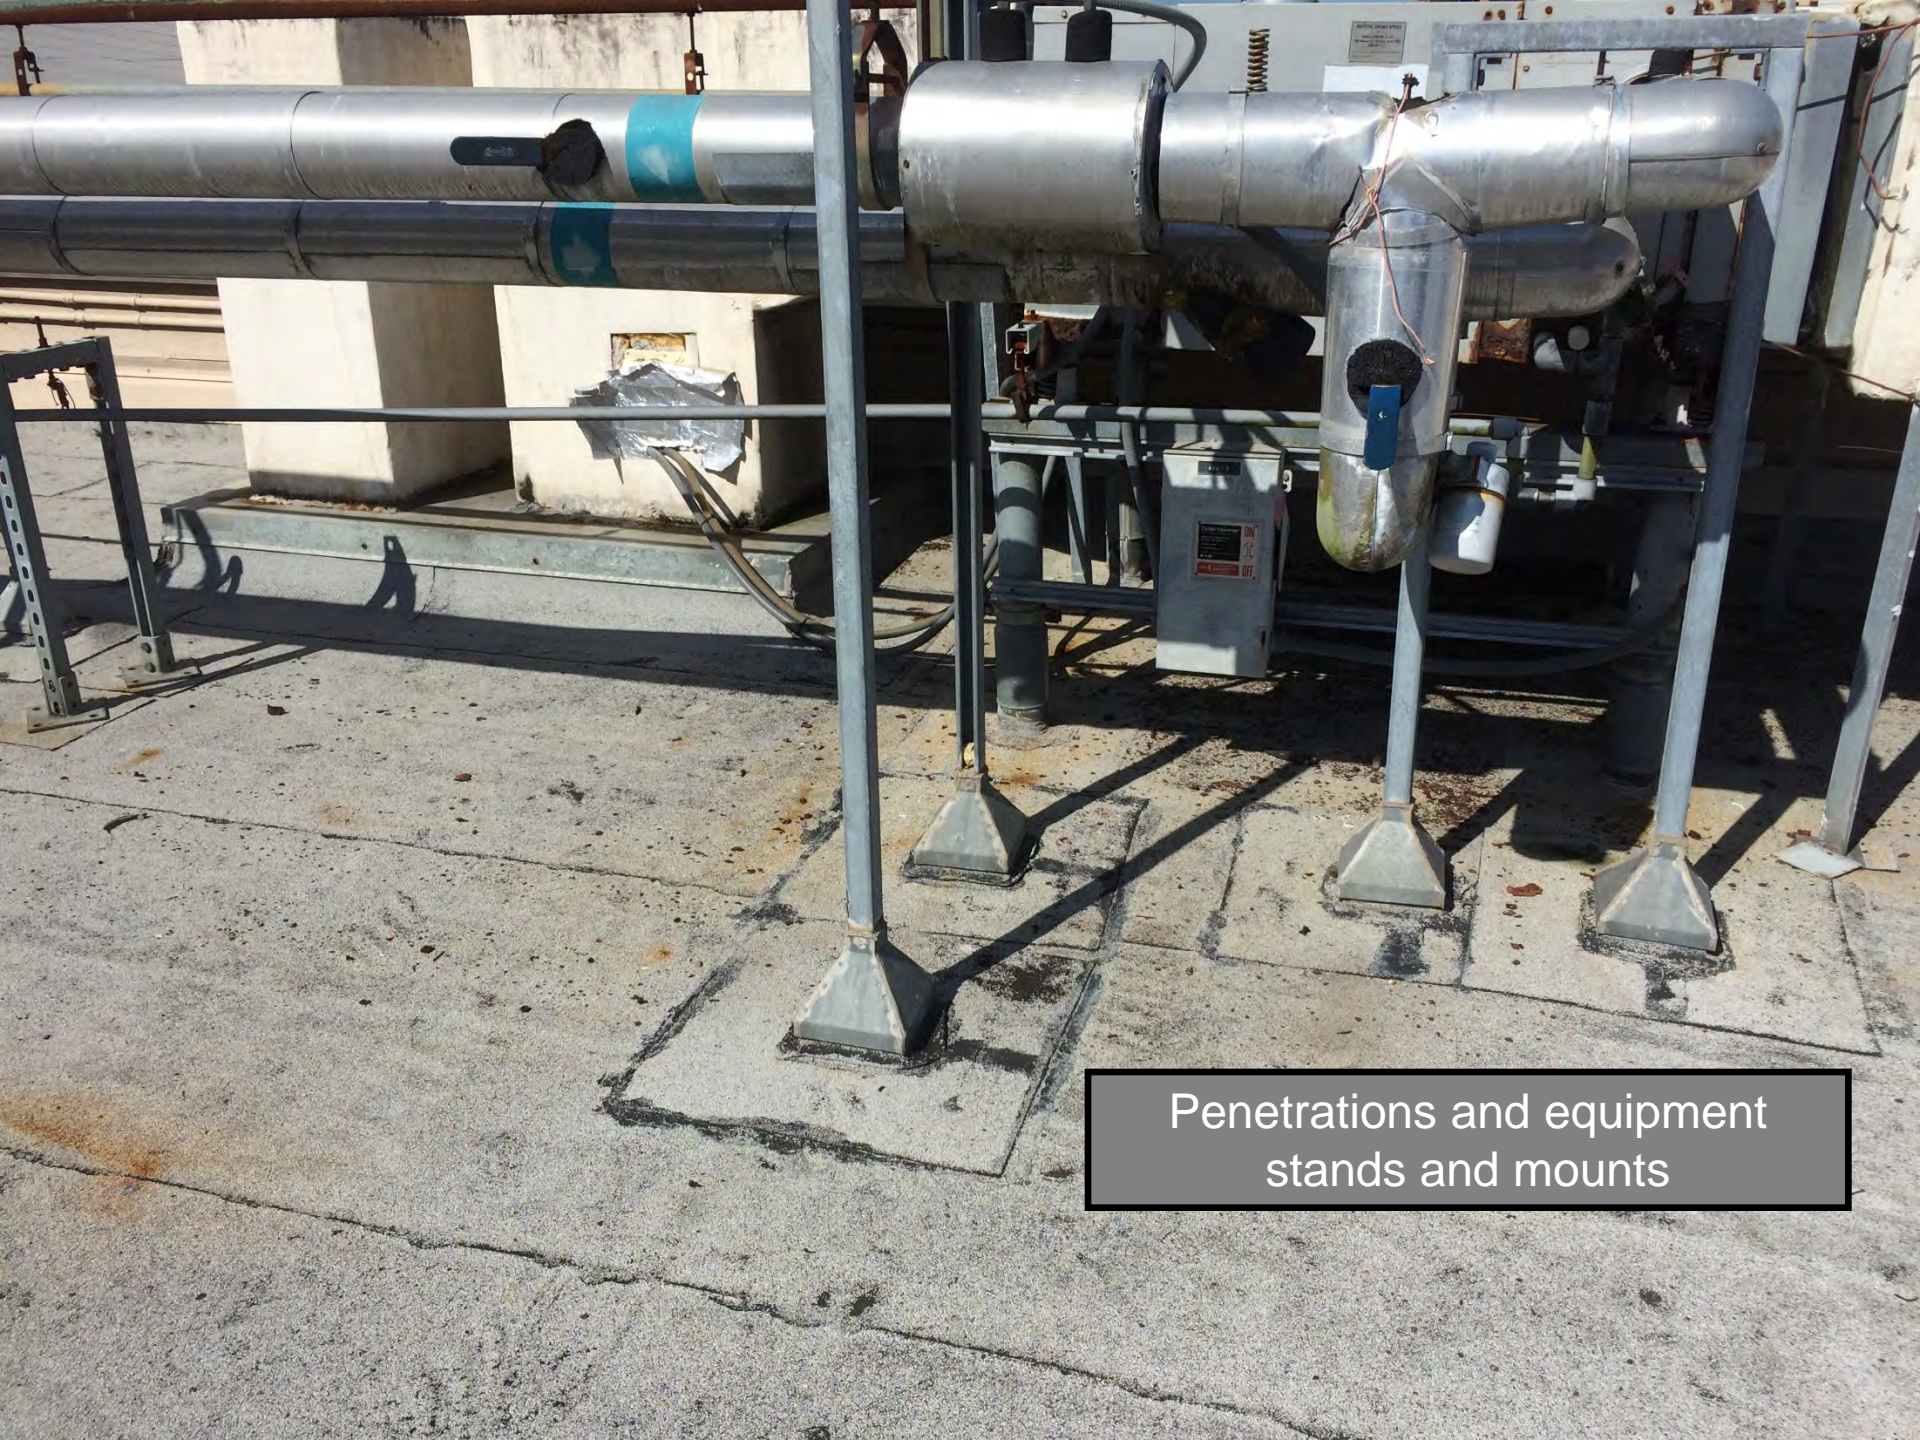
Penetrations and equipment stands and mounts

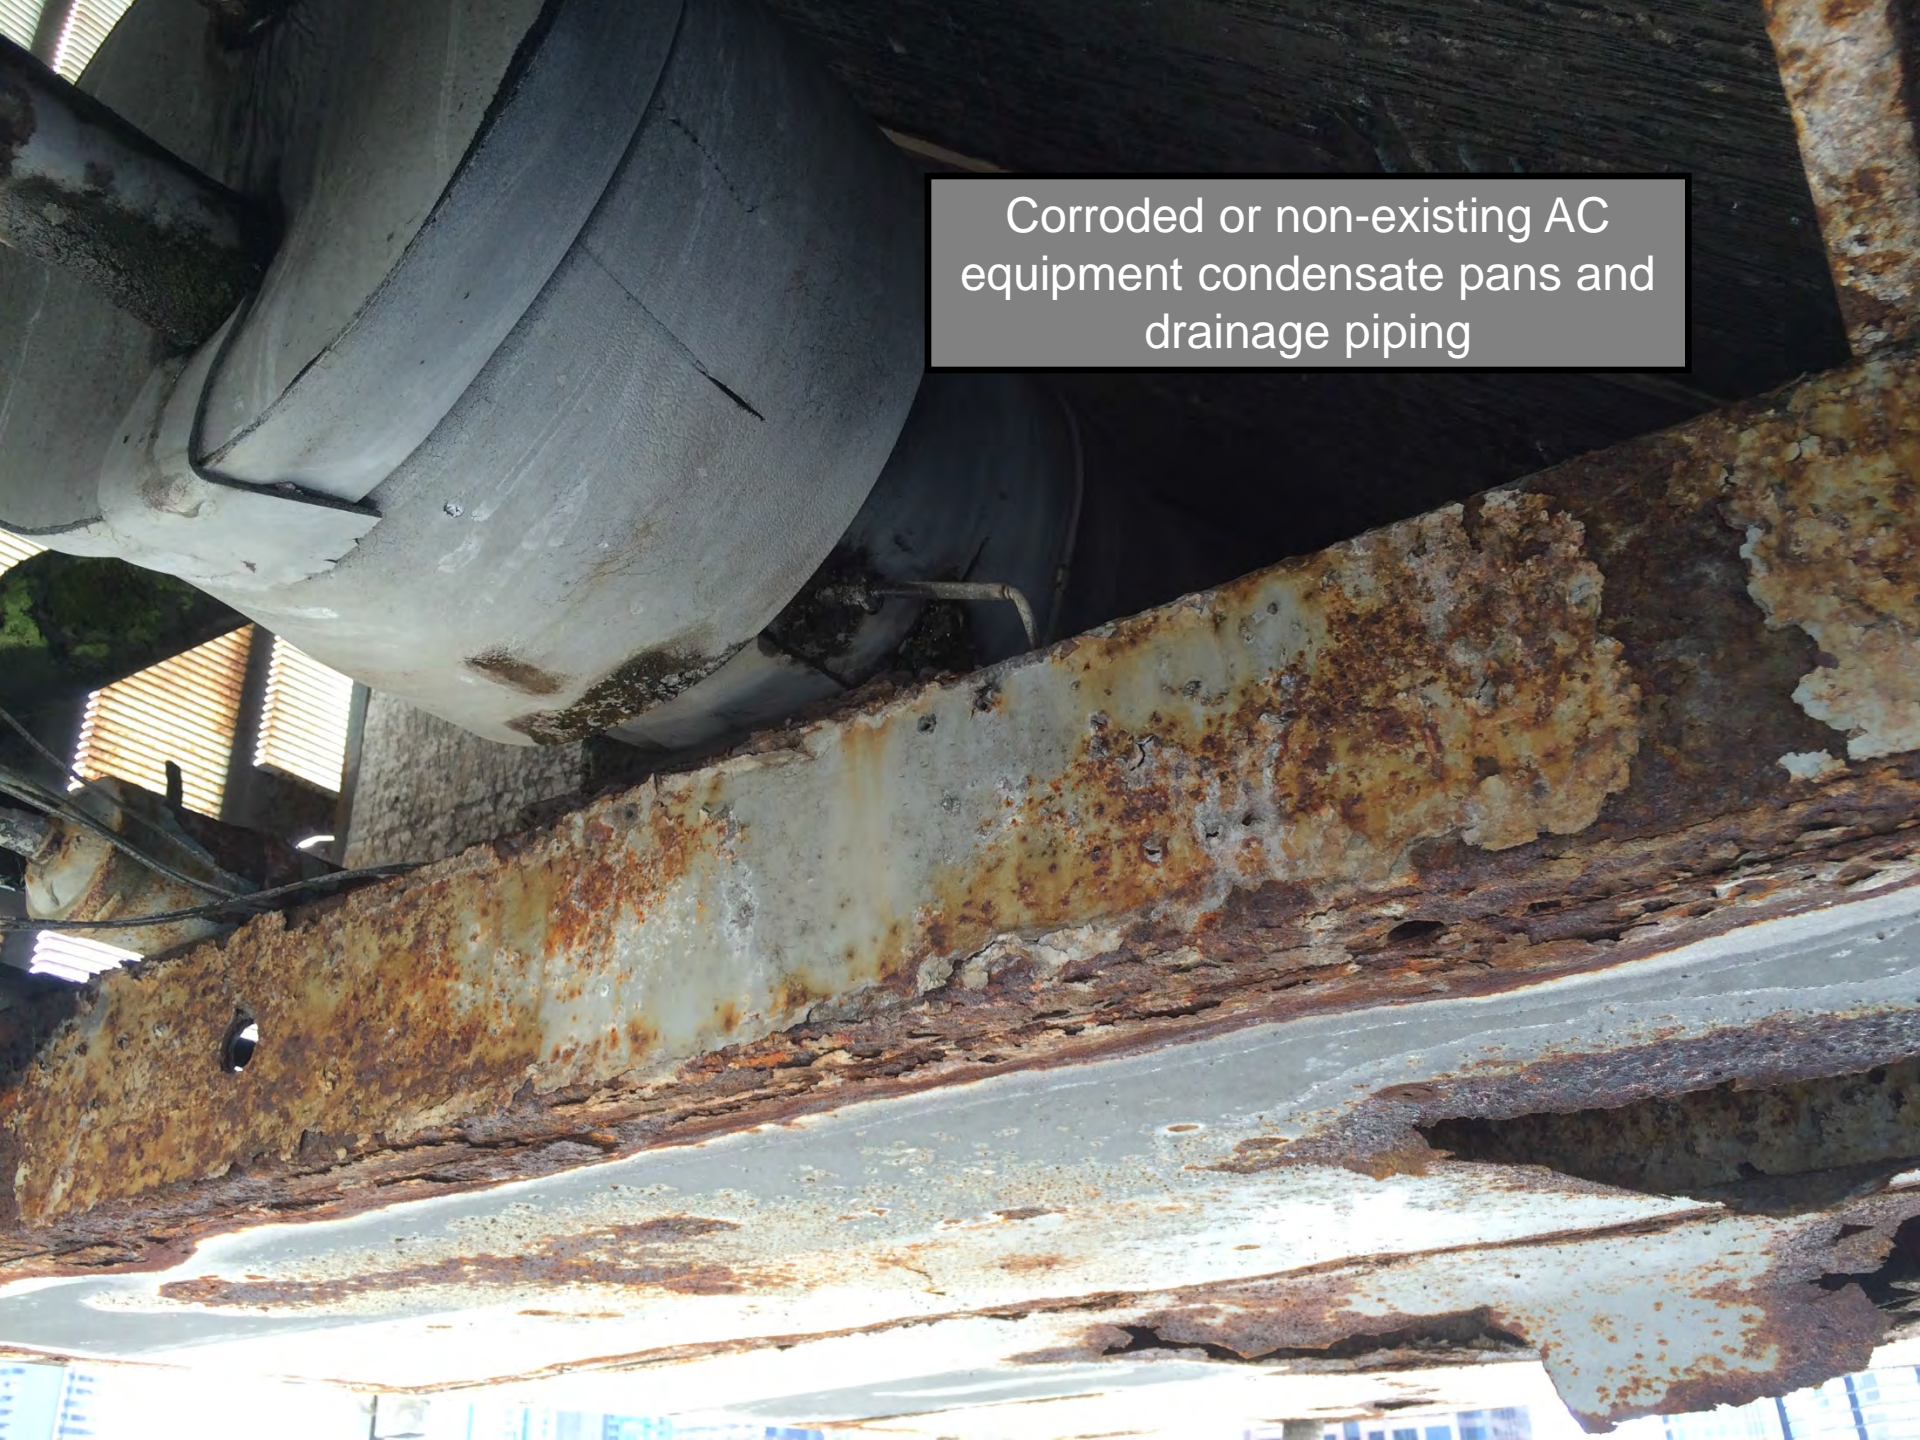
Corroded or non-existing AC  
equipment condensate pans and  
drainage piping

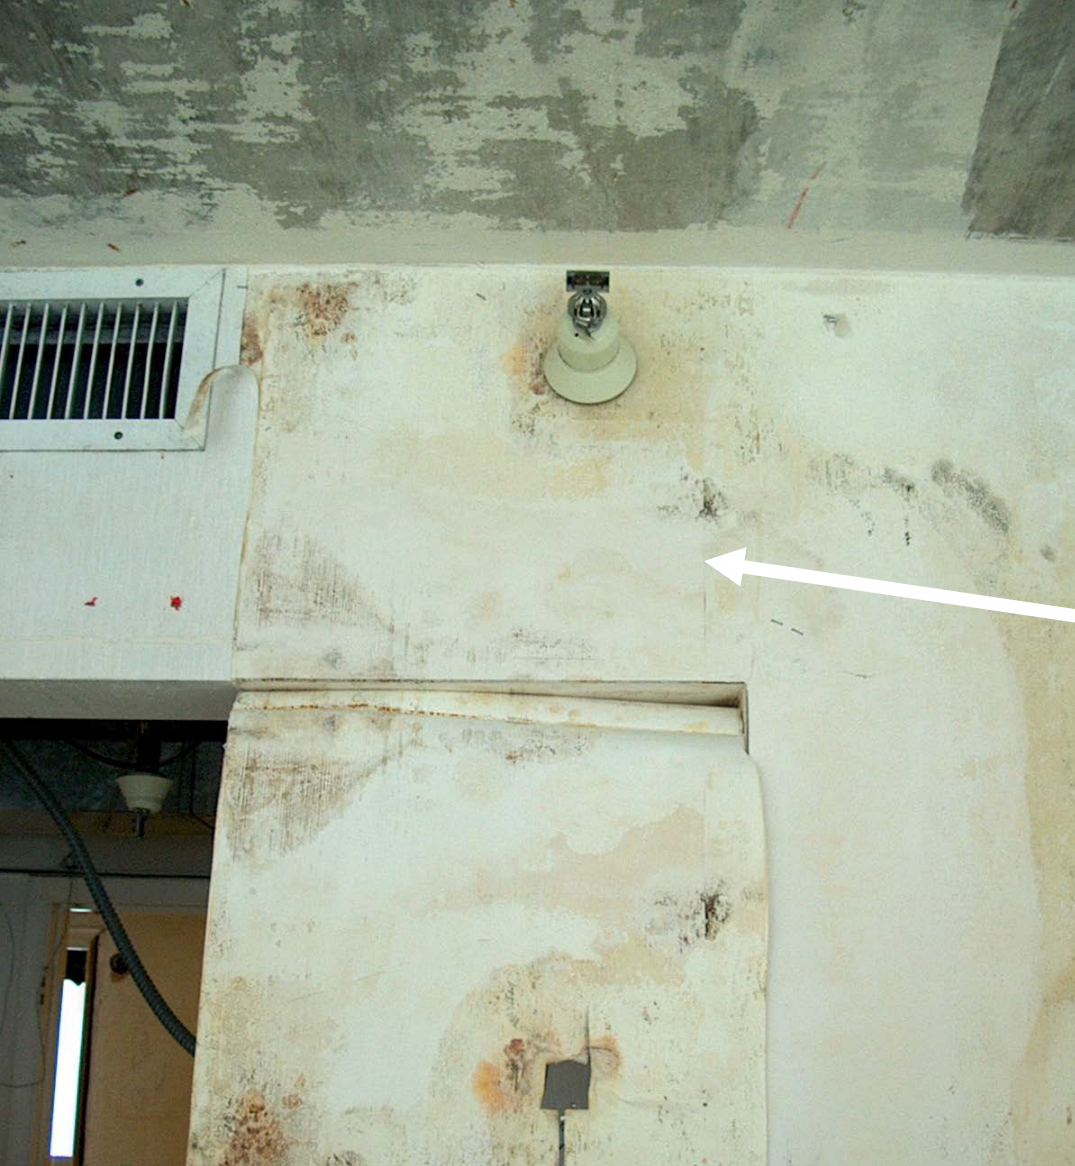
Older building – fan coil unit created condensation, rust and mold.

- Hotel
- Wrong Type of Insulation
- Wrong Size of Insulation
- Missing Insulation
  - No Insulation at Penetrations
- Improperly Installed Insulation
  - Leaks associated with old Fan Coil Units (FCUs)
- **RESULT = Entire Mechanical System (and insulation) was Replaced**

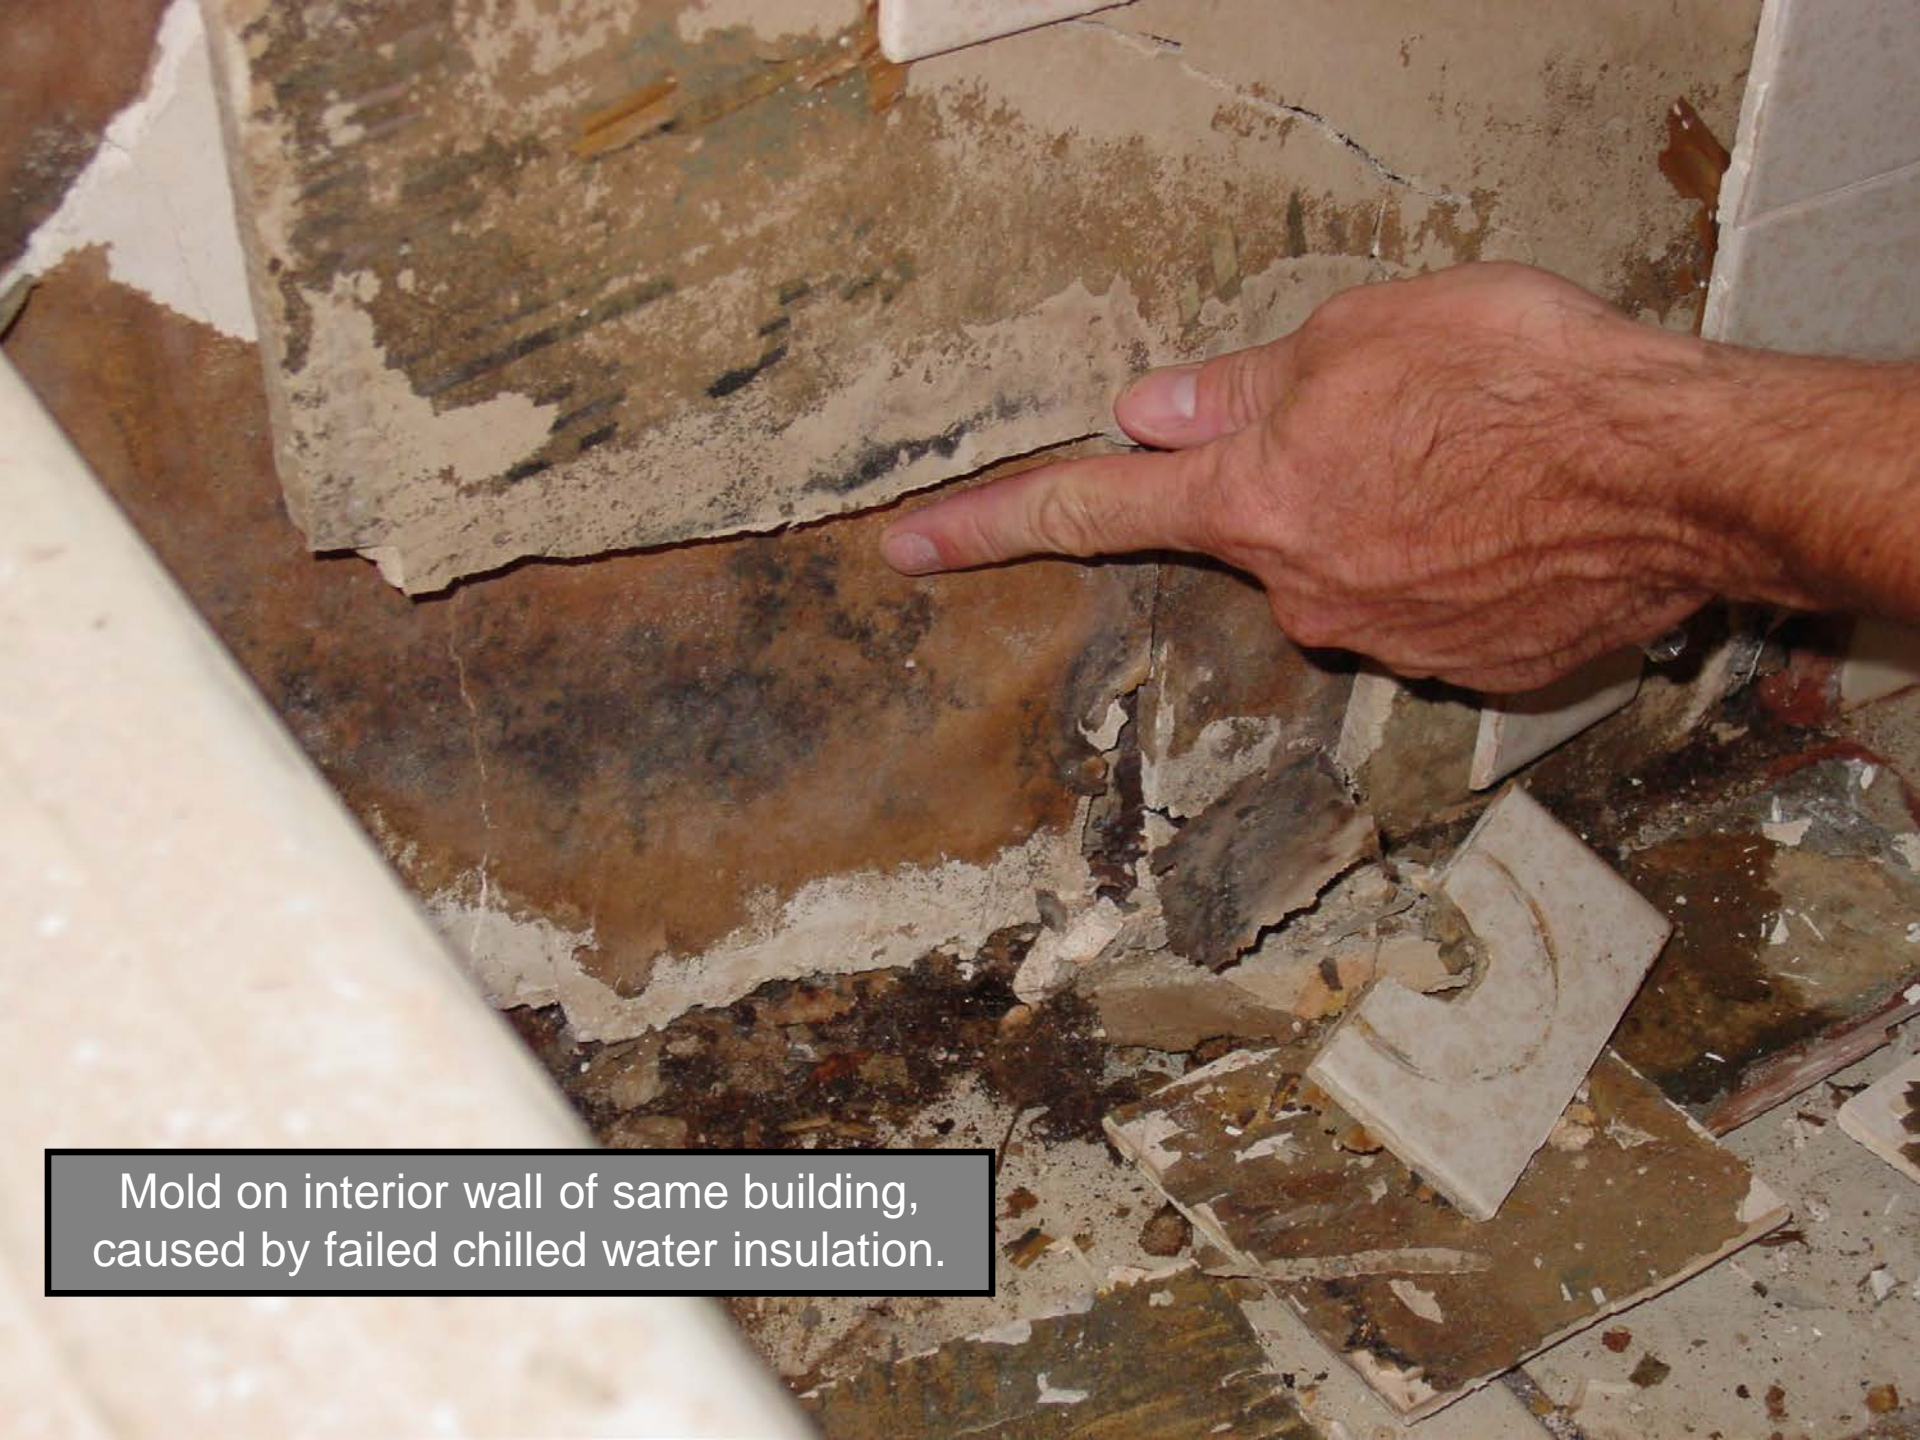
Mold on interior wall of same building, caused by failed chilled water insulation.

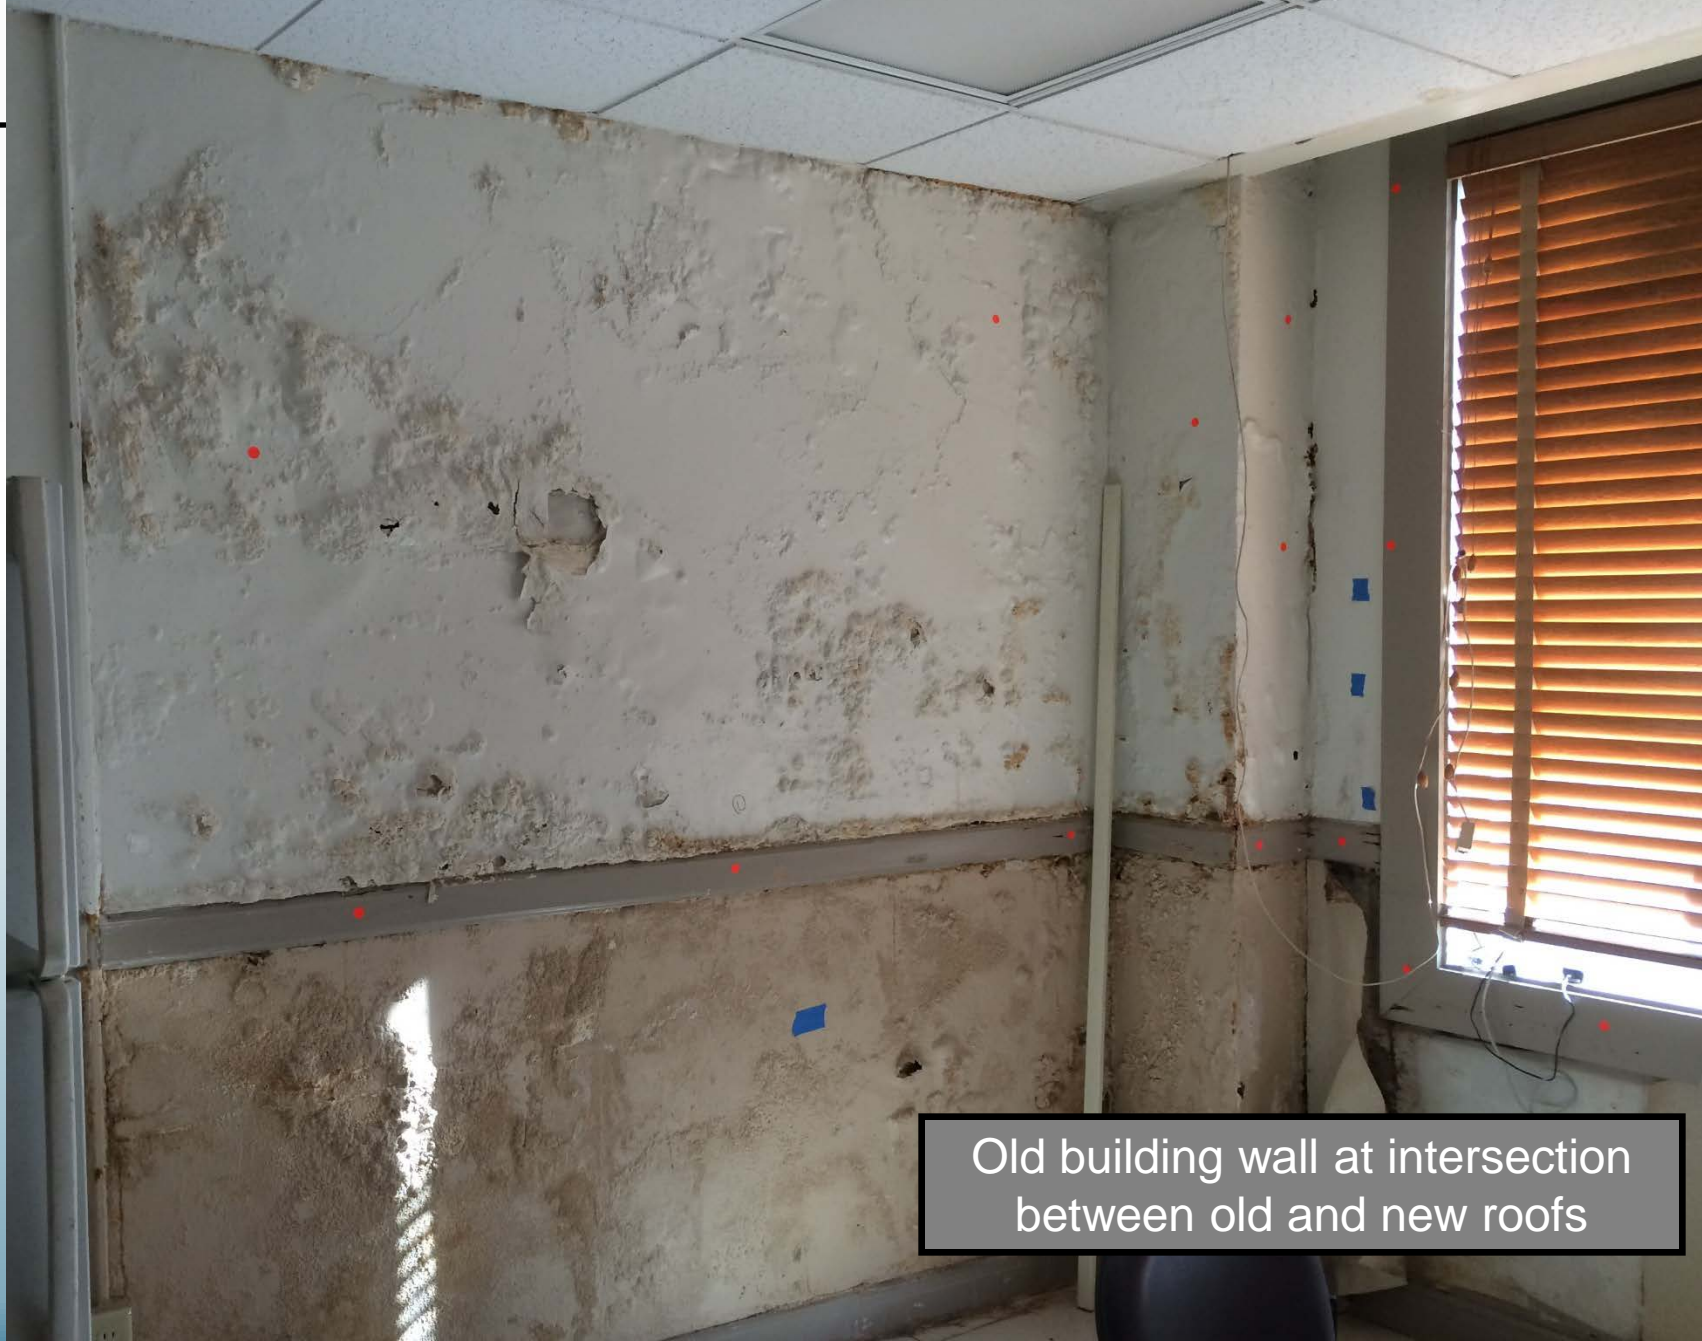
Old building wall at intersection between old and new roofs

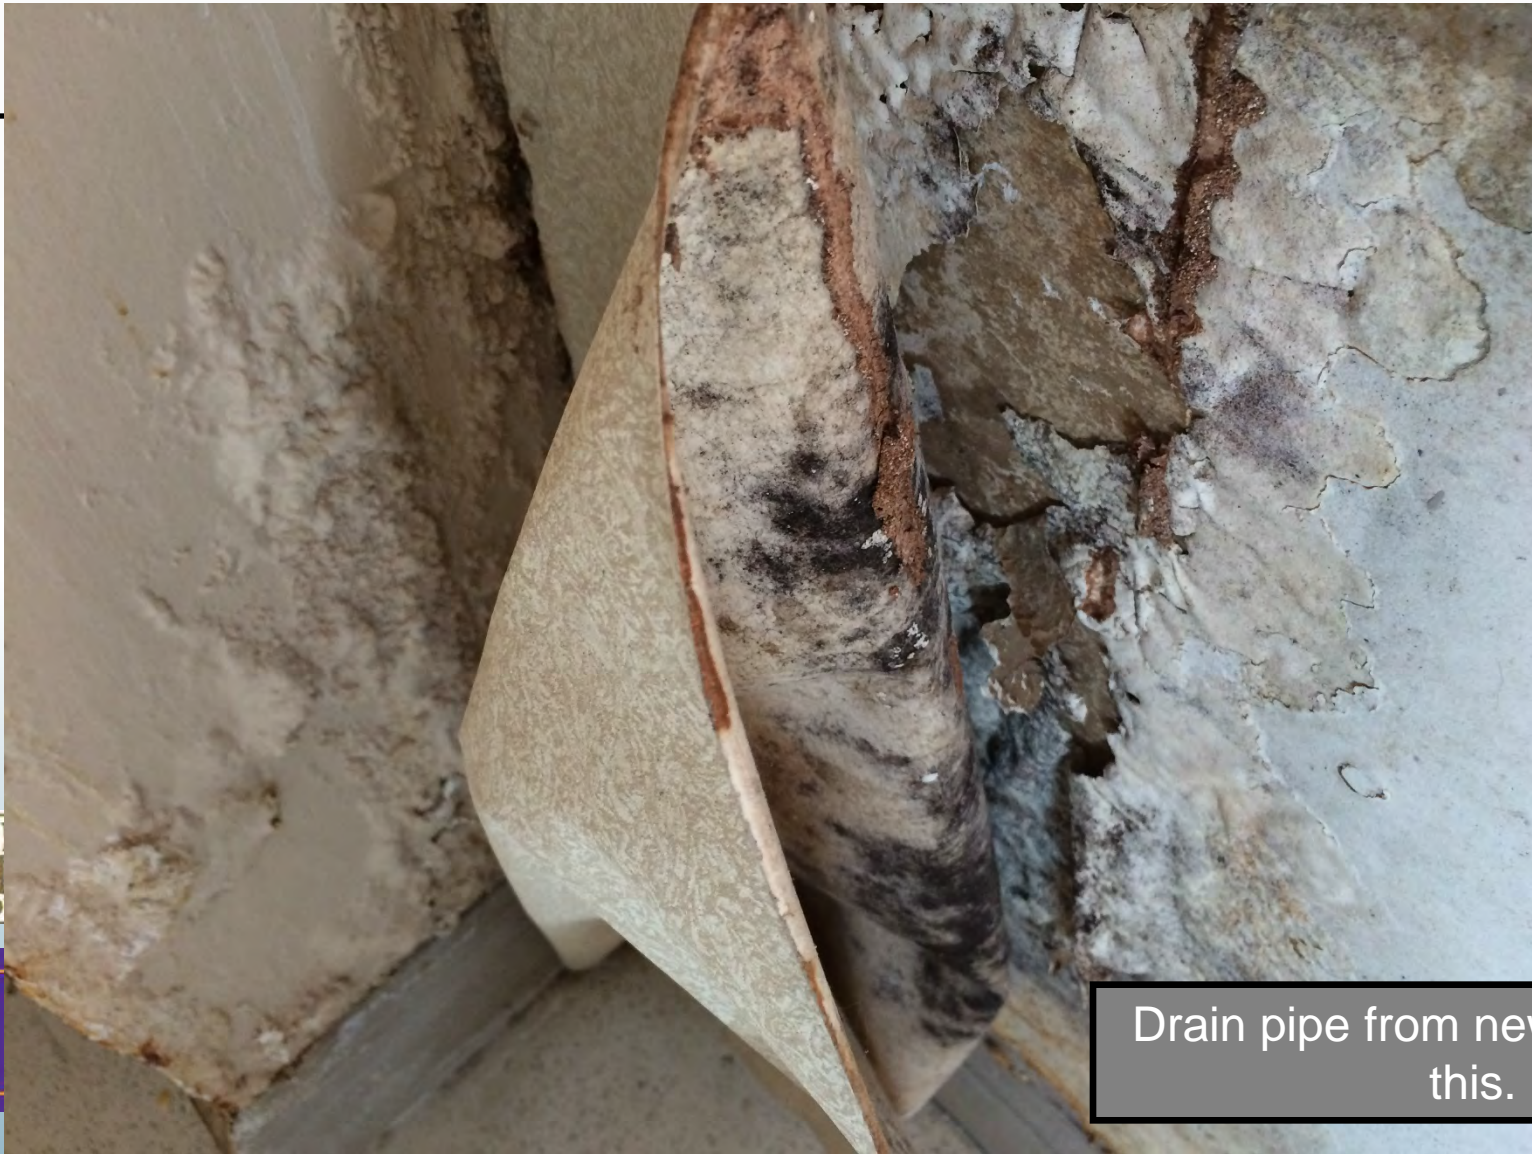
Drain pipe from new roof behind this.

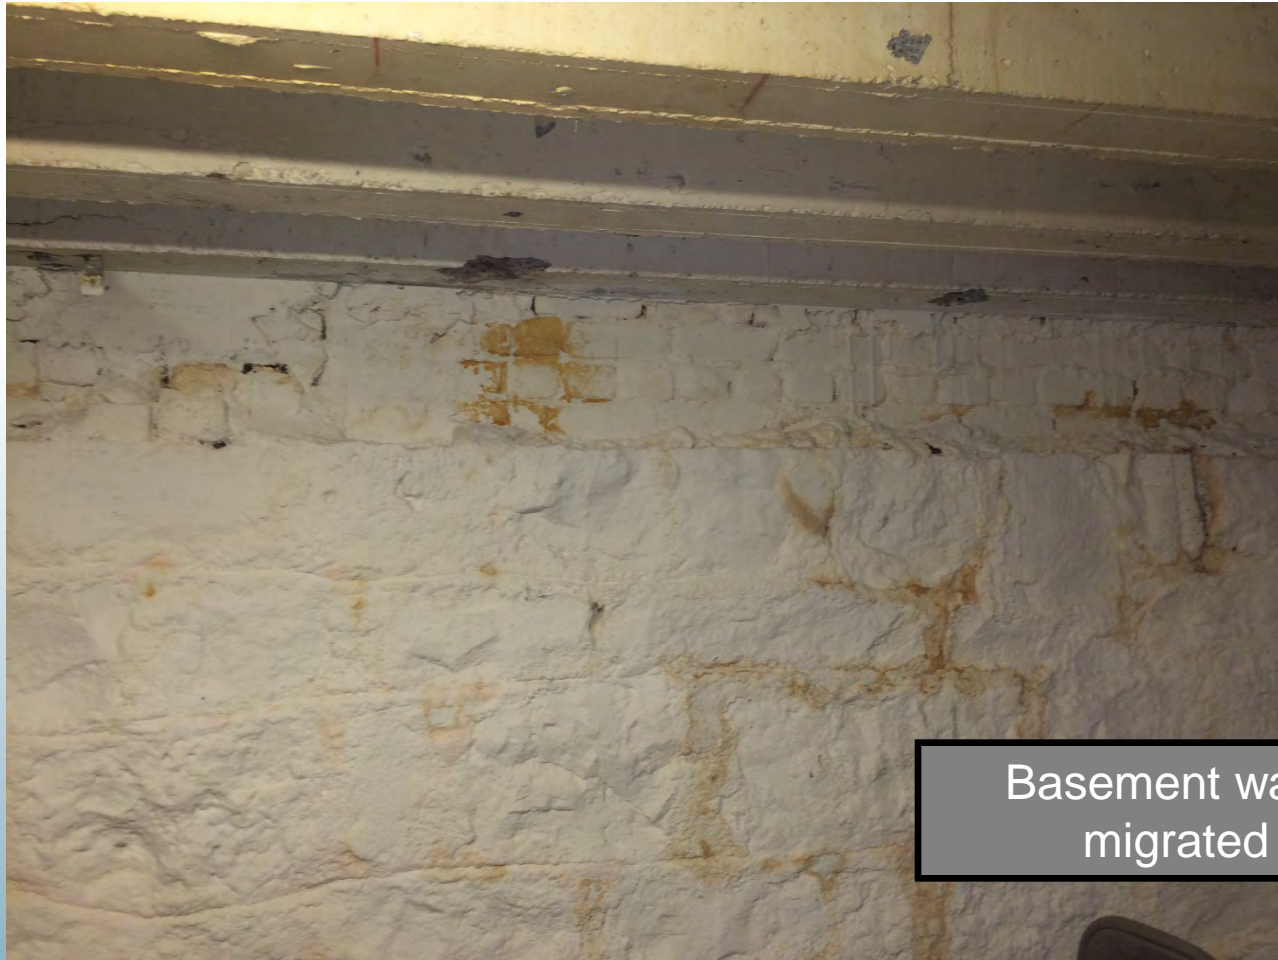
Basement wall where water migrated downward.

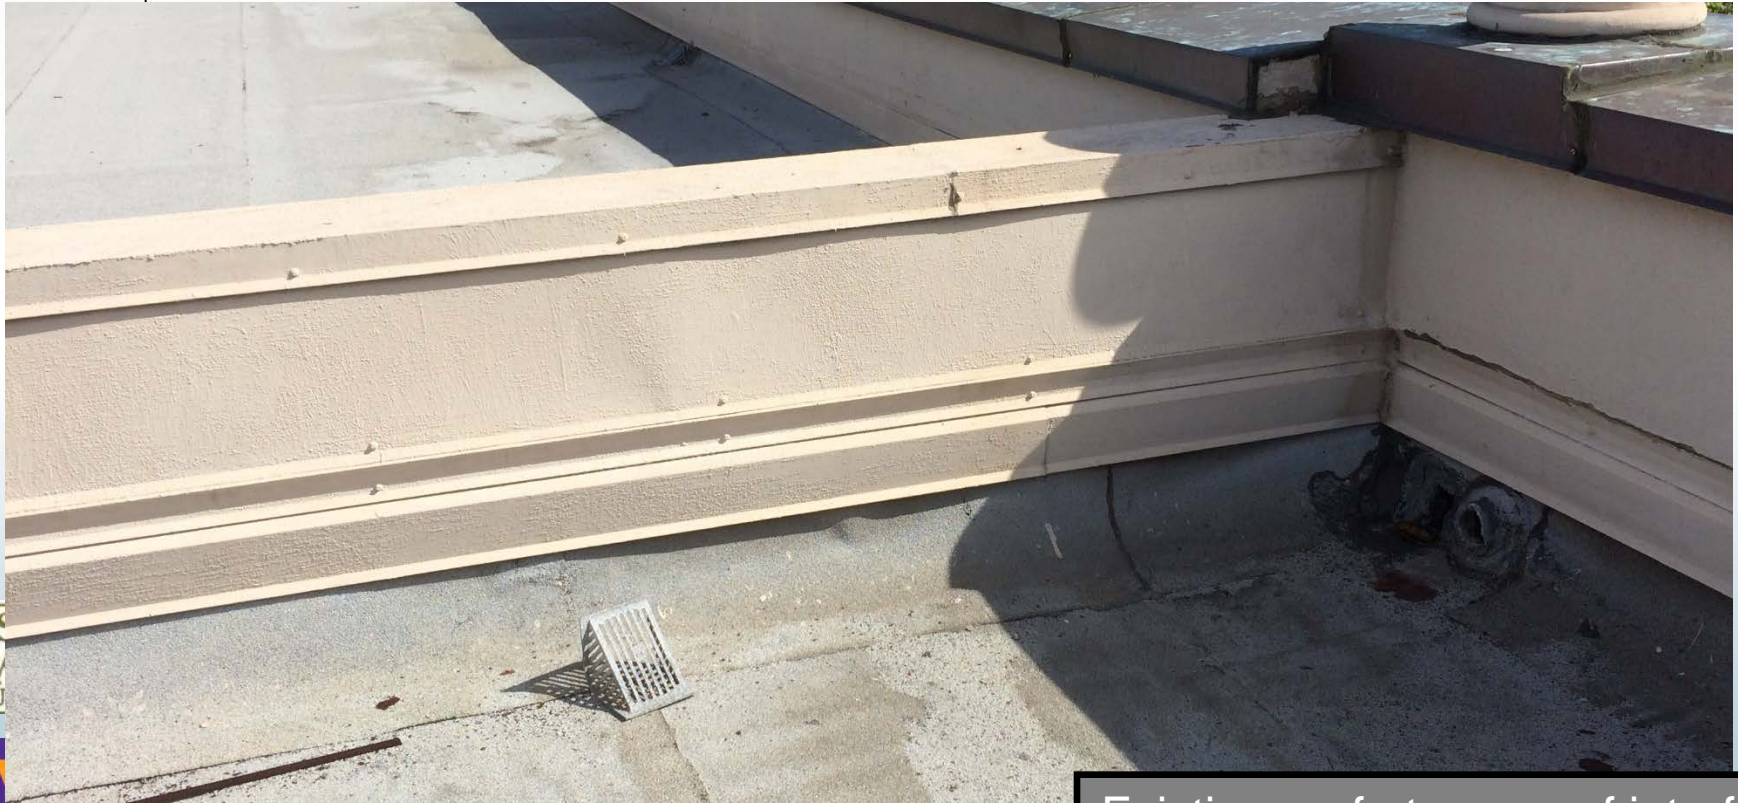
Existing roof at new roof interface and flashing.

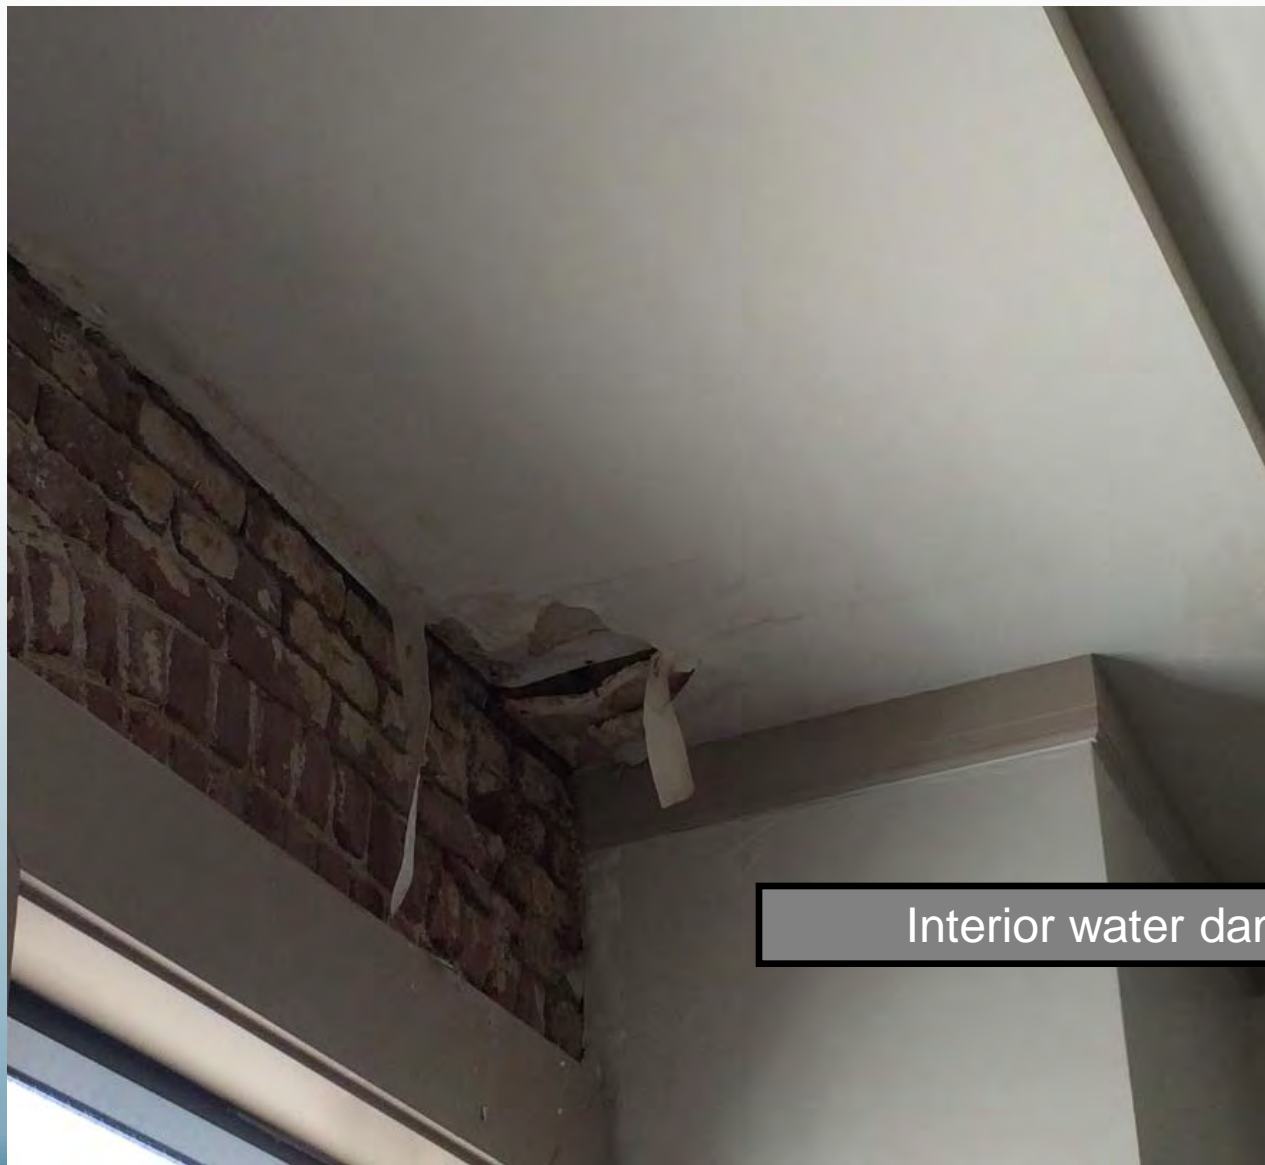
Interior water damage
