# Water Damage & Repair

James Engler, P.A.

Chinatown  
Preservation  
Talks 2015

Glenn Mason, AIA  
Mason Architects

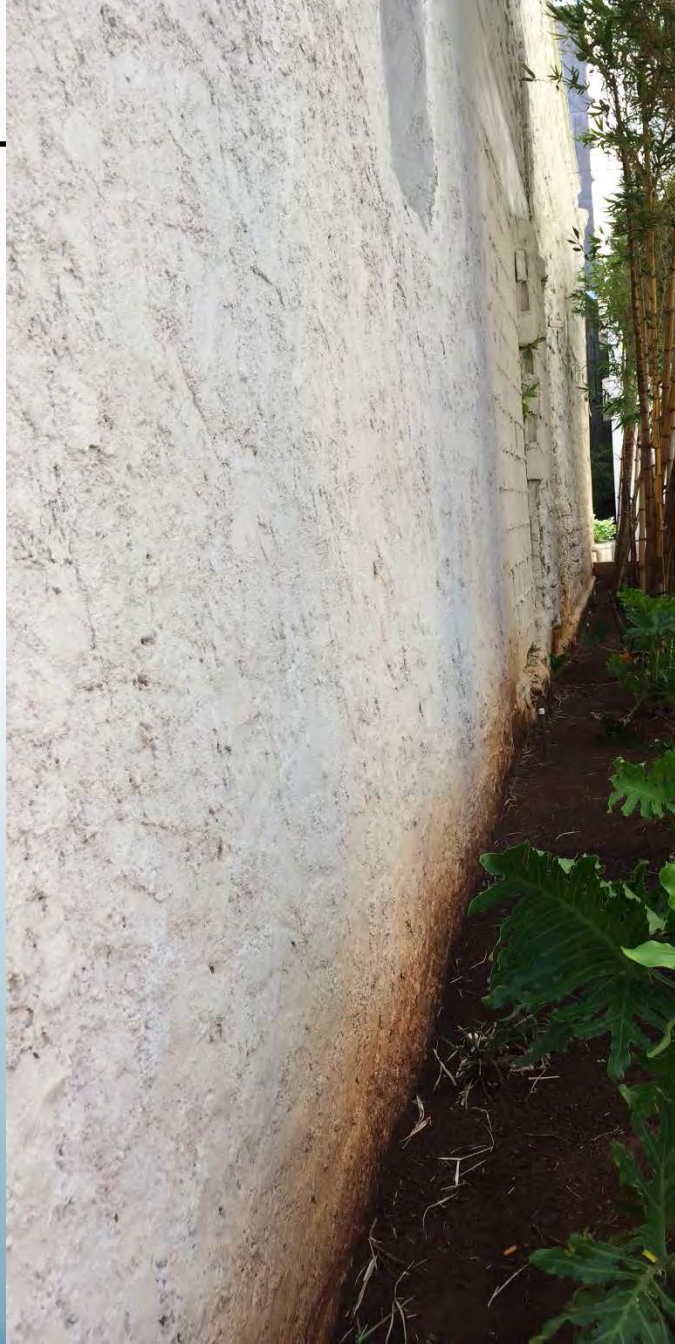
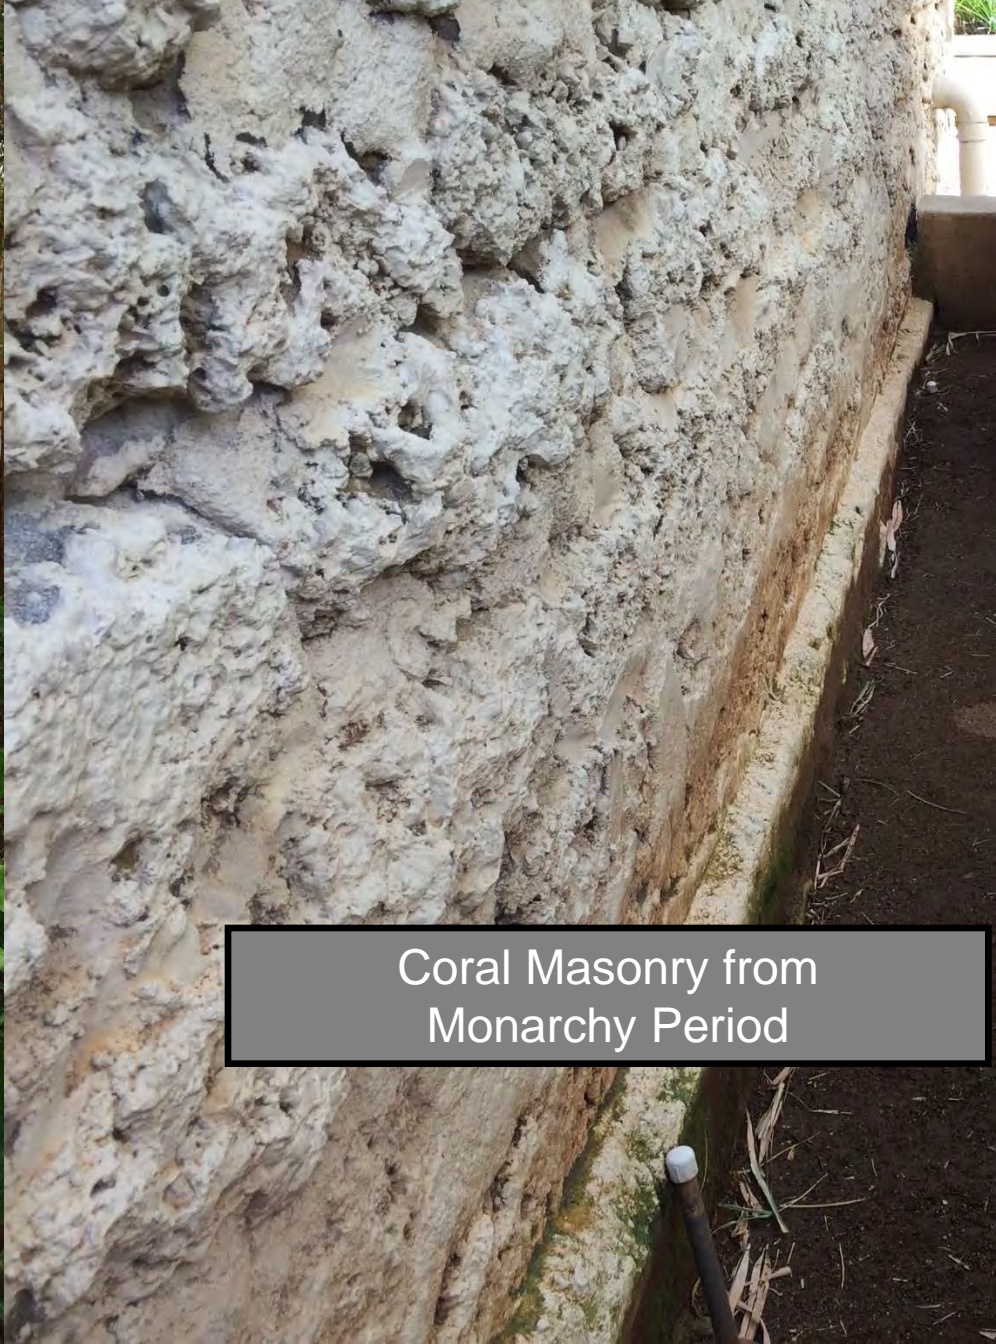
Coral Masonry from  
Monarchy Period

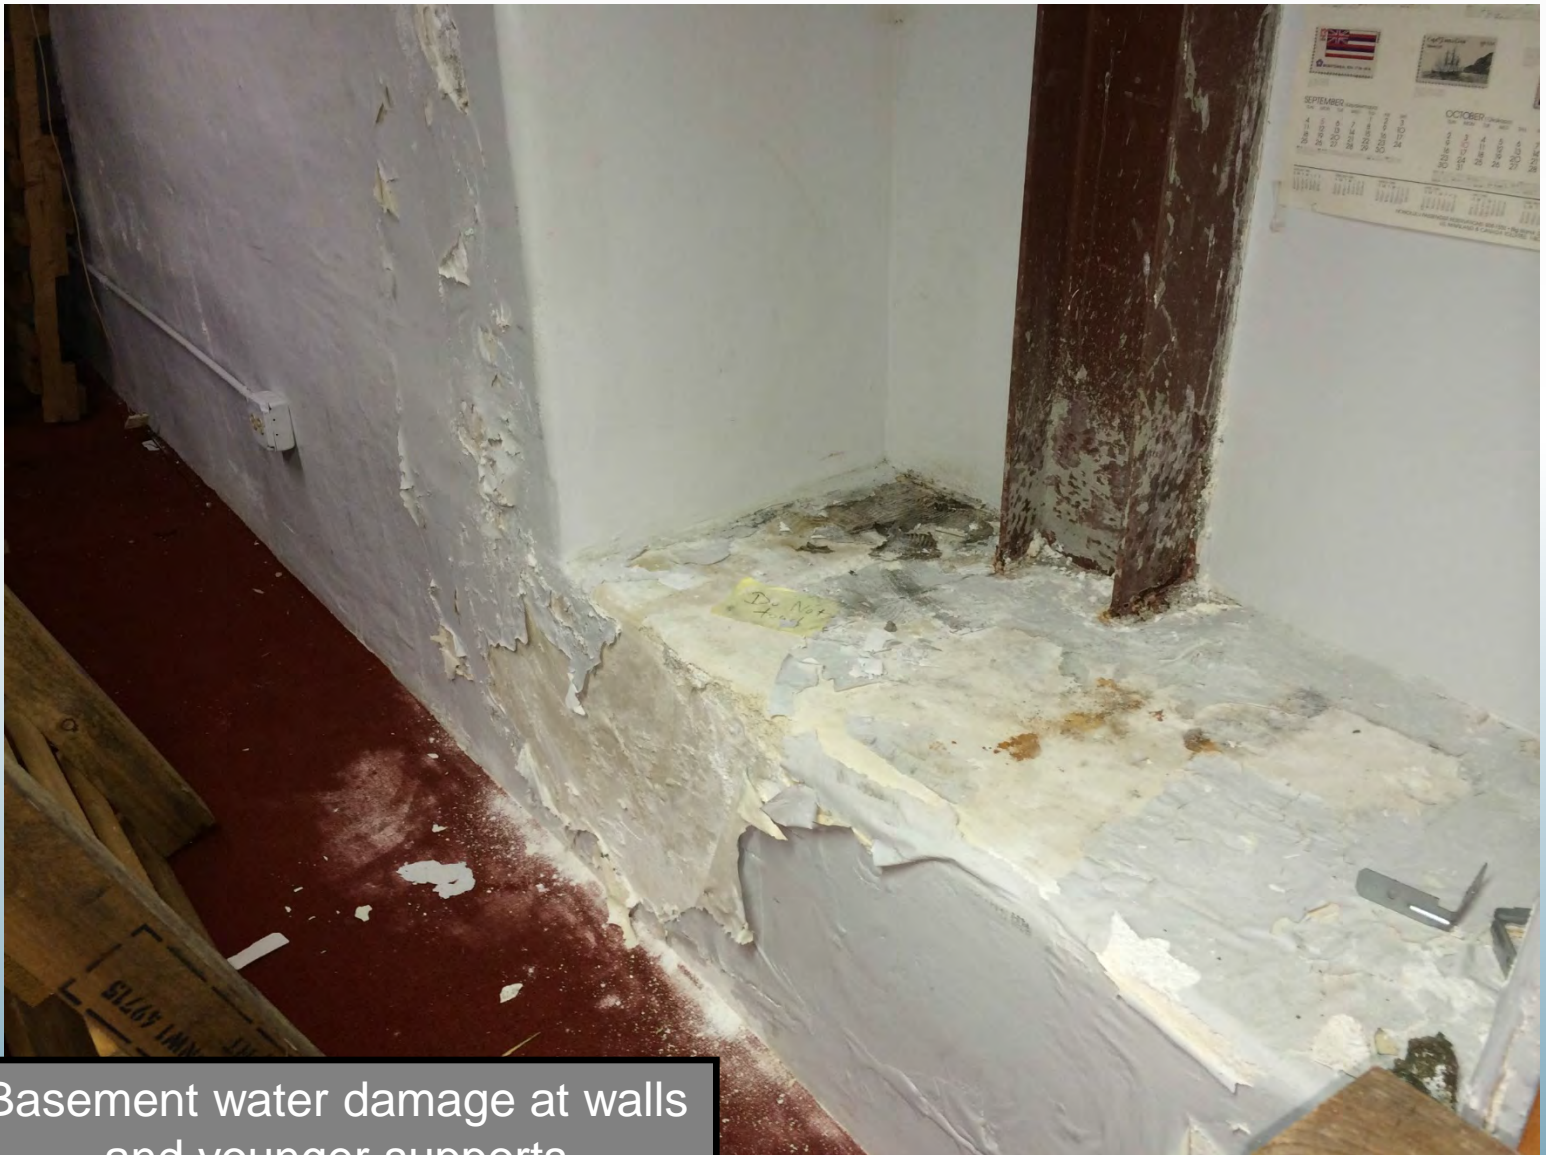
Basement water damage at walls and younger supports

1. Remove/prepare the existing plaster that is covering the interior masonry wall surfaces. Removal or preparation of the existing plaster will depend on the integrity of the plaster to masonry interface and the recommendation of the manufacturer.
2. Apply floor to ceiling mock-ups of three manufacturer's cementitious waterproof coatings four feet wide to the masonry wall surface.
3. Monitor the performance of the coatings and select the preferred product for the completion of the remaining basement walls.
4. If unsuccessful, consider building a new waterproofed interior wall and abandon waterproofing of exterior structural wall.
