Preservation Seminar:

Standards & Guidelines for Treatment of Historic Properties

Historic Hawai'i Foundation National Park Service Department of the Interior Office of Native Hawaiian Relations

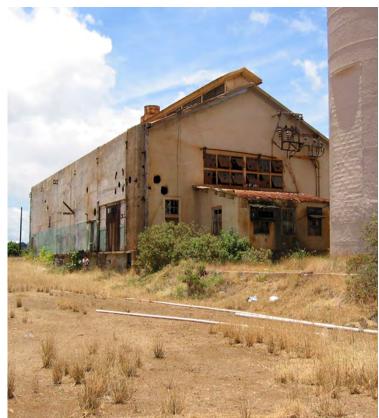
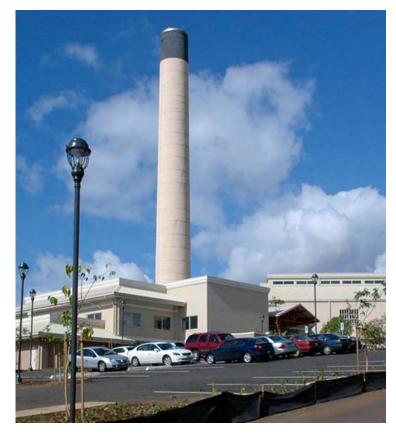
Rehabilitation Example: Waipahu Sugar Mill YMCA

Oʻahu Sugar Company Mill, Waipahu, Oʻahu

Center: exterior before rehabilitation. Above right: interior before rehabilitation. Left: exterior after rehabilitation. Below: interior after rehabilitation.

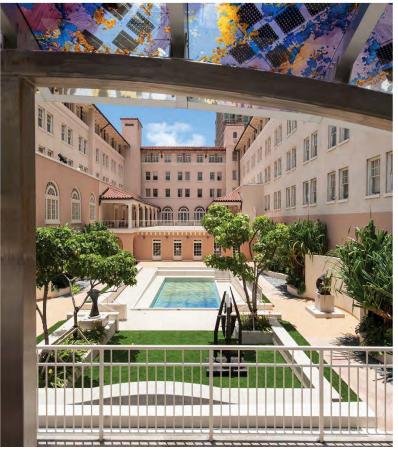
Hawai'i State Art Museum in the Hawai'i Capital Historic District, Honolulu, O'ahu. Originally the Armed Services YMCA, the building was adapted to house an art museum and state offices.

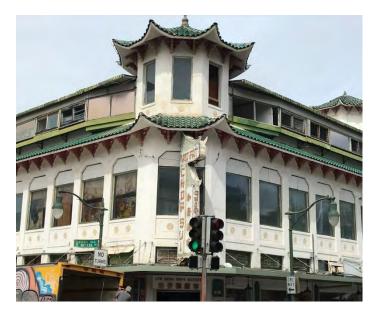
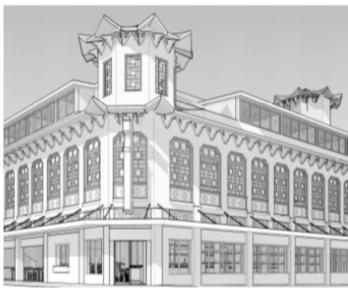
Wo Fat Building, Chinatown, Oʻahu. Rehabilitation plans include retaining distinctive roof lines, removing window fill to restore spatial relationships. Photo by HHF. Rendering courtesy Mighty Wo Fat LLC.

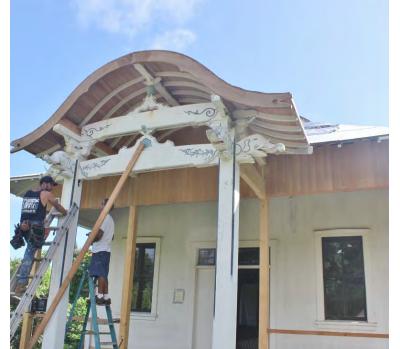
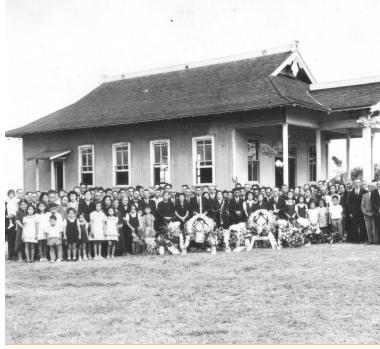
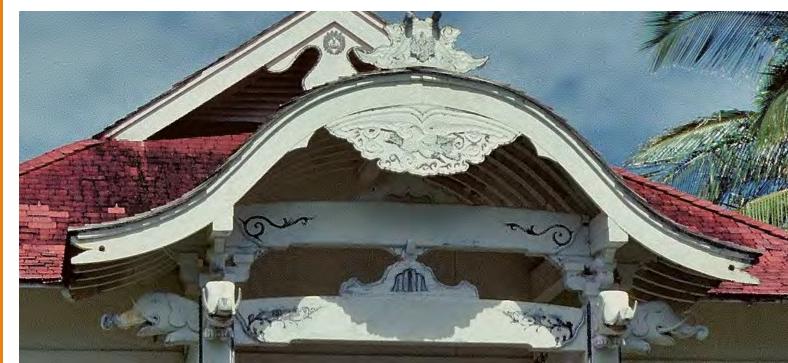
Hāna Buddhist Temple, Hāna, Maui.

The rehabilitation retained, repaired and reconstructed distinctive elements.

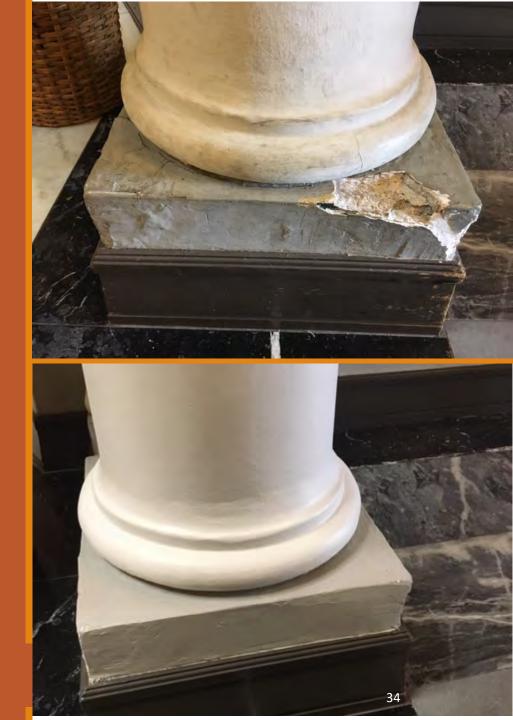
Ali'iōlani Hale, Honolulu, O'ahu. Damaged plaster on columns were repaired with in-kind materials.

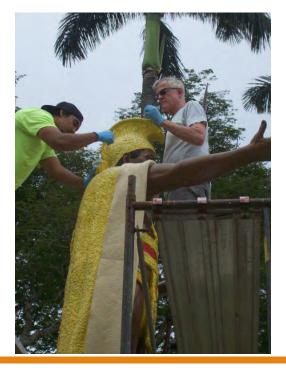
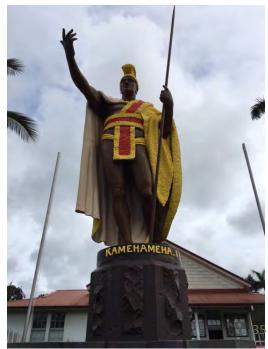
Regular cleaning with soap and water is part of the conservation plan for the statue of Kamehameha I in Kea'au, Hawai'i Island.

7. Chemical or physical treatments, if appropriate, will be undertaken using the gentlest means possible. Treatments that cause damage to historic materials will not be used.

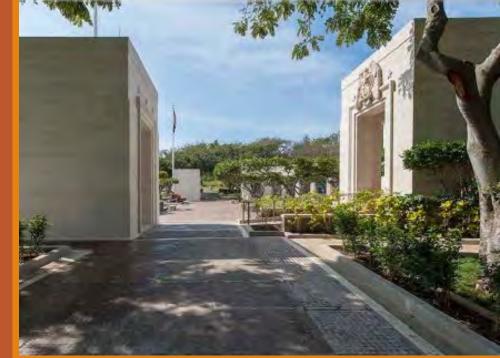
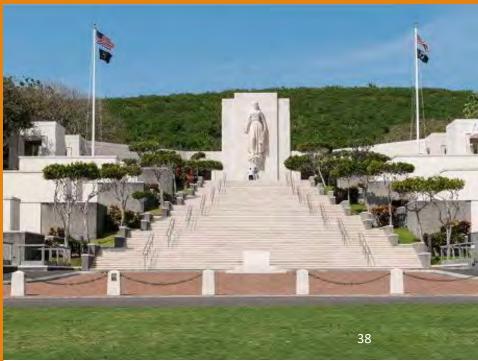
Vietnam pavilion addition to the Honolulu Memorial at National Memorial Cemetery of the Pacific.

New additions and adjacent or related new construction shall be undertaken in such matter that if removed in the future, the essential form and integrity of the historic property and its environment would be unimpaired.

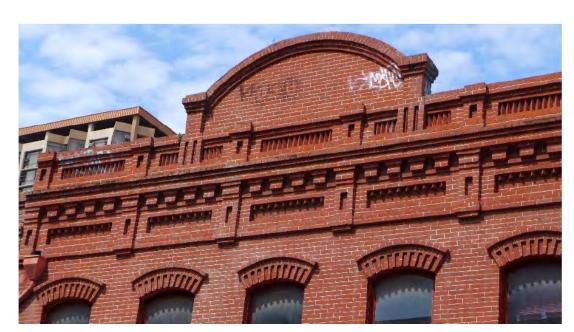
Knowledge Check 3

Graffiti has been painted on an unpainted brick wall in the Chinatown Historic District. The appropriate treatment is:

Standard #7 states that "chemical or physical treatments will be undertaken using the gentlest means possible. Treatments that cause damage to historic materials will not be used."

Power washing and chemical systems can damage the brick, removing the hard top layer and exposing the softer inner layer. The bricks may then turn powdery and fail.

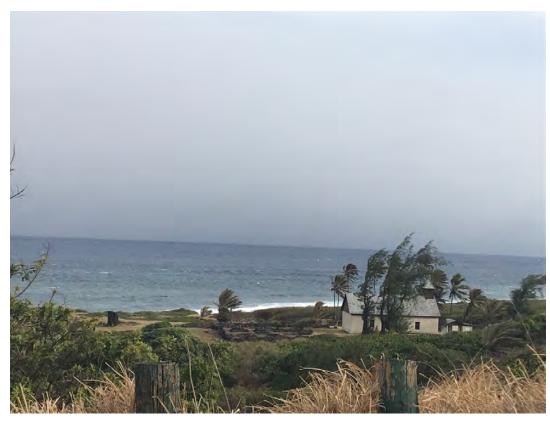
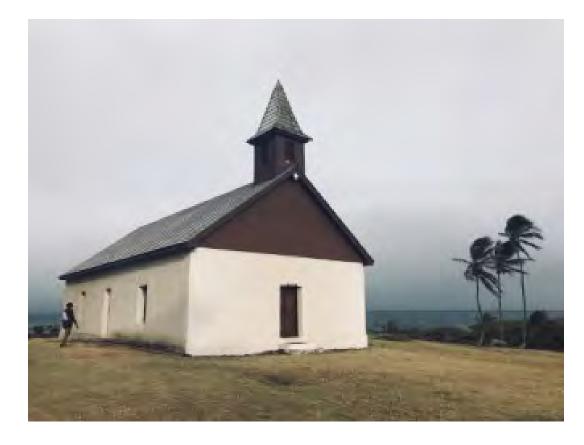
Huialoha Church, Kaupō, Maui. Photos by NPS.

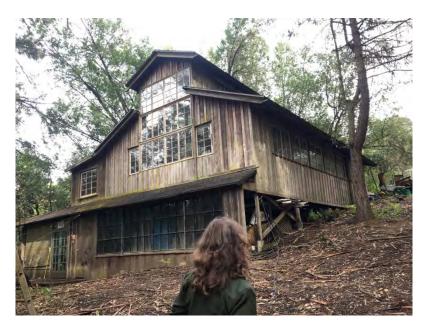
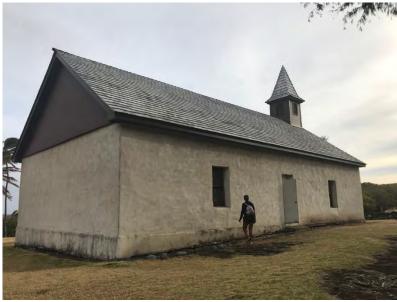
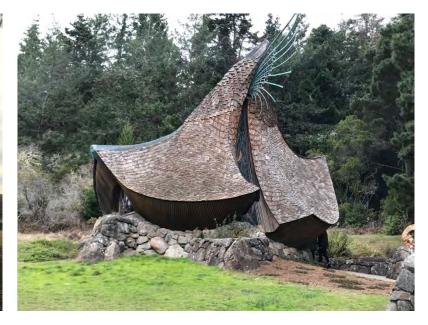
Druid Heights, Golden Gate National Recreation Area, California (left); Huialoha Church, Kaupō, Maui (center); Sea Ranch Chapel, Sea Ranch, California (right). Photos by NPS.

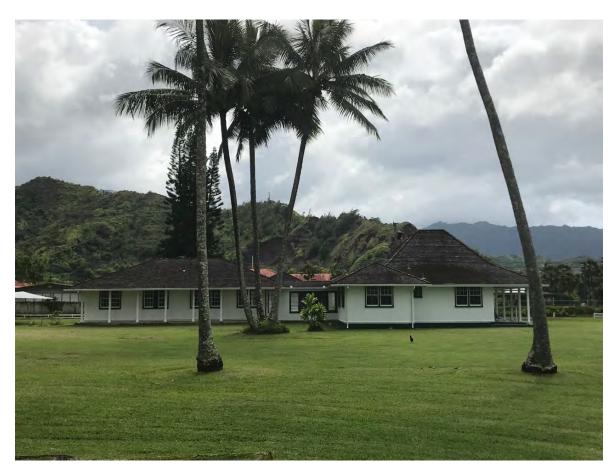
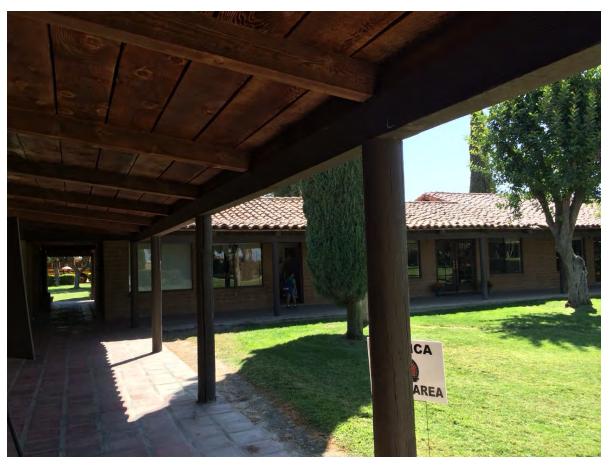
Wai'oli Mission Hall, Hanalei, Kaua'i (right); Agbauani Village, 40 Acres NHL, California (right). Photos by NPS.

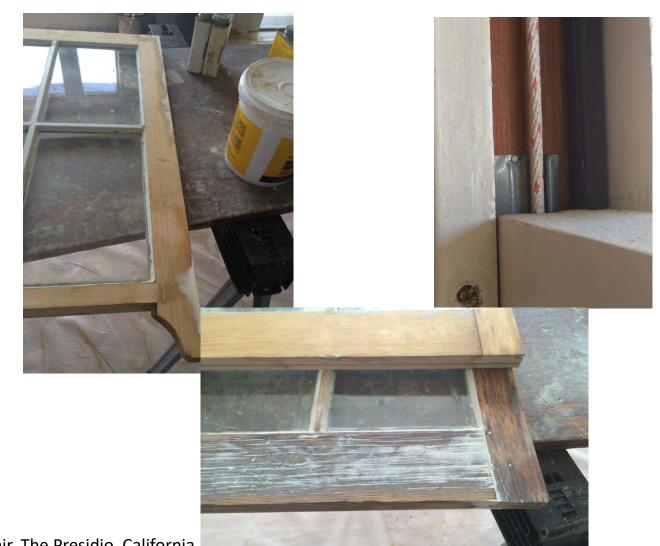
Window repair, The Presidio, California.

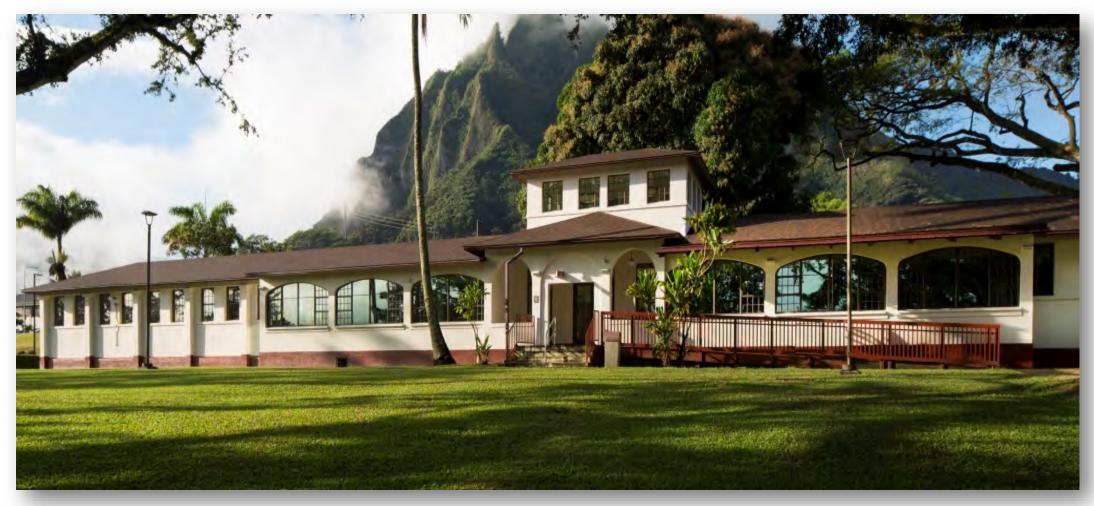
Hale Na'auao, Windward Community College, Kāne'ohe, O'ahu. Photo courtesy WCC.

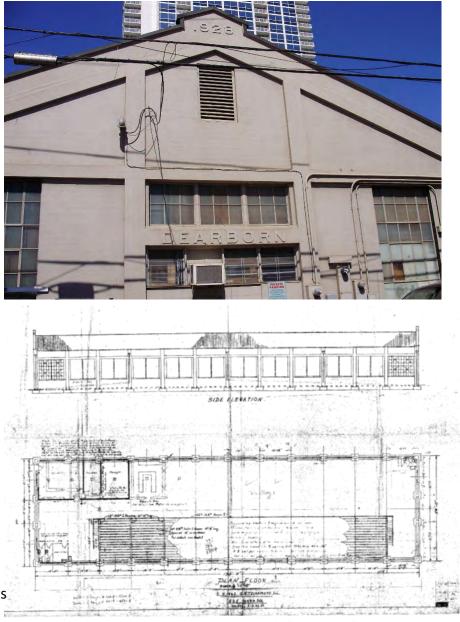
Top: pre-rehabilitation
Bottom: original drawings
(1927)

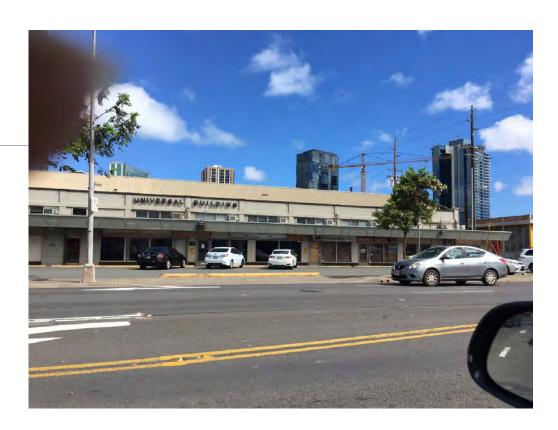
Universal Front Addition, 1965

Left: Elevation for addition (1965)

Right: pre-rehabilitation

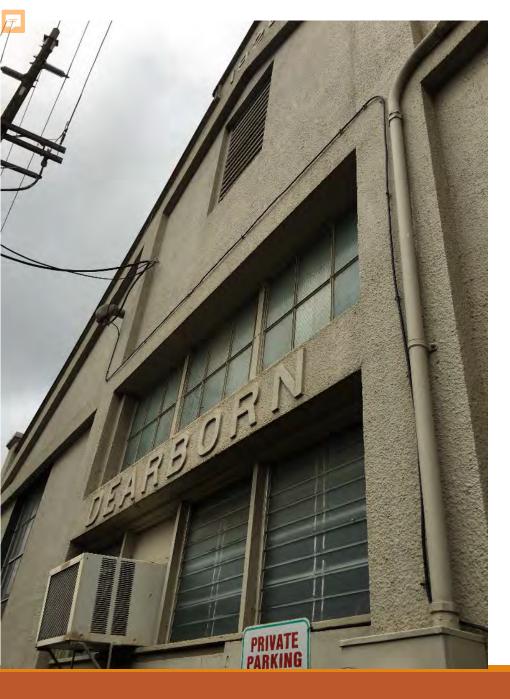
Character-Defining Features

- Single-story, utilitarian, concrete building with classical undertones
- Massing is 54' x 190', three bays wide by 12 bays long.
- Corrugated metal gable roof with pedimented gable ends have a parapet that terminates with a chevron
- Concrete slab foundation
- Square columns at the corners which terminate in Doric capitals
- Concrete walls, plastered on the exterior and impressions of the walls' form work evident on the interior
- Original fenestration pattern intact on Waimanu, Kawaiaha'o and alleyway facades including industrial steel windows with 30 panes of wire glass with hexagon mesh. Other windows are fixed, pivot or glass block.
- Some windows and doors were replaced, covered, infilled or in disrepair
- Fenestration on Ward Avenue was destroyed by the 1965 storefront addition.
- Details include the bas-relief date "1928" and the name "Dearborn"

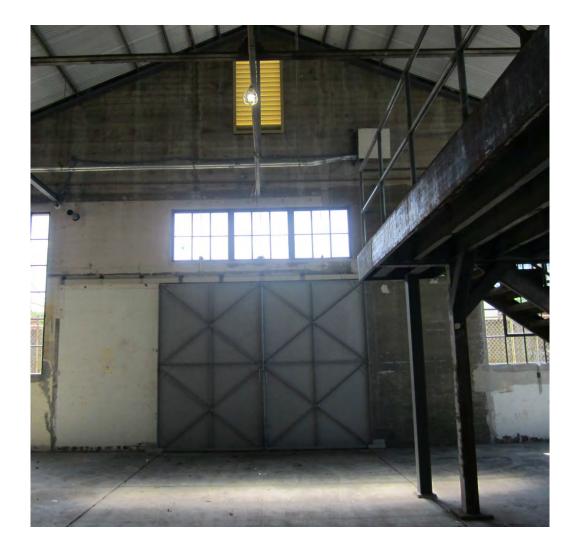
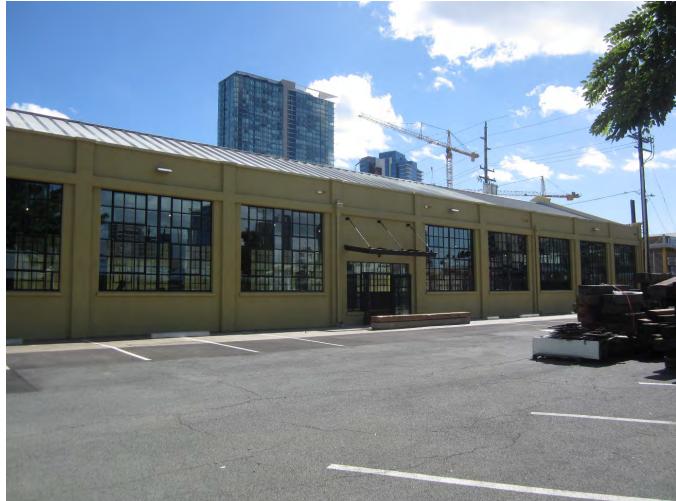
Rehabilitation of Interior

- Interior is one large open space. Interior partitions from the 1965 addition were removed. Several mezzanines were removed.
- One original mezzanine was partially removed and original metal staircase retained.

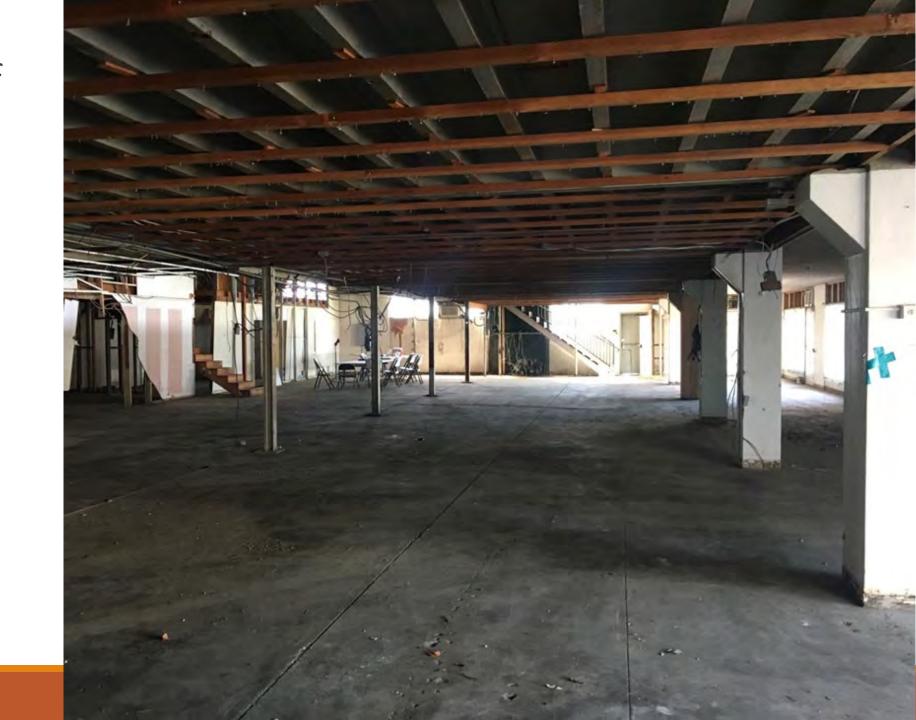
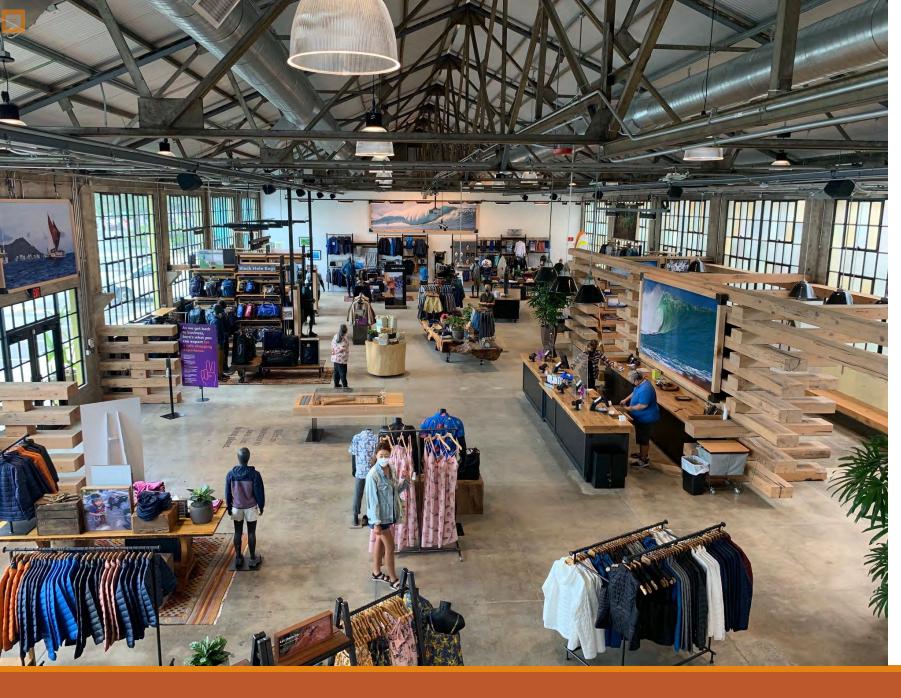
- Replace electrical system and add new electrical room.
- Mezzanine and stairwell added new metal guardrails to match existing and to meet code.
- Did not install an elevator to the mezzanine in order to protect the interior spaces and avoid ground-disturbance in an archaeologically sensitive area. Operational restrictions will keep the mezzanine off limits.
- Existing parking lot is restriped to add handicapped accessible stalls, loading zones and meet current parking codes.
- Bicycle racks, sidewalks and benches are added to Ward Avenue façade
- Plumbing system, water piping, sanitary and gas piping systems are brought to code.
- Mechanical, ventilation and air conditioning systems are brought to code.
- Fire protection systems are brought to code.

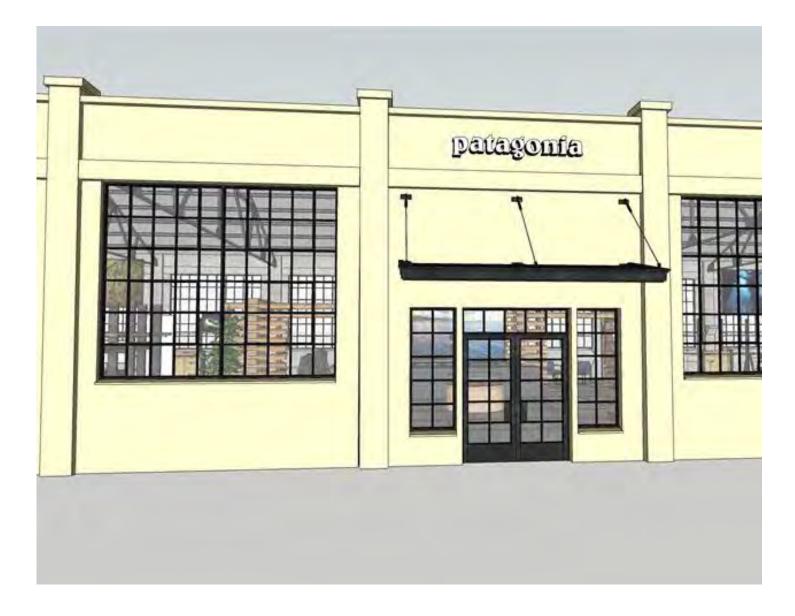
Sustainability

- Photovoltaic system added to both sides of the gable roof, with thin panels mounted in-line with the roof and will not be visible from the public right of way
- Tsunami and flood adaptation measures
- Salvage and reuse of wood from the demolished Ward Warehouse used for fixtures, furniture and equipment.

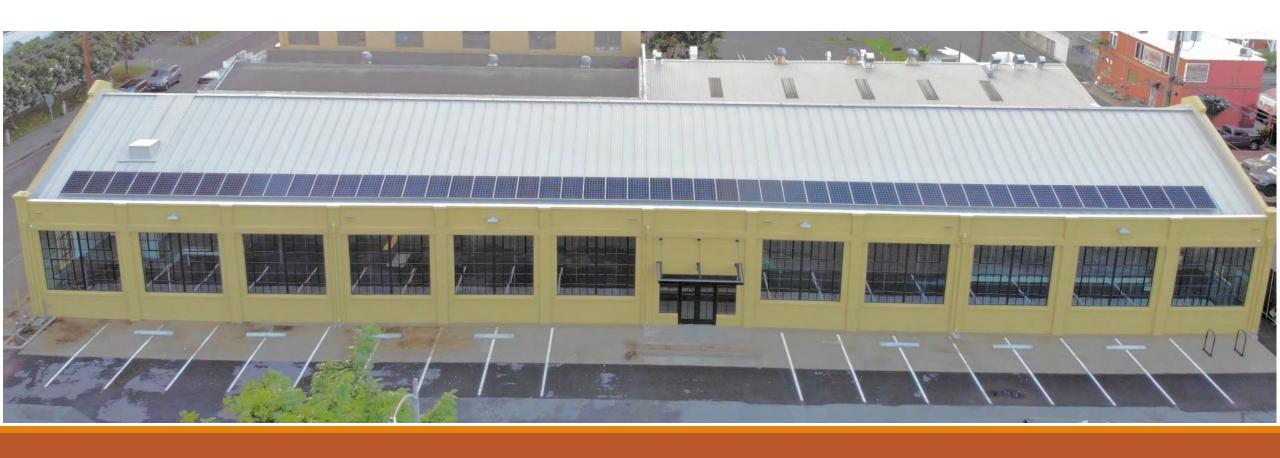
After Rehabilitation, 2020

- New windows match the design of the original wall to replace those that were infilled or deteriorated.
- Central metal doors on Waimanu façade were refurbished. Infilled door on Kawaiaha'o façade restored with metal doors to match the original.

- Metal louvers on end facades were refurbished.
- Prepare, prime and paint exterior to match original building
- Repair or replace gutters and downspouts, roof drainage, concrete splash blocks and pipes.

- New standing seam roof with insulation to comply with current codes
- New supports for roof structure to comply with codes and to support a new PV panel array.
