**NATIONAL REGISTER OF HISTORIC PLACES  
REGISTRATION FORM**

historic name Waiakea Mission Station, Hilo Station

other names/site number Haili Church (preferred), HRHP 7417

Haili Congregational Church  
name of property

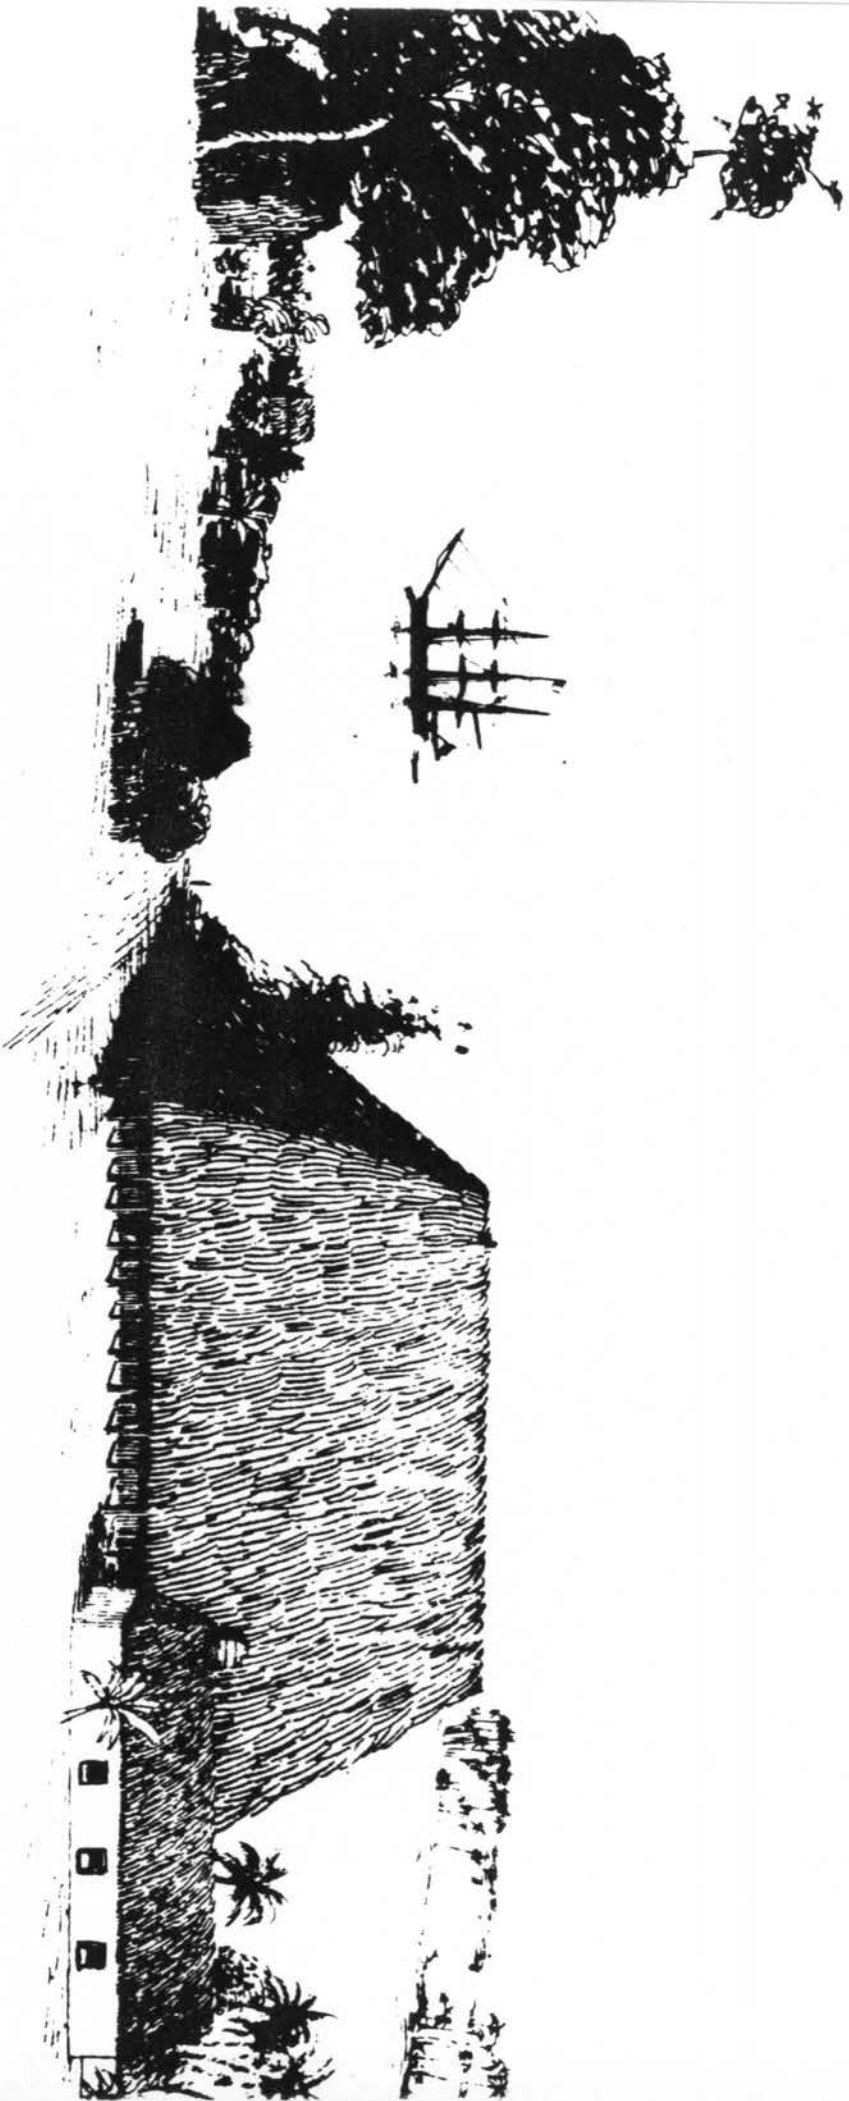
HAILI CHURCH & MISSION HOUSE IN 1849  
REDRAWN FROM SKETCH BY W.D. ALEXANDER  
BY S. HIRONAKA - 1926

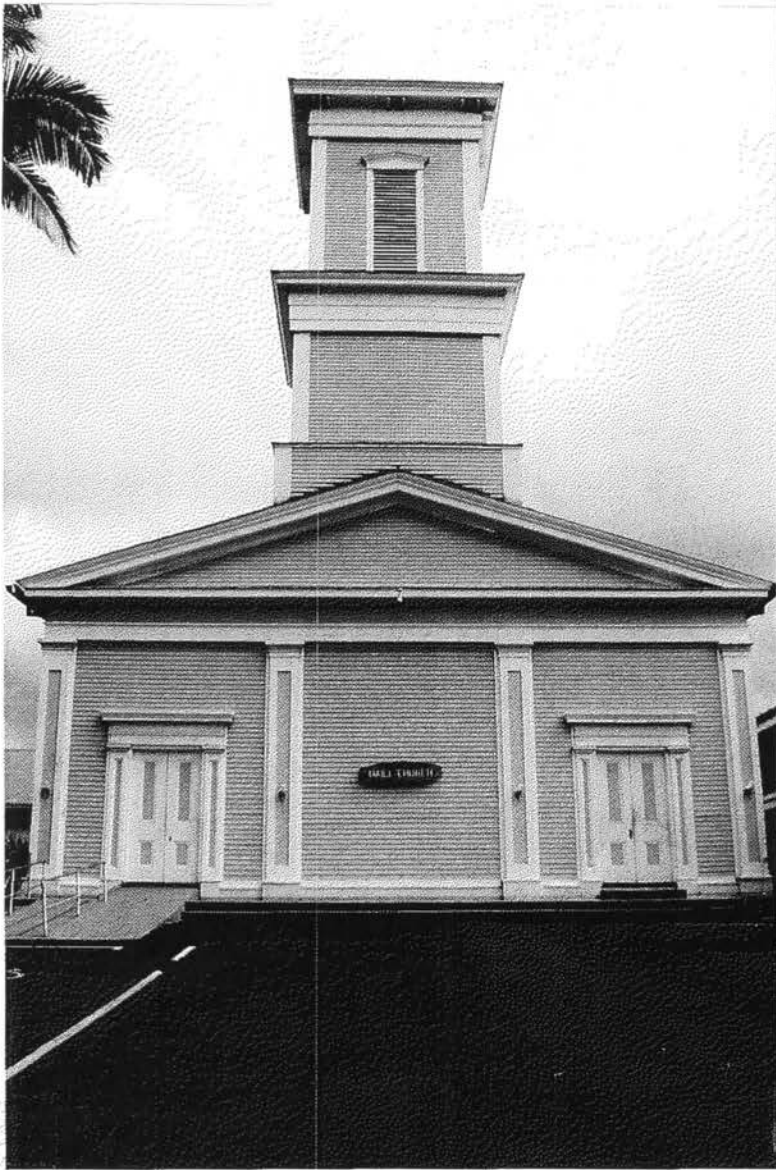
PHOTO OF HAILI CONGREGATIONAL CHURCH  
TAKEN LAST WEEK

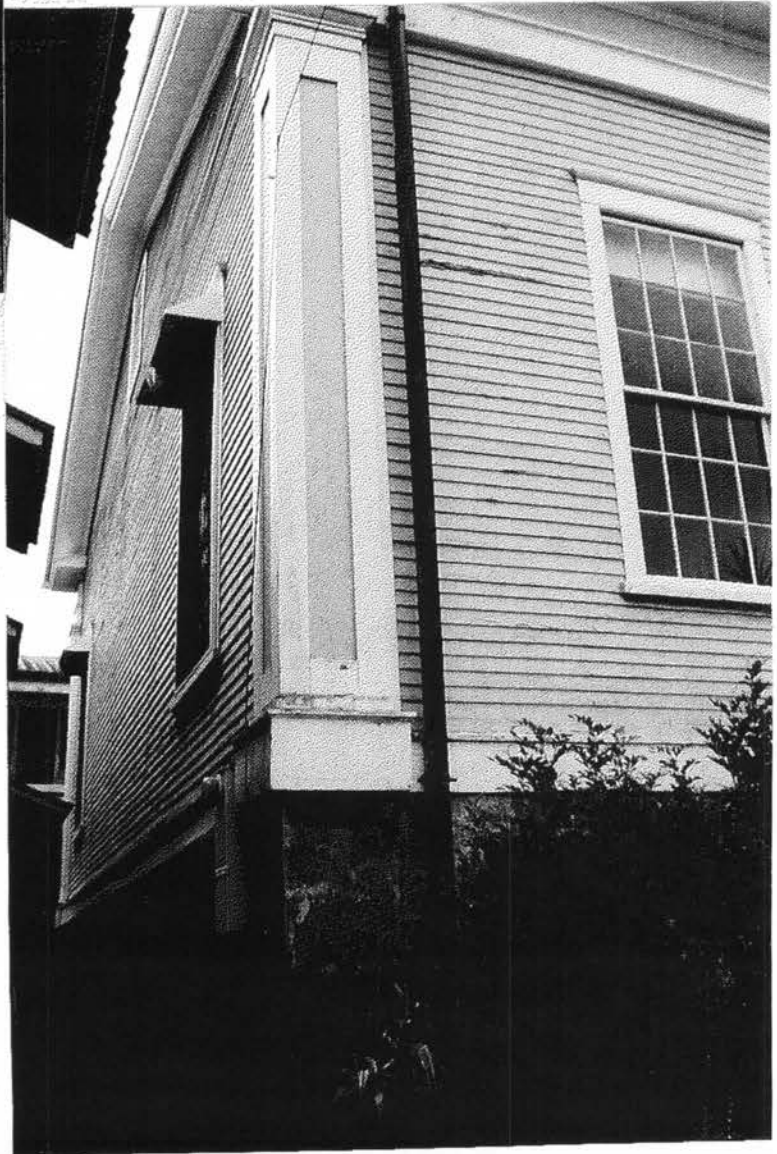
UNVEILED  
JUNE 28, 1908  
IN MEMORY OF  
TITUS COAN  
BY CHURCH  
MEMBERS  
AND FRIENDS  
OF CHURCH  
SELECTED BY  
TIFFANY  
GALLERIES  
IN NEW YORK

The other gable end, as well as the east and west side walls, have evenly spaced pilasters at the immediate corners of the building as well as in the central wall sections. The pilasters abut at the corners of the building, and finish the corners visually besides following in the proper tradition of the Greek Revival. The side elevations feature four large wood framed, twelve-over-twelve double hung windows, many with the original wavy glass, centered between the pilasters. The two windows at the south end of the building, to the left and right of the lectern were replaced with stained glass windows in 1908. The stained glass windows from Tiffany Galleries in New York, depict "Moses, the Law Giver" and "Jesus, the Good Shepherd."

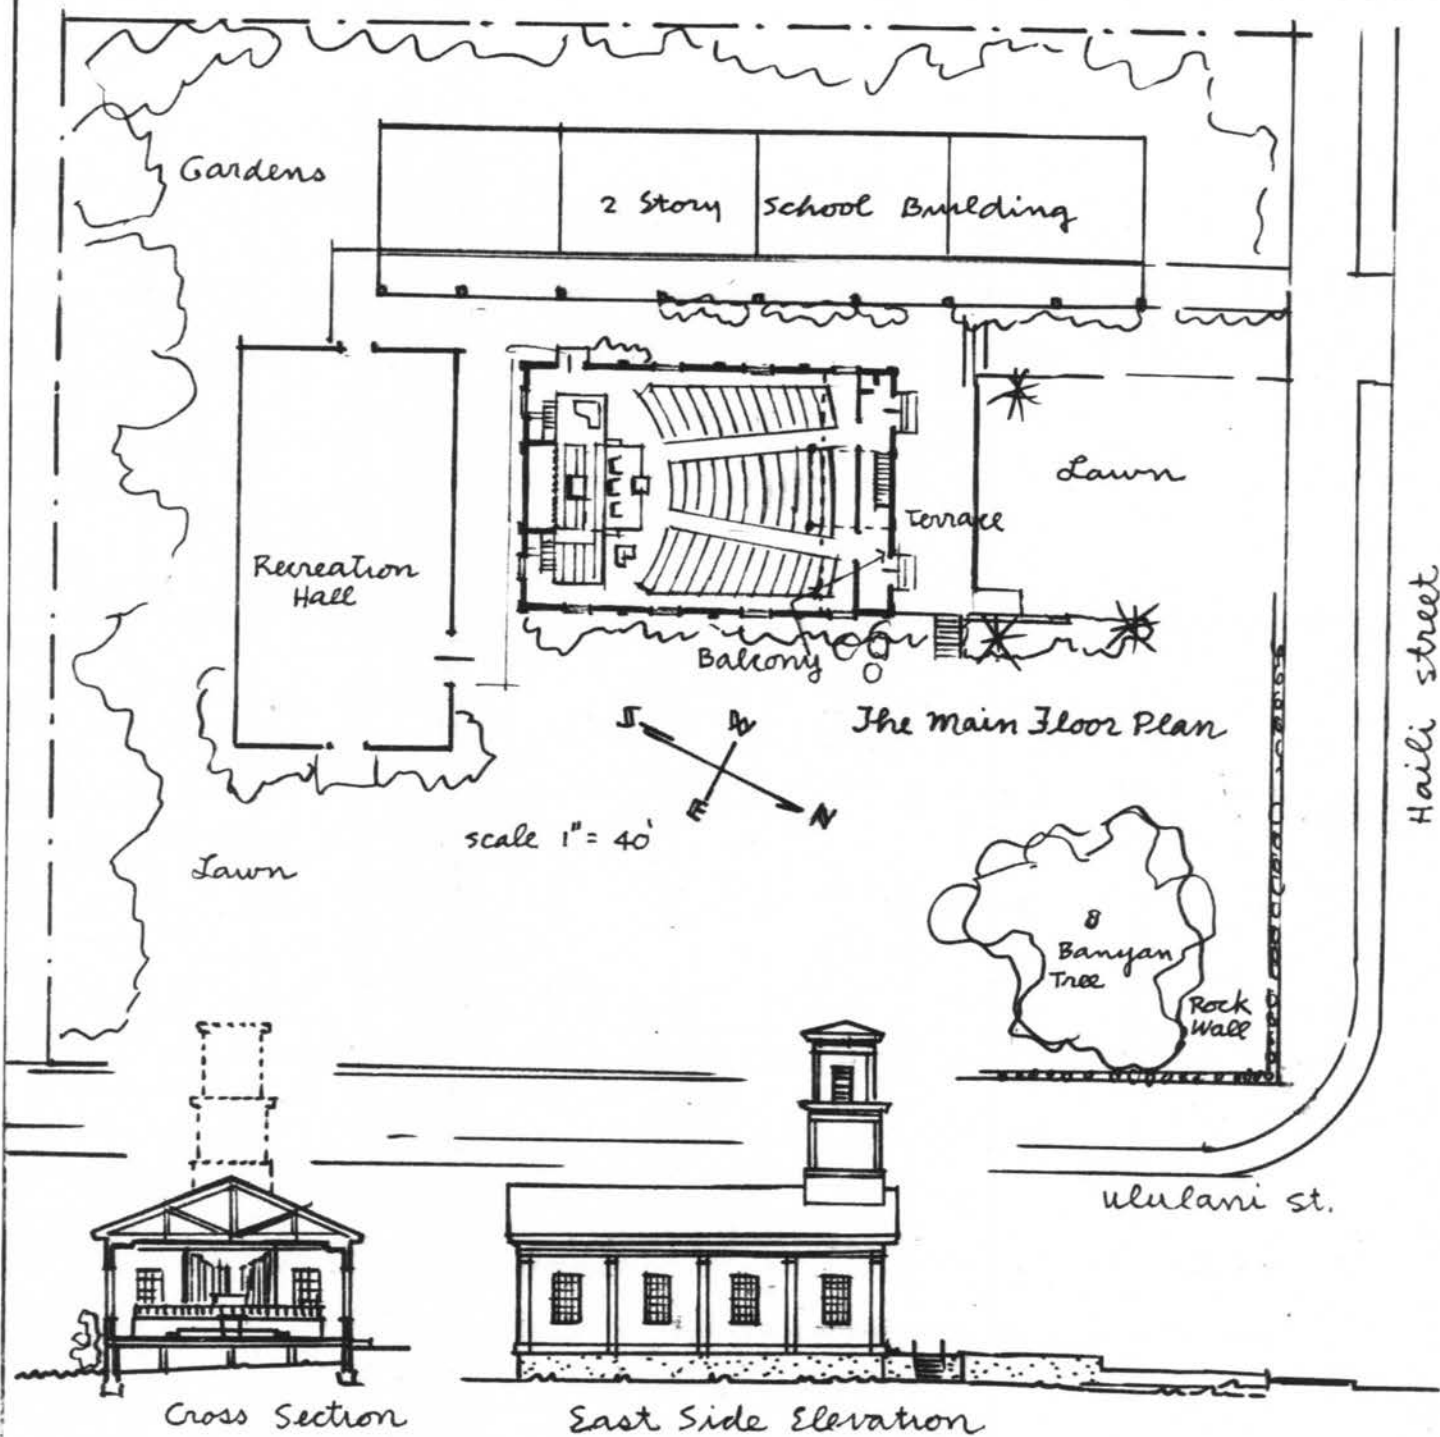
PLATE 13

• HAILI CONGREGATIONAL CHURCH •  
HILO • HAWAII.
