National Register of Historic Places Registration Form

Historic name: A Resort Home for Mr. & Mrs. David Barry, Jr.

| Street & number: 3625 Diamond Head Road | | | |

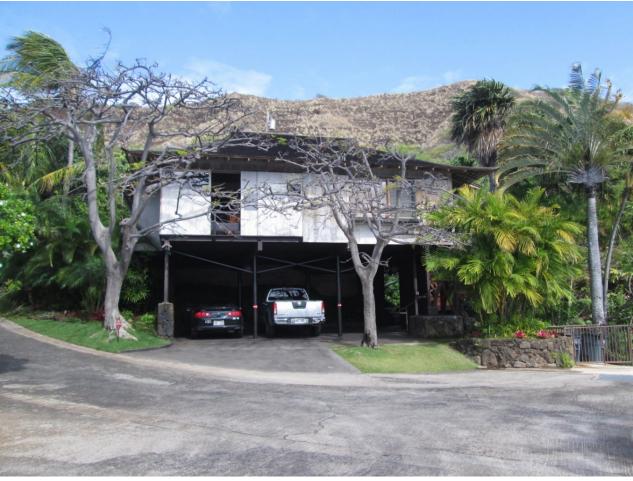
Barry_Resort_Home_002. Detail view of exterior south elevation of Lower Pavilion, showing horizontal sliding panels that stack to open the engaged lanai with carport underneath. View facing northeast.

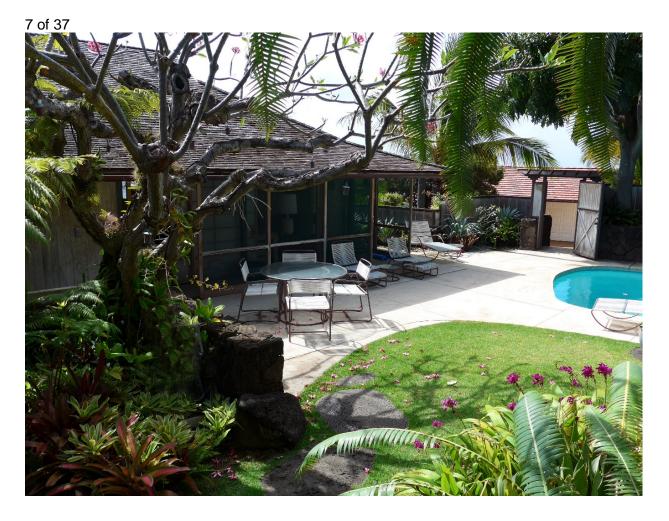
Barry_Resort_Home_007. Detail view of northwest elevation of the Lower Pavilion from the central courtyard, showing the west entrance gate, lava rock walls, fence, swimming pool, and plantings. View facing southwest.

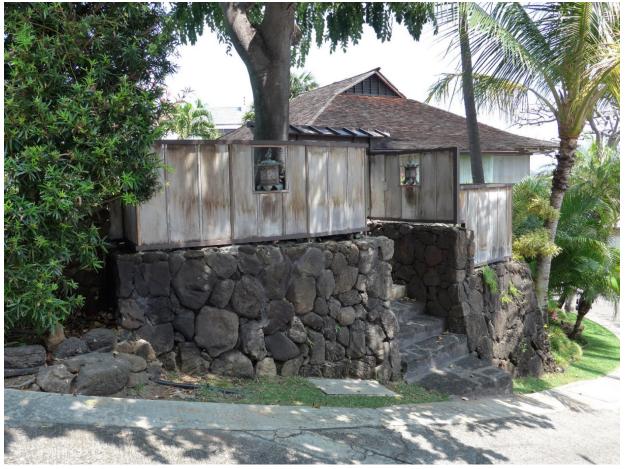
Barry_Resort_Home_012. Exterior view of west elevation of courtyard entrance (foreground) and Lower Pavilion (background), showing lava rock walls, entrance steps to west gate, and roof details. Photo taken from private drive off Diamond Head Road, view facing southeast.

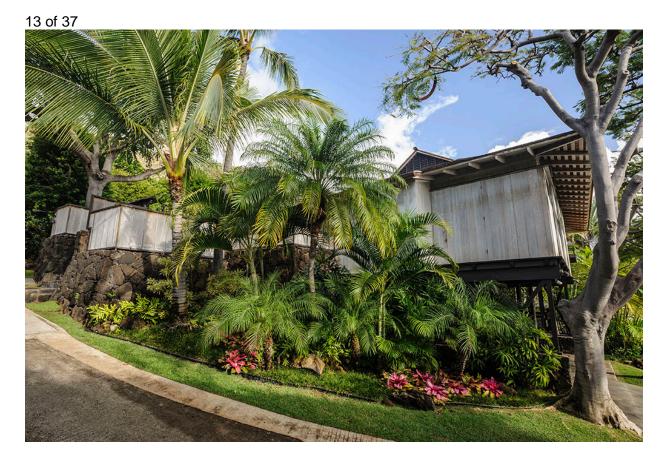
Barry_Resort_Home_014. Detail view of southwest exterior elevation of Lower Pavilion, showing vertical redwood folding doors that open the engaged lanai and architectural details, and carport below. View facing northeast.

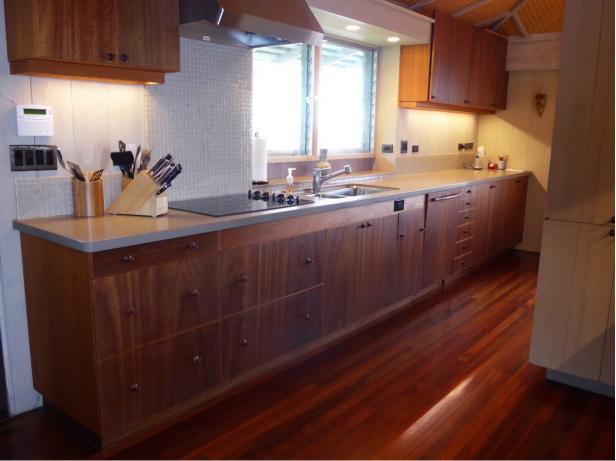
Barry_Resort_Home_015. Interior view of kitchen in the Lower Pavilion, showing Philippine mahogany cabinets on the east wall and *Eucalyptus robusta* flooring. View facing southeast.

Updates to the kitchen closely followed the original specifications and drawings. Although the faucets have been updated, the original double stainless steel kitchen sink remains. Appliances have been updated but remain in their original locations. Cabinetry has been repaired and refurbished.

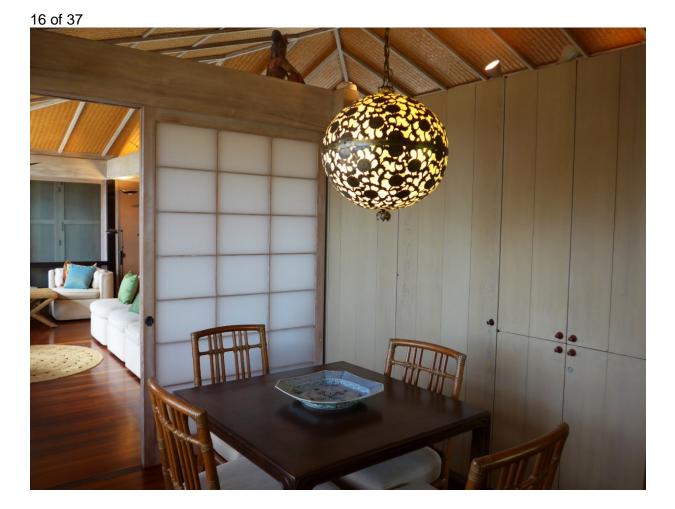
Barry_Resort_Home_017. Interior view of Ianai facing west in the Lower Pavilion. Note: Interior view of vertical folding redwood panels with redwood horizontal sliding panels located to the left of the image at the south elevation. Panels open the lanai to the southern/western ocean facing view.

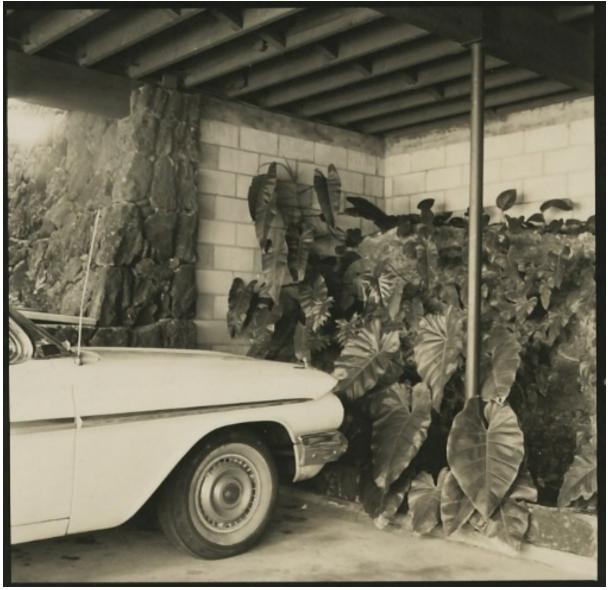
Barry_Resort_Home_030. Historic photograph dated 1961: Exterior north elevation of Lower Pavilion. View facing southeast. Photographer unknown.

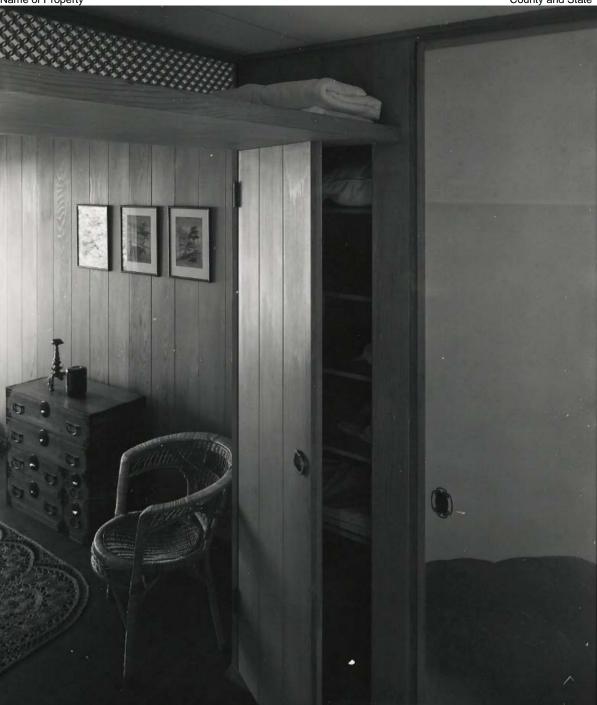
Barry_Resort_Home_037. Historic photograph dated 1961: Interior view in the master bedroom of the Upper Pavilion, showing the soffit/transom detail between the master bathroom and bedroom. View facing southwest. Photographer unknown.
